State of Oregon  
Department of  
Environmental  
Quality

# LANDFILL INSPECTION REPORT

| <b>FACILITY:</b> | Riverbend Landfill | | |
| <b>INSPECTOR(S):</b> | Bob Schwarz | <b>INSPECTION DATE:</b> | Jan 14, 2014 |

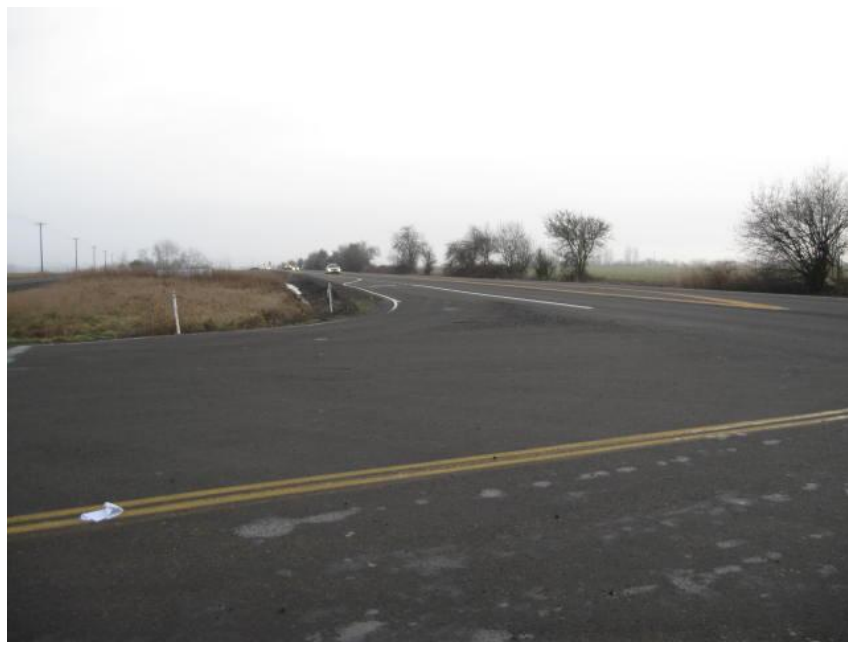
**Erosion and sediment controls.** Highway 18 looked fairly clean (very little mud or stones). See photos 1,2, 6 and 7. This differs from observations of at least two neighbors, who recently complained of mud on the roads and dust kicked up by trucks driving over the mud. A neighbor complained of a large cloud of dust on the road during the same time that I was conducting this inspection. I did not observe dust clouds over the road.

1. Highway 18 viewed from Masonville Road, looking northeast.

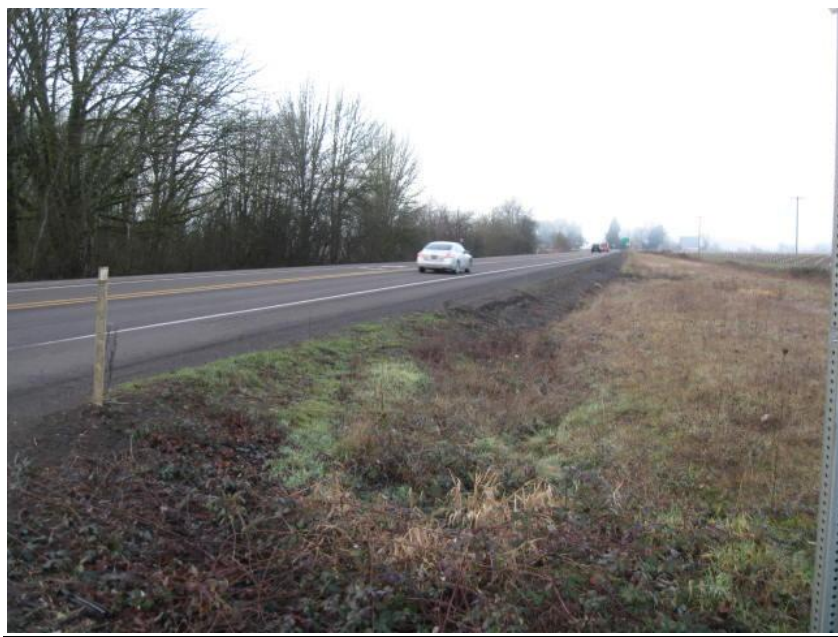
2. Highway 18 and eastern drainage swale, looking northeast from point near northern extent of Waste Management property.

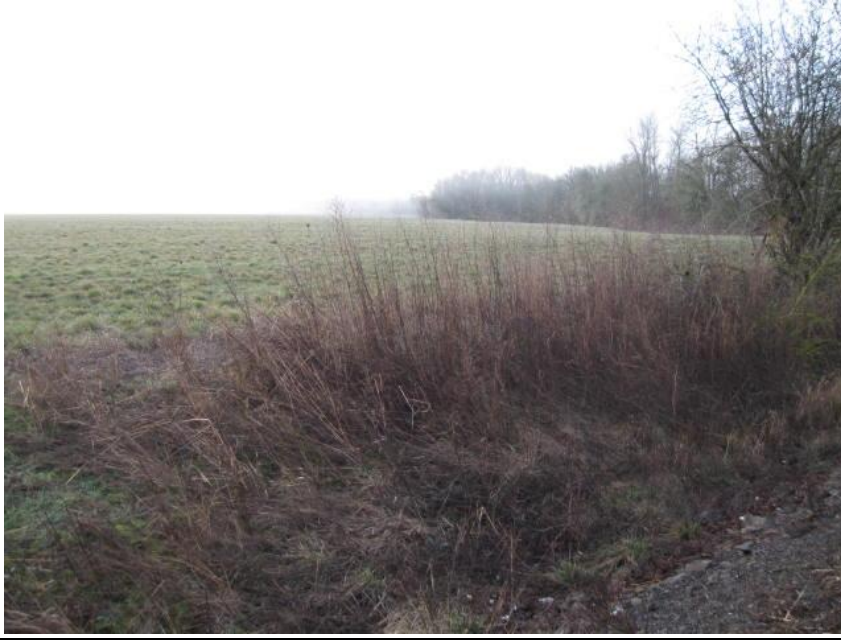
**Litter and birds.** I drove north along Highway 18 from the landfill prior to entering the site to assess the amount of litter on and along the side of the road. I did see some litter most of the way. DEQ has received complaints recently of a large amount of roadside litter near the landfill. I then drove along back roads west of the landfill and observed litter there as well. This included blowable litter, such as plastic bags, which could have come from the landfill or trucks. I also observed steel cans and other debris, which presumably are not from the landfill. I then proceeded further north on Highway 18. North of the junction with 99, the roads had less litter because a litter pickup had been done recently. Bags of litter were placed along the roadway for pickup. Neighbor Ramsey McPhillips has complained recently of an increase in litter, birds and rats on his property. I did observe approximately 80 seagulls on that portion of his land that I could see from the highway. I did not see litter on his property. See photos 3, 4 and 5.

3. View of field on McPhillips property, from Highway 18.

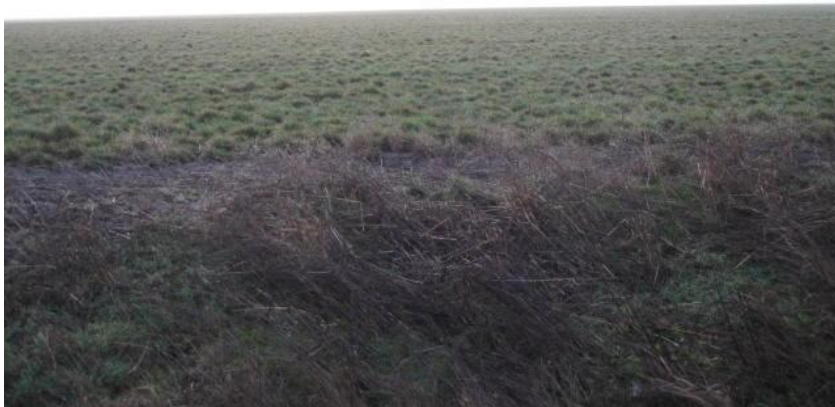
4. View of field on McPhillips property, from Highway 18.

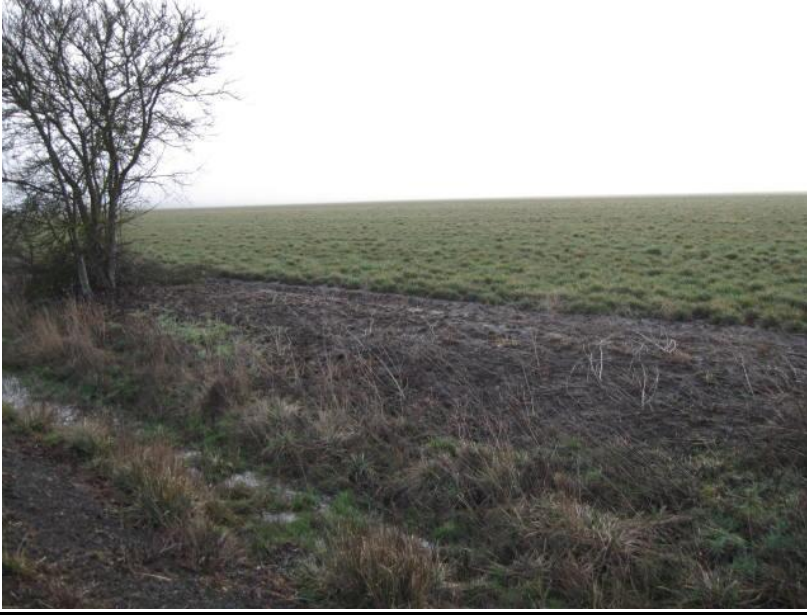
5. View of field on McPhillips property, from Highway 18.

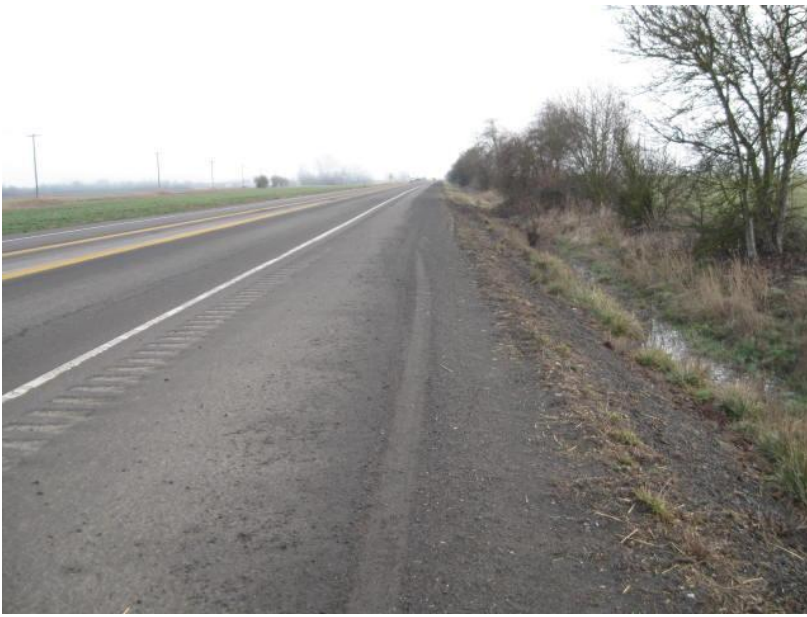
6. Highway 18 and eastern drainage swale, looking northeast from point adjacent to McPhillips property.

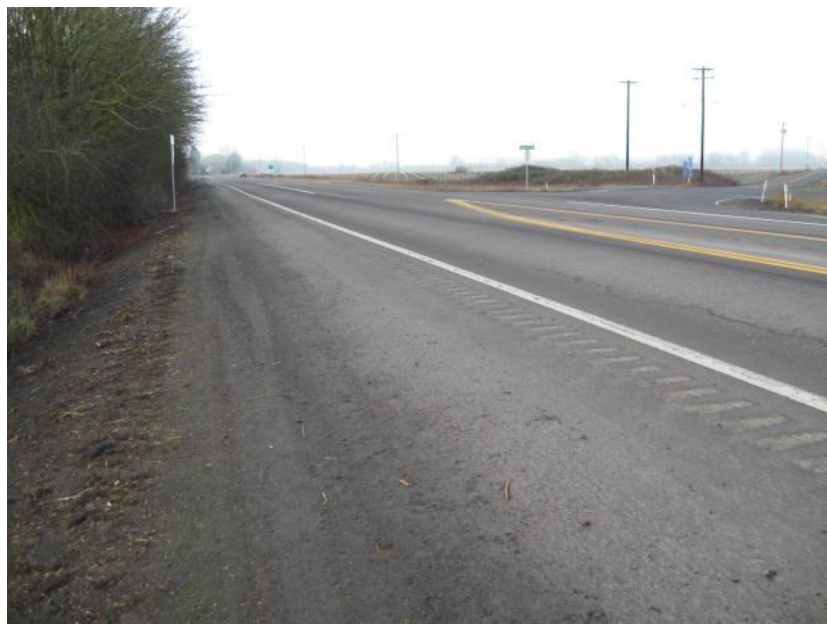
7. View of Highway and Masonville Road, looking southwest.

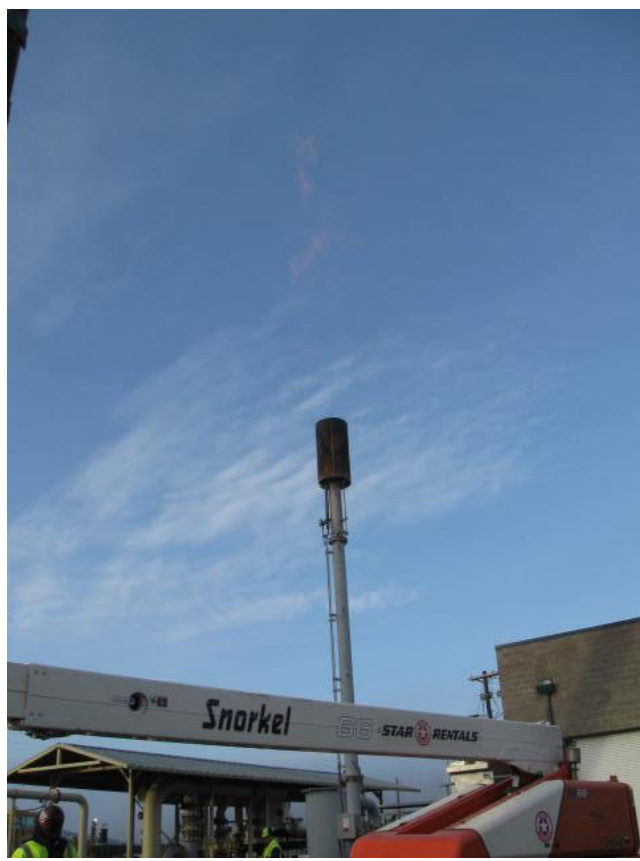
**Gas flare.** The landfill's enclosed flare has been down for repairs. Repair personnel were onsite today. The flare has a vertical wall that divides it into a large and small chamber, to enable it to work efficiently at large and small gas loading rates. This vertical wall appears to have been damaged, possibly due to heat. Pieces of this wall were removed during my observation. One member of the repair crew told me the problem could be that portions of the wall had fallen on some of the gas burners. Waste Management brought in a candlestick flare for use in the meantime. This is shown in photo 8. The landfill has received several complaints that the landfill is on fire. This is presumably because this replacement flare has an open flame, unlike the landfill's regular flare. The flame is very

visible at night.

8. Candlestick flare brought to the site because the site's enclosed flare is down for maintenance. The flame is somewhat visible above the unit.

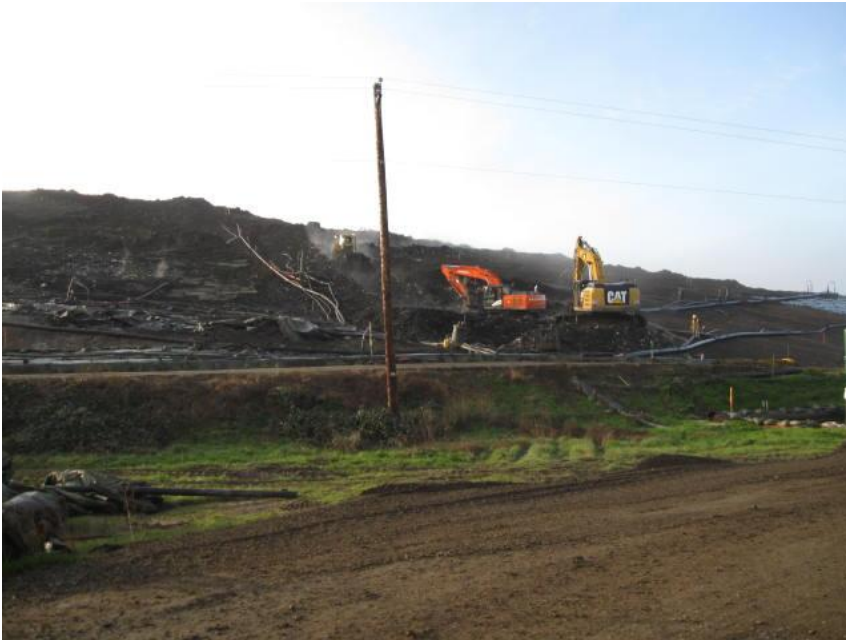
9. Relocation of waste along north slope. This is being done partly for construction of the north access road and partly to accommodate the revised grades associated with the northern portion of the MSE berm.

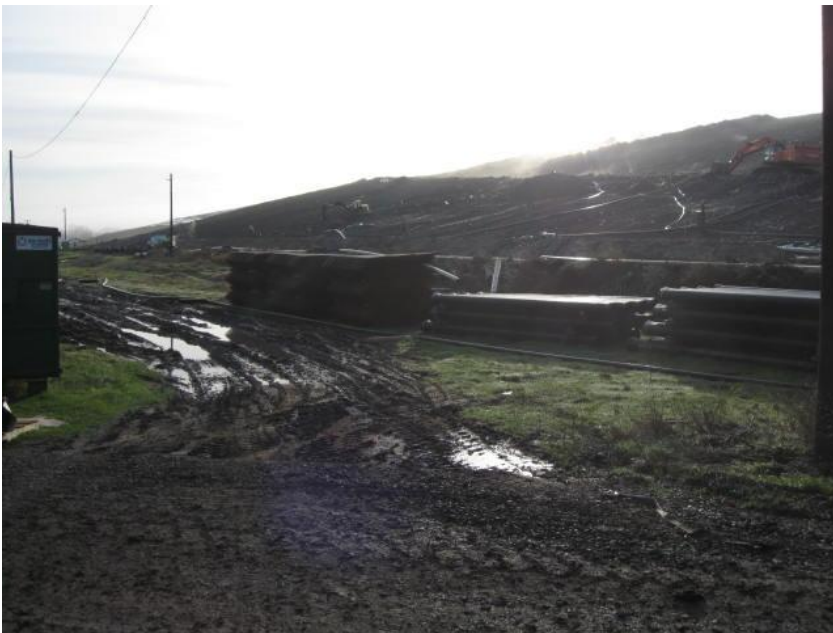
10. Another view of north slope of landfill.

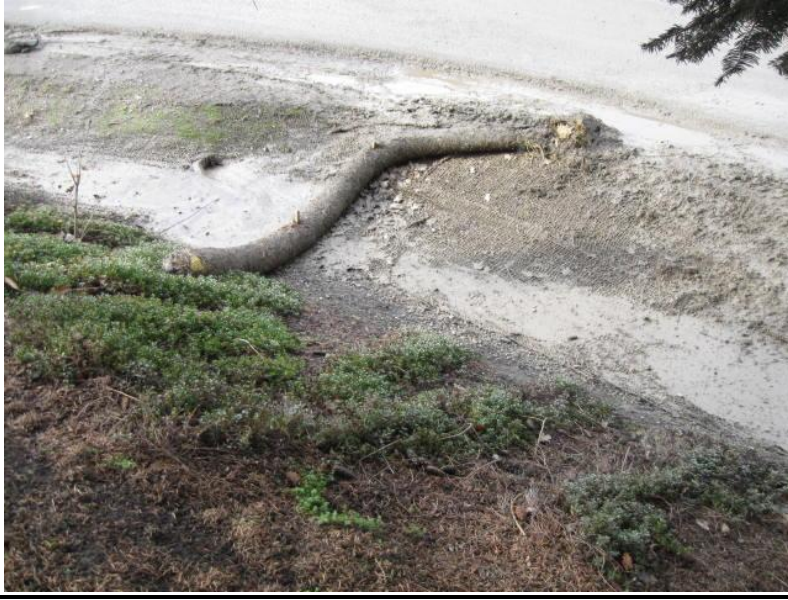
The wattles (photo 11) used to collect sediment along the side of the Highway 18 are not working as well as intended. Some mud is passing under them. Contractor said today that these will be replaced with aggregate check dams.

| <b><u>V</u></b> | <b><u>STORMWATER MANAGEMENT</u></b> | <b>In<br/>Compliance</b> | <b>Not in<br/>Compliance</b> | <b>N/A for this<br/>Inspection</b> | <b>Follow-up<br/>required</b> |
|---|---|---|---|---|---|
| | Notes: Some mud is getting under wattles placed in drainage swale along highway. Contractor noted that they will replace these with gravel check dams. | | | | |

11. Wattle (netting filled with mulch) to block sediment and reduce velocity of stormwater. As shown, some sediment is passing under the wattles. The contractor plans to replace these with aggregate (rock) check dams. These will therefore be replaced with aggregate (rock) check dams.
