State of Oregon  
Department of  
Environmental  
Quality

# LANDFILL INSPECTION REPORT

| <b>FACILITY:</b> | Riverbend Landfill | | | | |
| <b>INSPECTOR(S):</b> | Bob Schwarz | | <b>INSPECTION DATE:</b> | Mar 19, 2014 | |

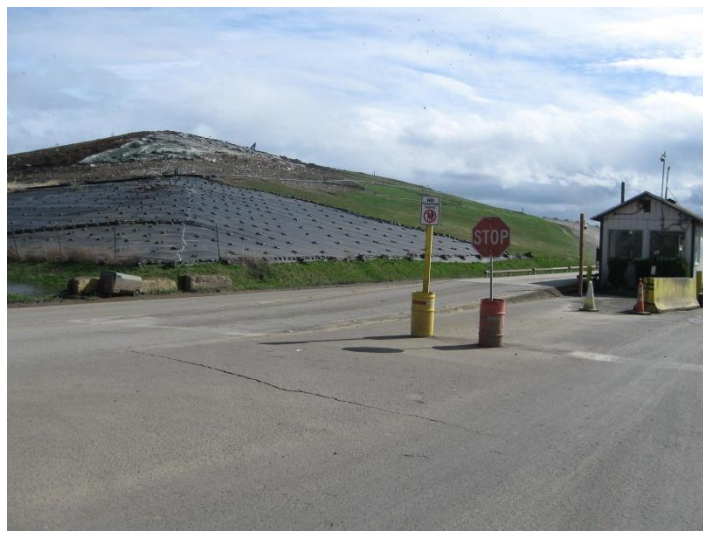
Photo shows state of grass cover on NW side of landfill, as well as cleanliness of road near scalehouse. Landfill roads near exit are generally free of mud. However, mud and stones remain on the center strip of Hwy 18 near landfill entrance. Contractor had been discussing with ODOT how to obtain permission to clean road. ODOT has recently said they intend to do it themselves.

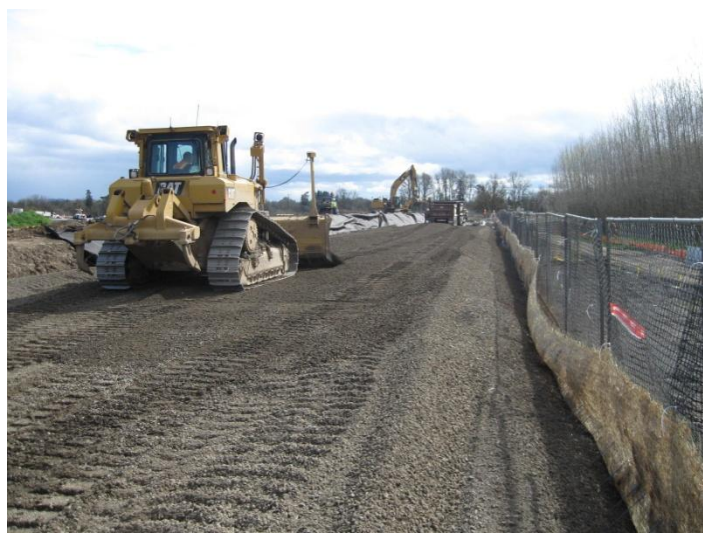
Spreading and compacting granular soil in the outer portion of the mechanically stabilized earthen (MSE) berm. This portion of the berm is the “reinforced fill zone”. It is reinforced by layers of uniaxial geogrid placed every 18 vertical inches.

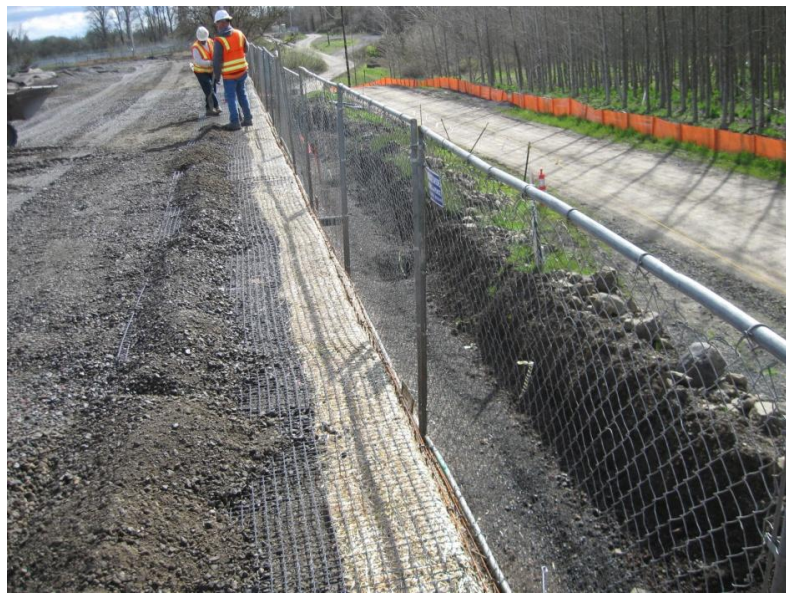
Outer face of MSE berm. Berm is 7 lifts high at this location. Each lift is 18 inches, so berm is approx 10 feet above surrounding ground elevation.

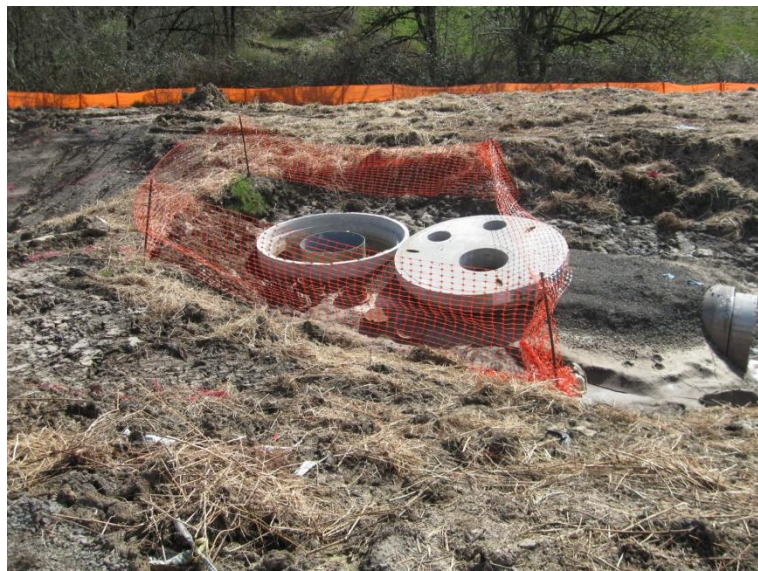
Inlet structure at uphill end of the stormwater drainage pond at SW corner of landfill. This pond was recently cleaned out as part of the MSE berm construction.

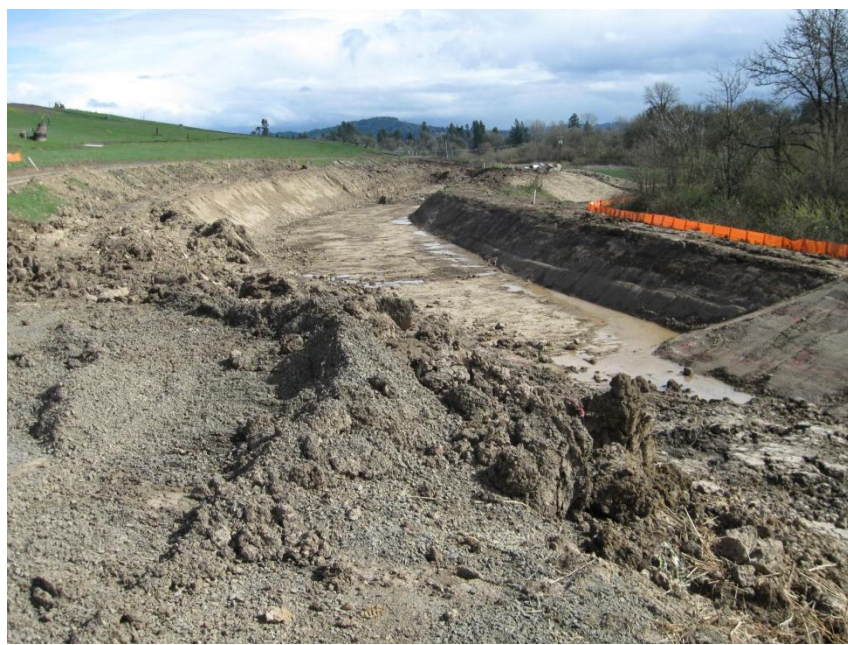
View of stormwater pond near SW corner of landfill, from the uphill (west) end, looking east.

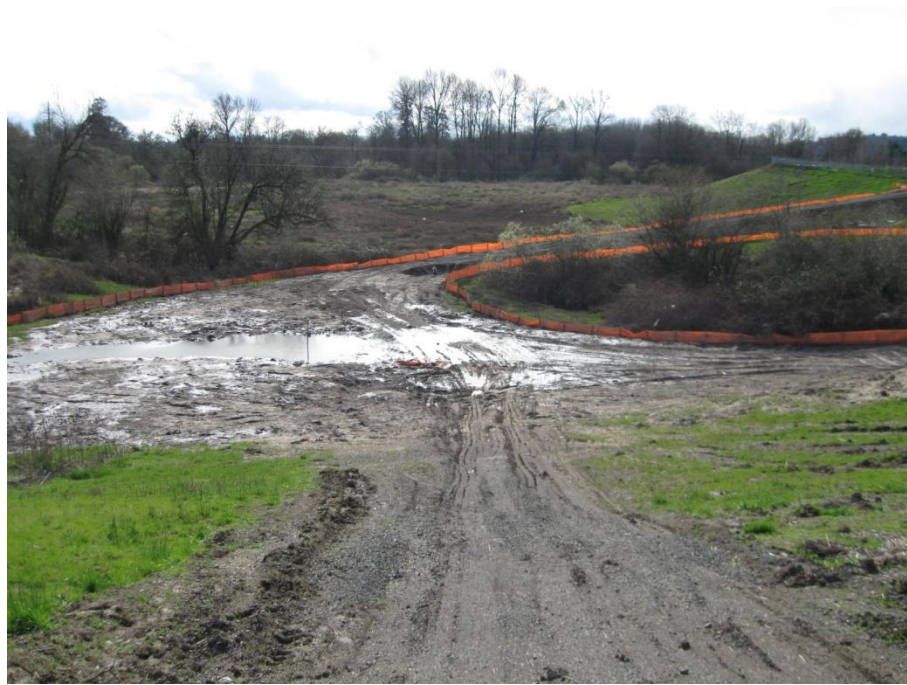
View of the cleanout pipe for the leachate line connecting sump 4/5 to the leachate pond. (Cleanout pipe is just left of where the orange construction fence takes a sharp bend.) The berm of the leachate pond is in the right side of the photo.

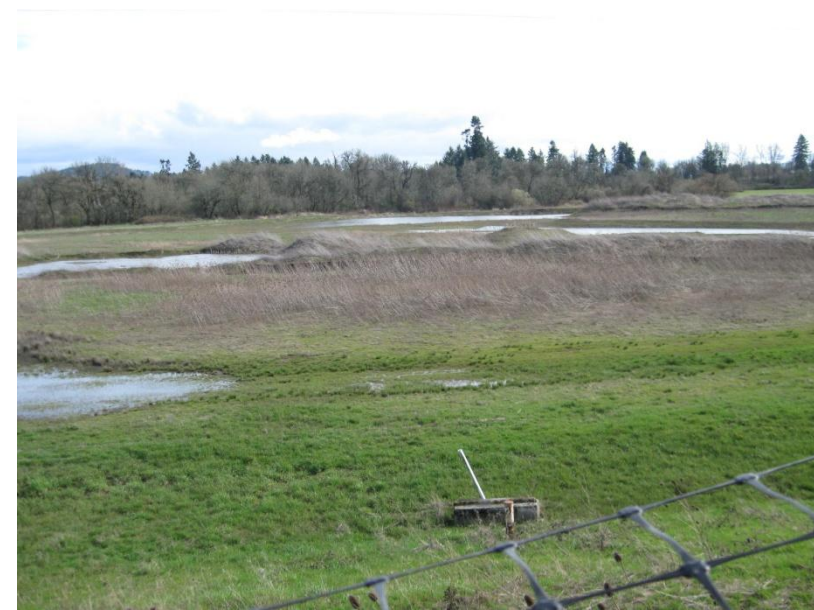
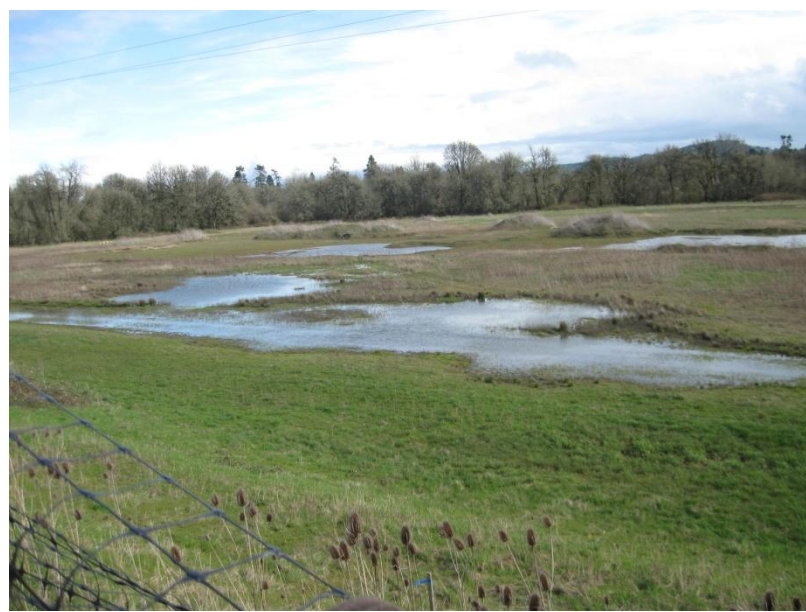
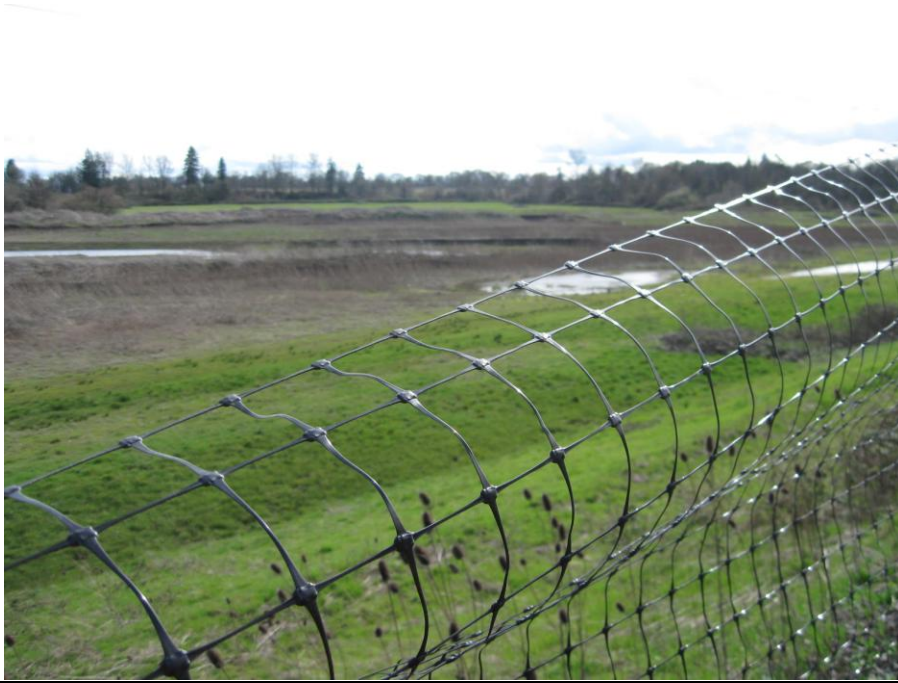
FOLLOWING THREE PHOTOS: Views of the soil borrow areas south of the landfill. This area has not been disturbed for at least two years. Soil removal from this area is only allowed during the summer months.

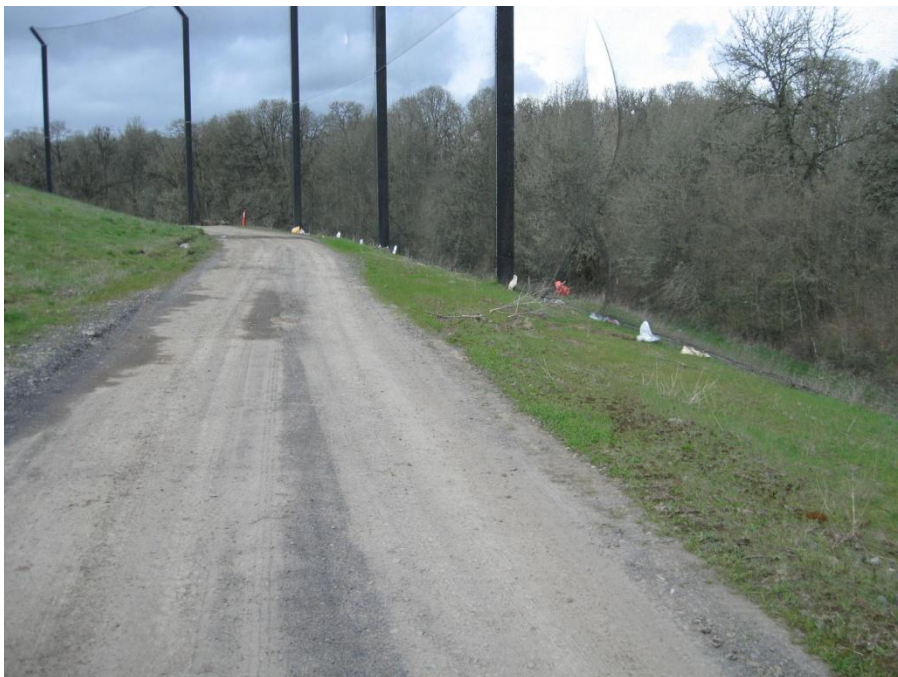
| I. | OPERATIONS | In Compliance | Not in Compliance | N/A for this Inspection | Follow-up required |
|---|---|---|---|---|---|
| | Notes: I observed approximately 50 to 100 bags on the north and east sides of the landfill, blowing to the northeast. The tall litter fence placed there had several very large holes, and some of the bags were getting through the holes and leaving the landfill. Tim Watson mentioned that these slopes were free of litter just a few hours before, and were the result of the wind gusts that had started in the afternoon. Tim also said he was working on getting bids for repair of the litter fence. Following my inspection, I contacted the landfill by email and requested details of schedule for repair of the fence and improved litter control efforts. | | | | |

Tears in tall litter fence on east side of landfill. Some plastic bags have escaped from the landfill.

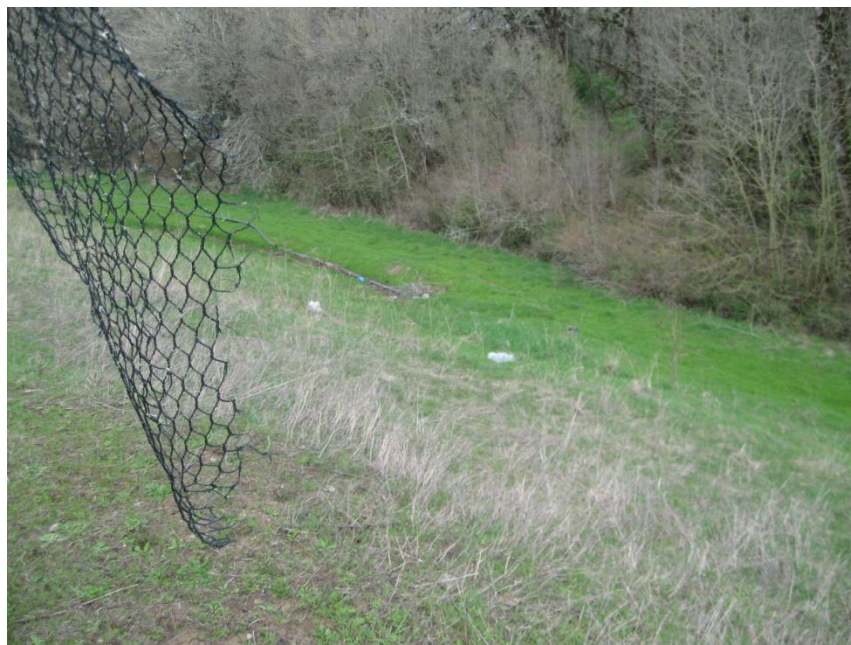
Plastic bags on east slope of landfill.

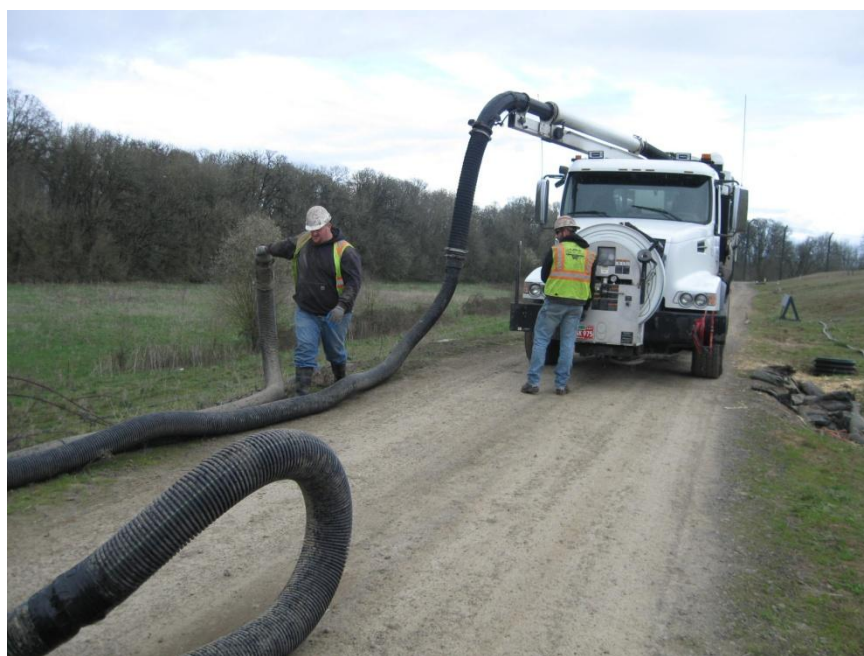
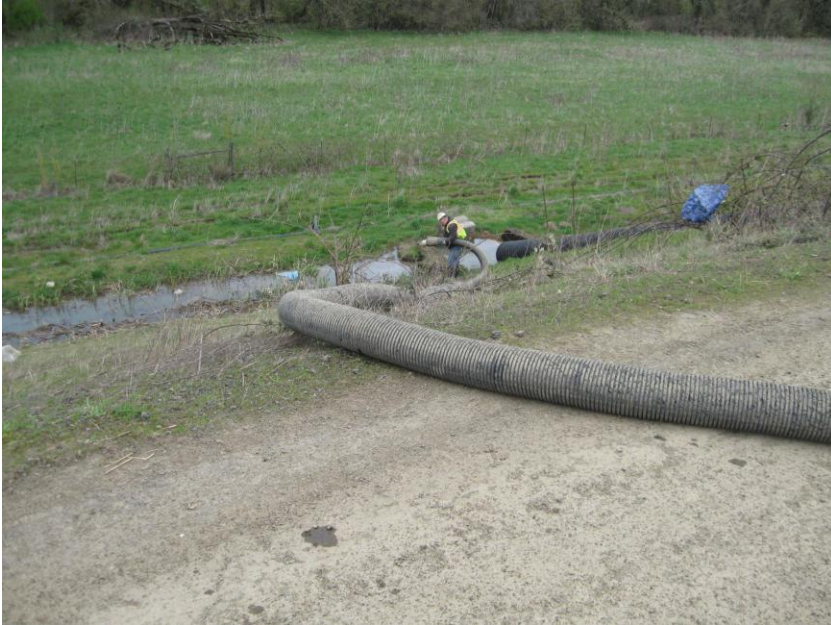
NEXT TWO PHOTOS: Pumping stormwater from swale at base of landfill. This is done to prevent weakening of soil at the base of the landfill berm.
