State of Oregon  
Department of  
Environmental  
Quality

# LANDFILL INSPECTION REPORT

| <b>FACILITY:</b> | Riverbend Landfill | | | | |
| <b>INSPECTOR(S):</b> | Bob Schwarz, Mark Riedel | | <b>INSPECTION DATE:</b> | Thur, Jan. 8, 2015 | |

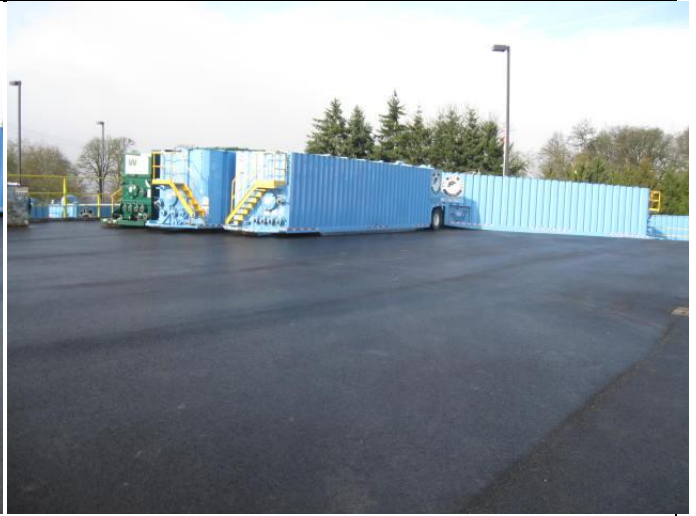
Recent rains have caused erosion rills on the landfill north slope. To prevent release of contamination to the environment, all rain running off the landfill is being collected and treated as leachate.

Tanks for storing stormwater prior. Recent rains have caused erosion on the north side of the landfill. Stormwater coming off this slope is therefore being sent offsite for treatment and disposal in case of incidental contact with waste. Repairs to this slope will be conducted this spring, when site conditions are dry enough to allow such work.

| IV | <u>LEACHATE MANAGEMENT</u> | In Compliance | Not in Compliance | N/A for this Inspection | Follow-up required |
|---|---|---|---|---|---|
| | Notes: Recent rains have caused erosion rills on landfill's north slope. This likely increases amount of liquid entering the landfill. In addition, stormwater reaching the stormwater ponds is being treated as leachate as a precaution. Repair of these rills will be done in late spring, when drier conditions make that possible. | | | | |

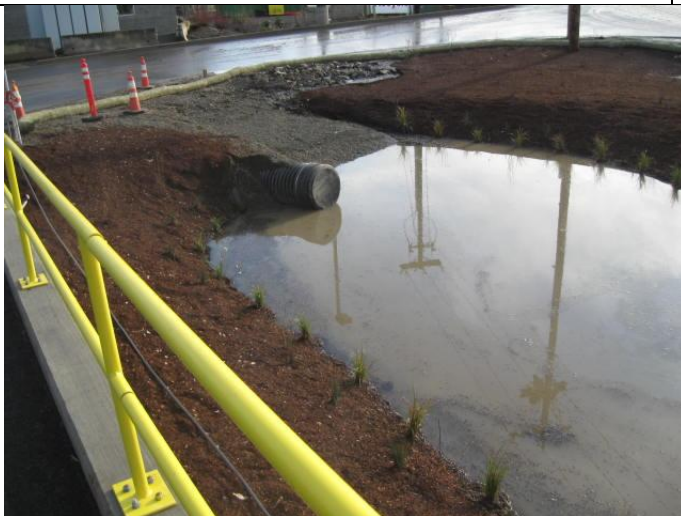
Stormwater pond near NW corner of landfill. Outlet pipe is plugged so that stormwater is not released to the environment. As noted above, this water is assumed to be contaminated due to erosion of cover soil during recent rains.

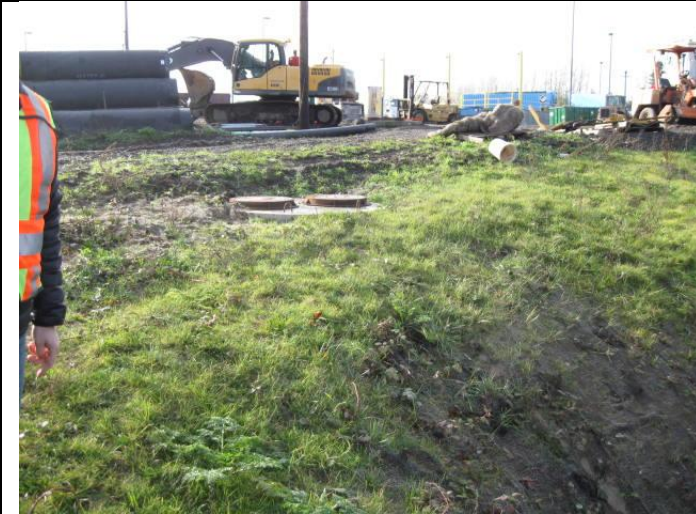
Stormwater vault. This vault, near the front entrance facilities, has an oil/water separator for removing oil and grease from road runoff.

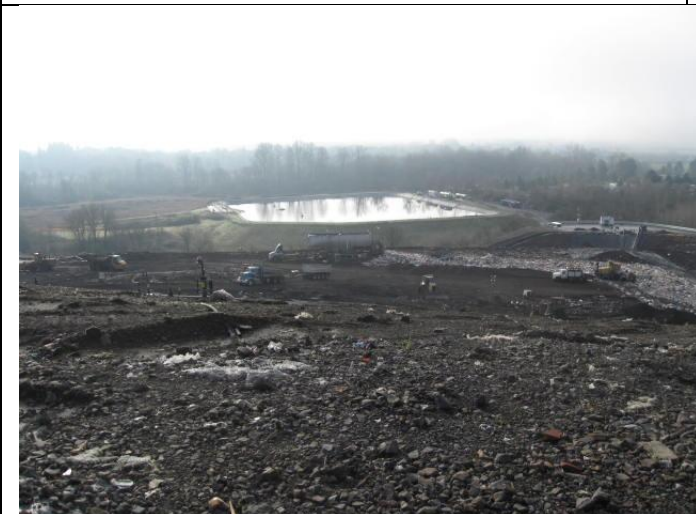
| <b><u>IV</u></b> | <b><u>LEACHATE MANAGEMENT</u></b> | <b>In<br/>Compliance</b> | <b>Not in<br/>Compliance</b> | <b>N/A for this<br/>Inspection</b> | <b>Follow-up<br/>required</b> |
|---|---|---|---|---|---|
| | Notes: Leachate level in lagoon is higher than usual (roughly 5 feet below top), but below the 3-ft limit. | | | | |

View from top of landfill, looking SW. At right is the current work face, in module 9. Leachate lagoon is at left. Water level is higher than usual due to recent rain, and is approximately 5 feet below the top of the lagoon. (Maximum allowable elevation is 3 feet below top of lagoon). Waste Management is currently hauling approximately 250,000 gallons of leachate per day to offsite wastewater treatment plants.

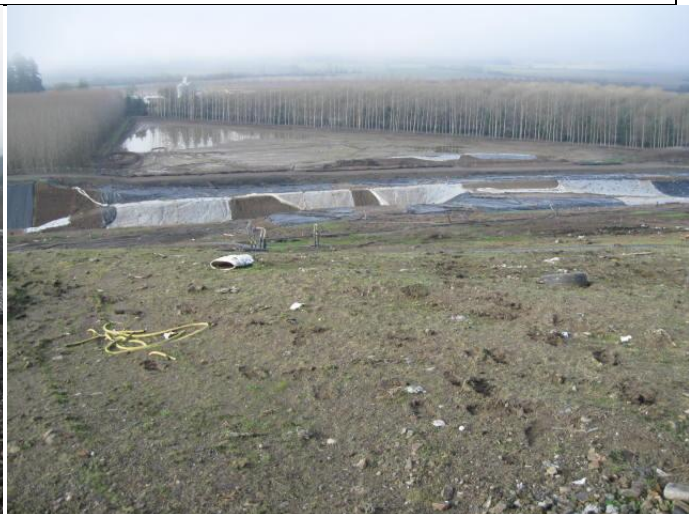
View from top of landfill, looking west. Construction of Phase 1B of MSE berm is halted for the winter. Plastic sheet to cover soil has been disturbed by wind. Triangular area in background is the former northern poplar field that used to be irrigated with leachate. That area is currently used for soil processing and storage.

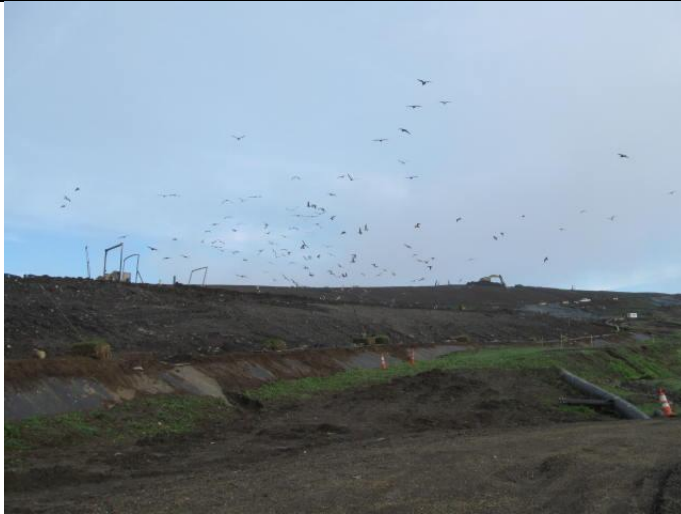
Birds were seen in large numbers despite presence of falconer and falcons. DEQ noted that this may be due in part to the fact that the working face is larger than has been observed recently. WM noted that they are taking steps to reduce the size of the working face. This will be evaluated during the next inspection.

| I. | OPERATIONS | In Compliance | Not in Compliance | N/A for this Inspection | Follow-up required |
|---|---|---|---|---|---|
| | Notes: Despite presence of falconer and falcons, a large number of birds were observed on the south side of the landfill. DEQ inspector noted that working face (exposed waste) is larger than has been observed recently, and that this could be a factor in the number of birds. | | | | |

View of southern side of the landfill, looking northeast. A large number of birds were observed, despite the presence of falcons and falconer.
