State of Oregon  
Department of  
Environmental  
Quality

## DEQ Solid Waste Program

# LANDFILL INSPECTION REPORT

| <b>FACILITY:</b> | Riverbend Landfill | | | | |

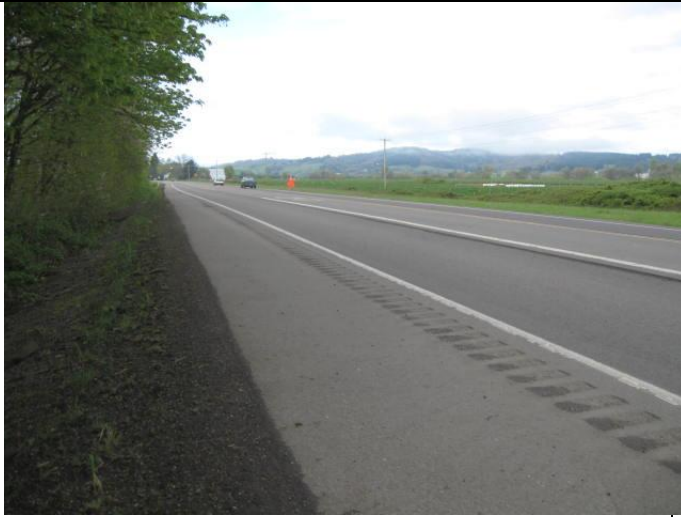
1. Hwy 18 looking south.

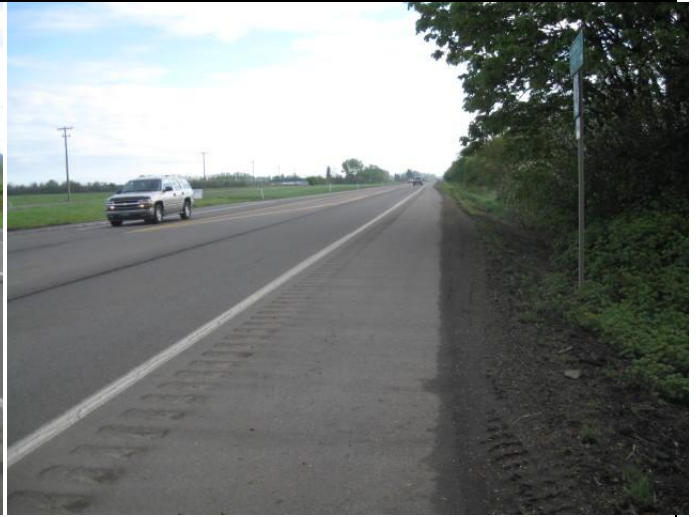
| I. | OPERATIONS | In Compliance | Not in Compliance | N/A for this Inspection | Follow-up required |
|---|---|---|---|---|---|
| | <p>Onsite road cleaning was observed several times during this inspection. Contractor was also sweeping acceleration lane on Highway 18 heading north. Some discoloration of the northbound lane was observed. I checked for dust as cars drove over this portion of the road. I saw a small amount of dust.</p> <p>Odors: moderate odor within the landfill property. I did not notice odors off the property. I checked this as I drove along Highway 18, and stopped at the intersection of Masonville Road and Highway 18 for about 5 minutes.</p> <p>I did not notice excessive noise from landfill operations.</p> | | | | |

2. Hwy 18 looking north.

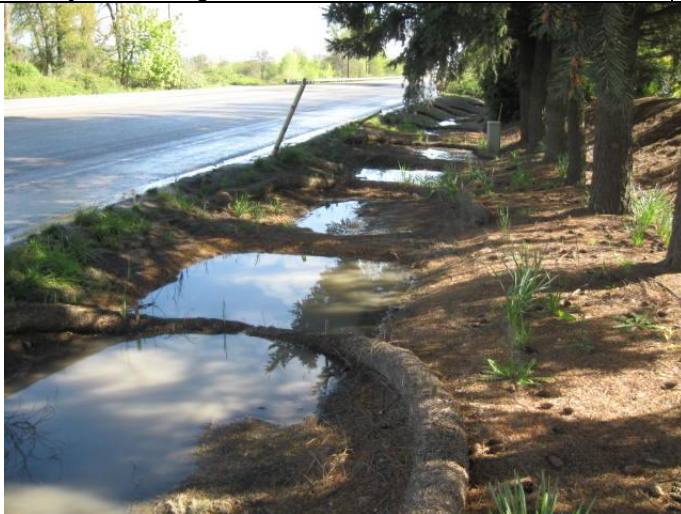
3. Sediment traps in swale along landfill side of Hwy 18, looking north. These include wattles (mesh tubes filled with mulch) and gravel sediment traps.

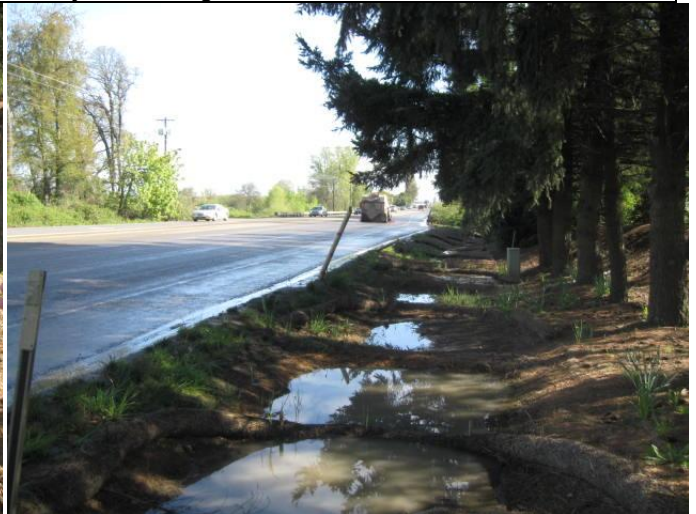
4. Highway and drainage swale, looking north.

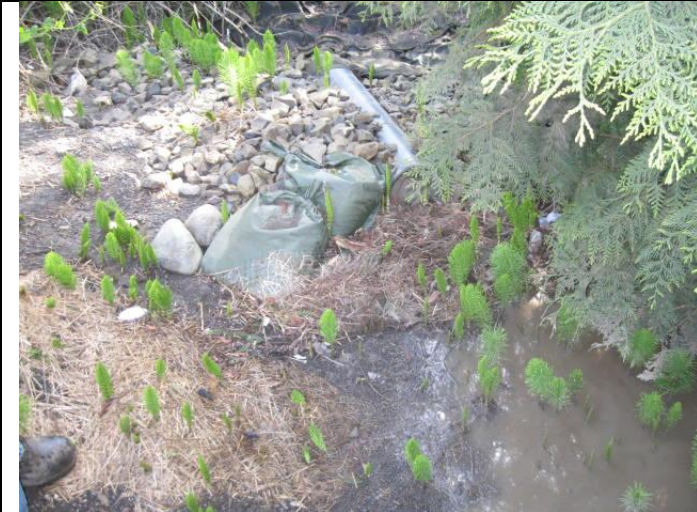
5. Discharge pipe where swale enters creek. Downhill side of pipe is covered by geotextile filter fabric.

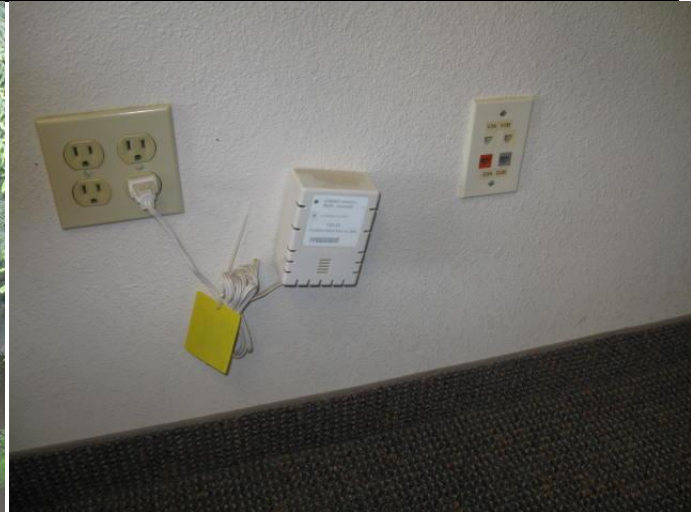
| <b><u>VI</u></b> | <b><u>LANDFILL GAS MANAGEMENT</u></b> | <b>In<br/>Compliance</b> | <b>Not in<br/>Compliance</b> | <b>N/A for this<br/>Inspection</b> | <b>Follow-up<br/>required</b> |
|---|---|---|---|---|---|
| | Notes: Buildings are slab on grade, and are equipped with landfill gas sensors. | | | | |

6. Methane sensor in office building conference room.

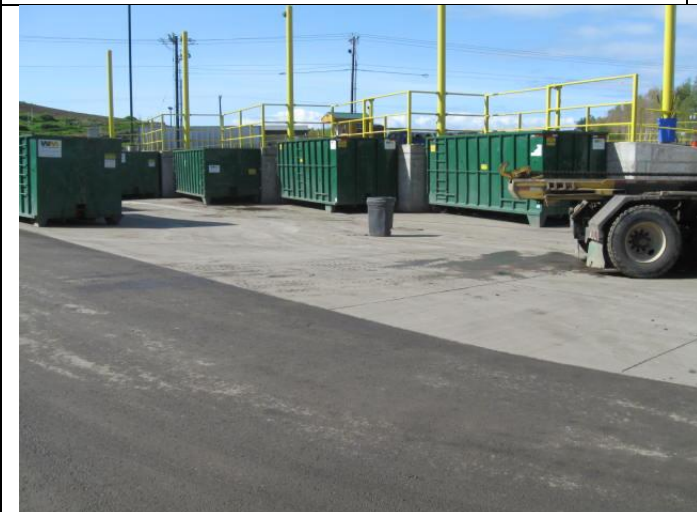
7. Residential drop-off area.

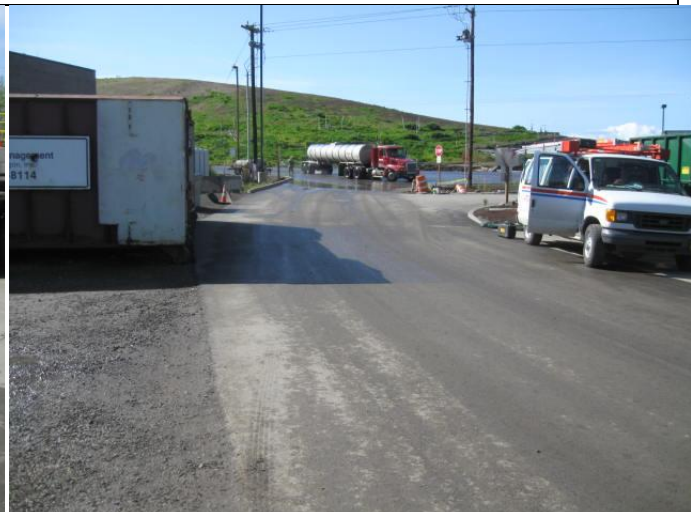
8. Pressure-washing truck tires by hand.

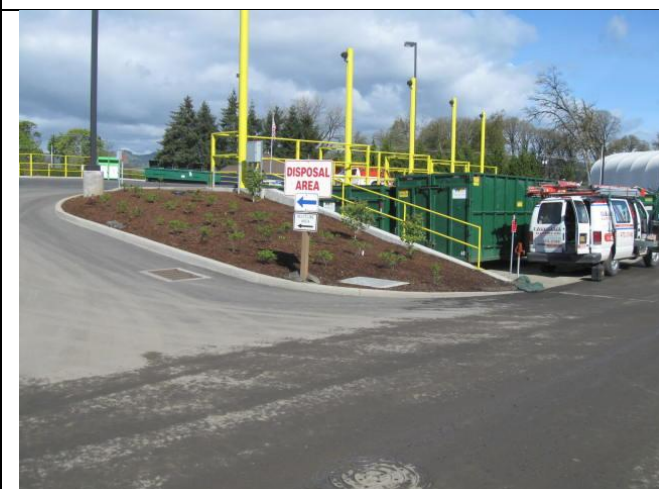
9. Signs for residential trash drop-off area.

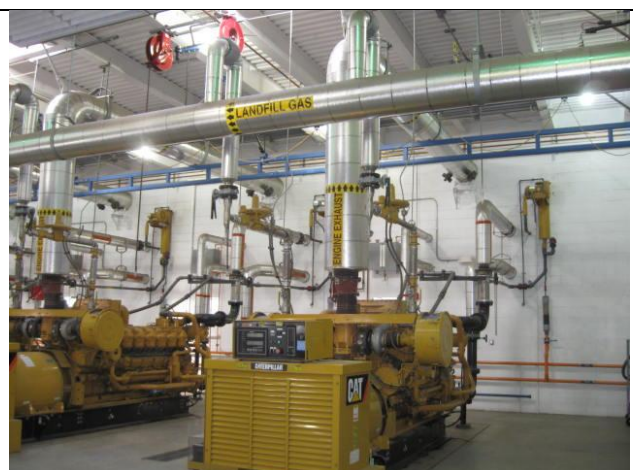
| <b><u>VI</u></b> | <b><u>LANDFILL GAS MANAGEMENT</u></b> | <b>In<br/>Compliance</b> | <b>Not in<br/>Compliance</b> | <b>N/A for this<br/>Inspection</b> | <b>Follow-up<br/>required</b> |
|---|---|---|---|---|---|
| | Notes: Gas equipment was not inspected in detail. However, I met with landfill personnel in charge of the gas collection turbines and discussed operation of the engines that convert landfill gas to electricity. No significant landfill odors observed. | | | | |

10. Engines that convert landfill gas to electricity (six total)

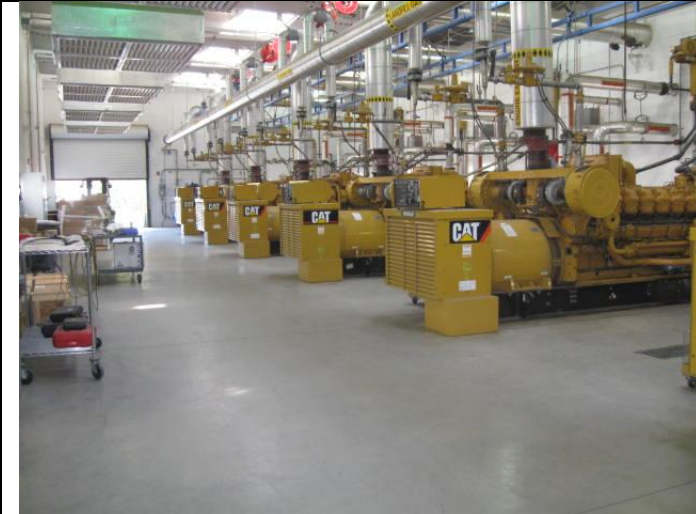
**11. Another view of gas engines.**

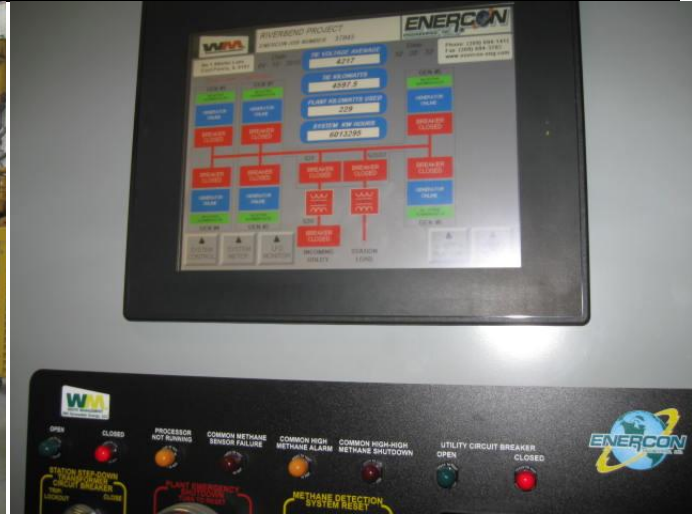
**12. Control panel for landfill gas engines.**

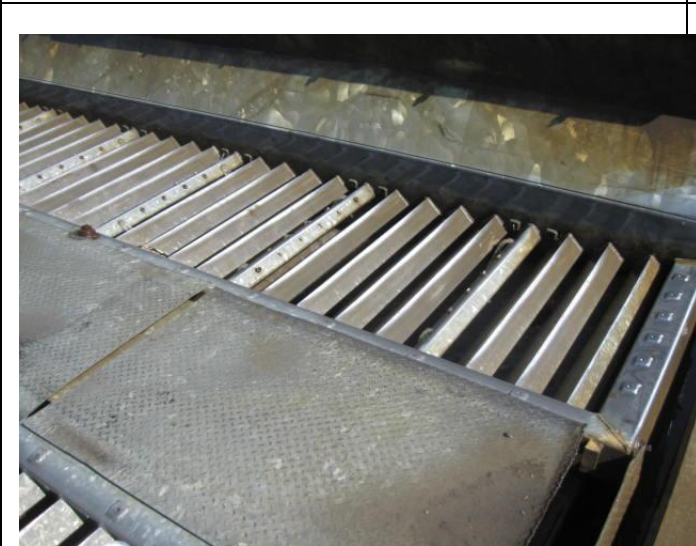
**13. Floor of truck wash station.**

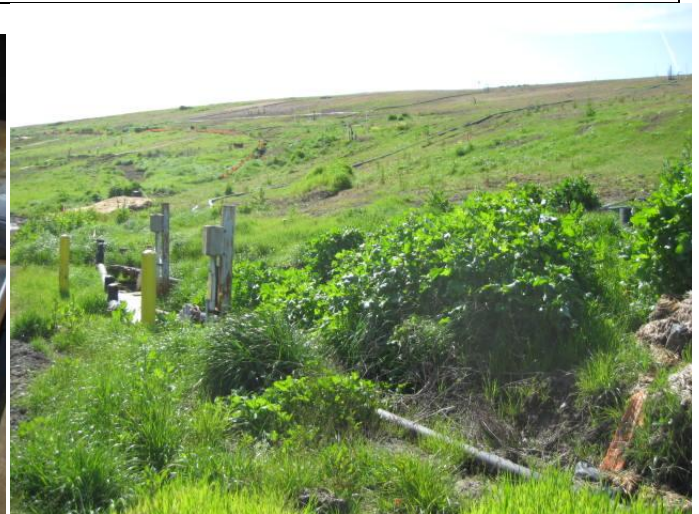
| IV | <u>LEACHATE MANAGEMENT</u> | In Compliance | Not in Compliance | N/A for this Inspection | Follow-up required |
|---|---|---|---|---|---|
| | Notes: Recent rains have caused erosion rills on landfill's north slope. This likely increases amount of liquid entering the landfill. In addition, stormwater reaching the stormwater ponds is being treated as leachate as a precaution. Repair of these rills will be done in late spring, when drier conditions make that possible. | | | | |

**14. North slope of landfill.**

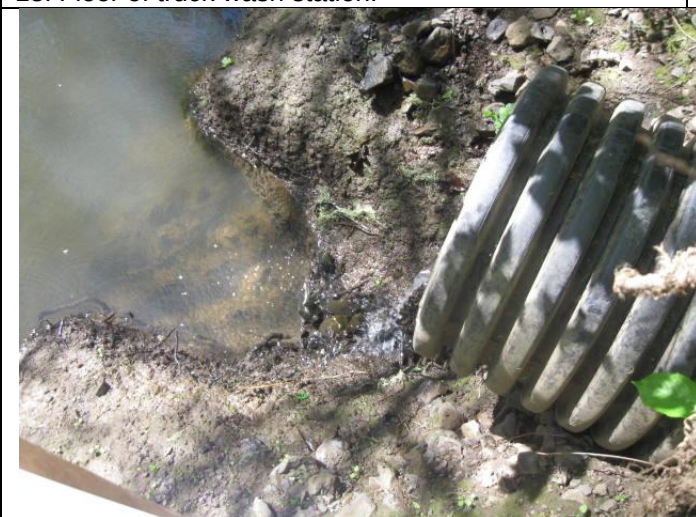
**15. Stormwater outfall #4. Water discharge is difficult to see in photo; water is quite clear.**

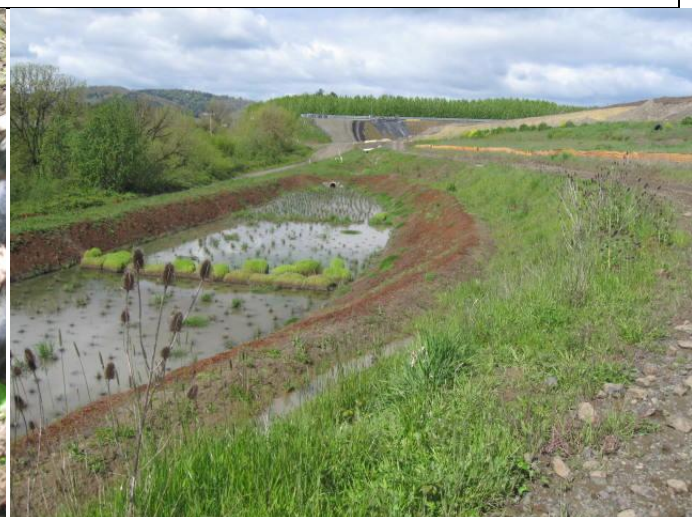
**16. Stormwater basin near SW corner of landfill, looking west.**

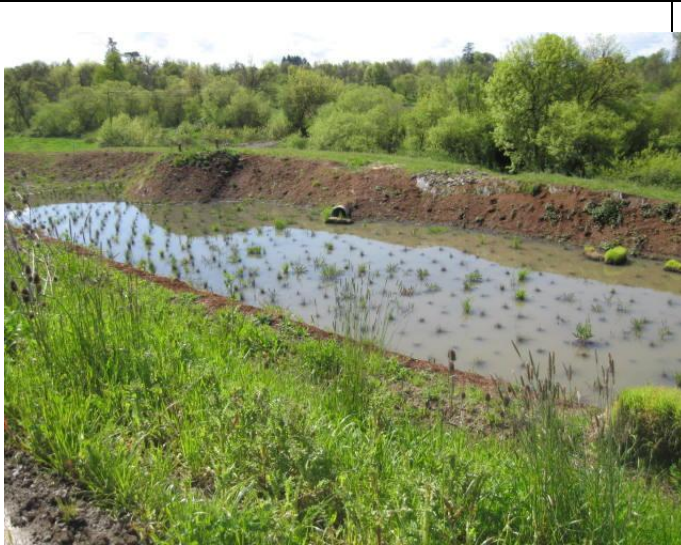
**17. Stormwater basin near SW corner of landfill, looking southeast.**

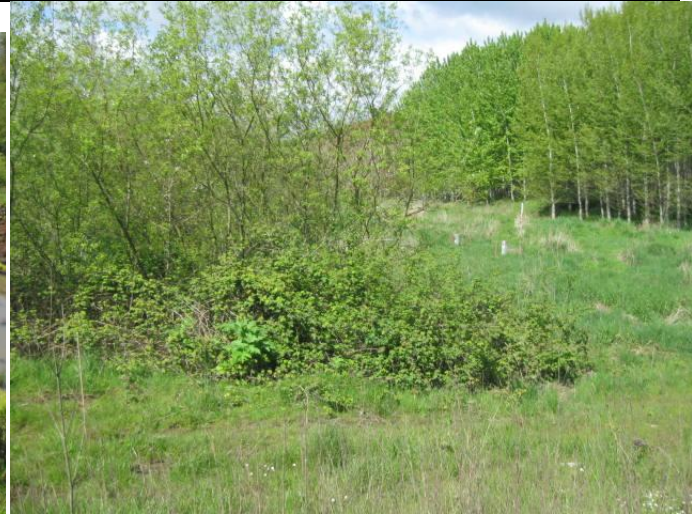
**18. View, looking west, of creek that runs south of proposed Module 11 landfill expansion area. Poplar trees are to the right (north).**

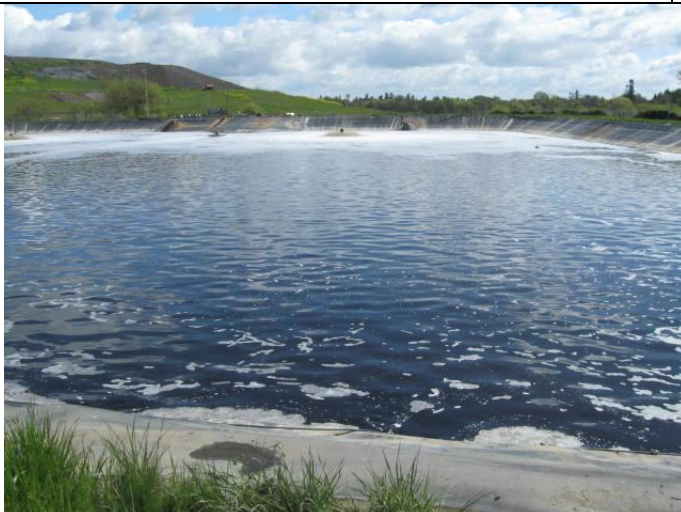
| <b><u>IV</u></b> | <b><u>LEACHATE MANAGEMENT</u></b> | <b>In<br/>Compliance</b> | <b>Not in<br/>Compliance</b> | <b>N/A for this<br/>Inspection</b> | <b>Follow-up<br/>required</b> |
|---|---|---|---|---|---|
| | Notes: Leachate level in lagoon is approx 6-8 below top of berm. Minimum allowable freeboard is 3 feet. | | | | |

**19. Leachate storage pond.**

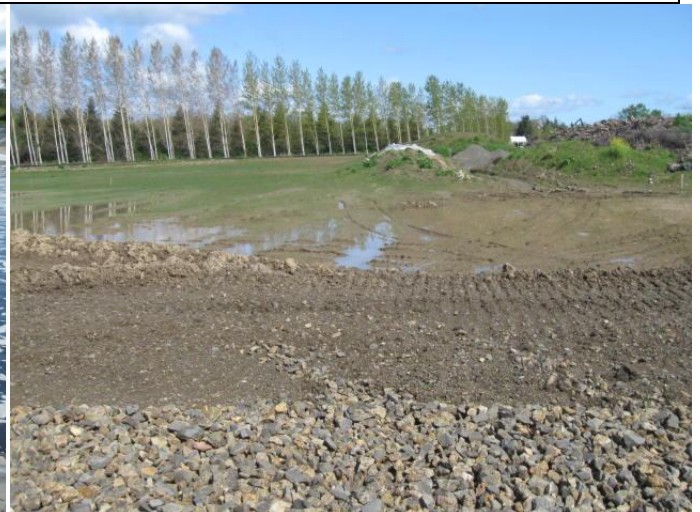
**20. Module 11 area, looking north.**

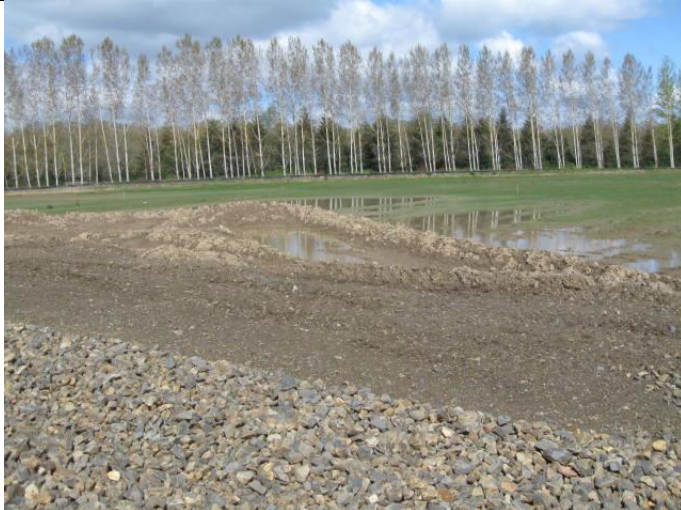
**21. Module 11 area, looking northwest. Highway 18**

is just beyond poplar trees.

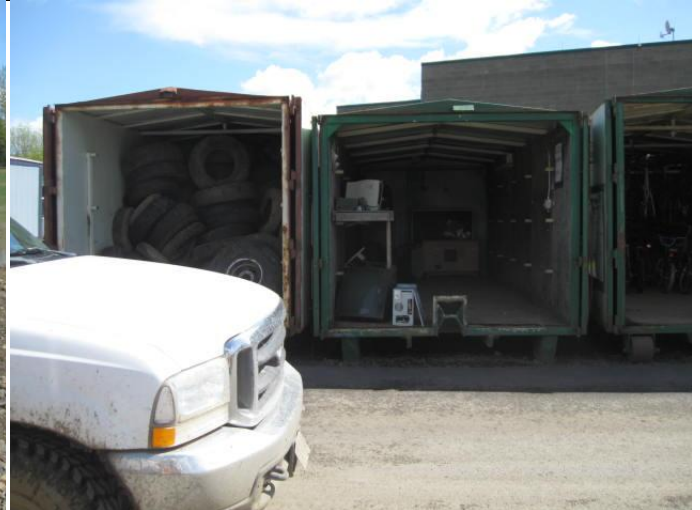
| I. | OPERATIONS | In Compliance | Not in Compliance | N/A for this Inspection | Follow-up required |
|---|---|---|---|---|---|
| | Notes: Approx 50-100 tires stored within a trailer onsite. | | | | |

**22. Trailers holding (left to right) tires, electronics,**

bicycles.

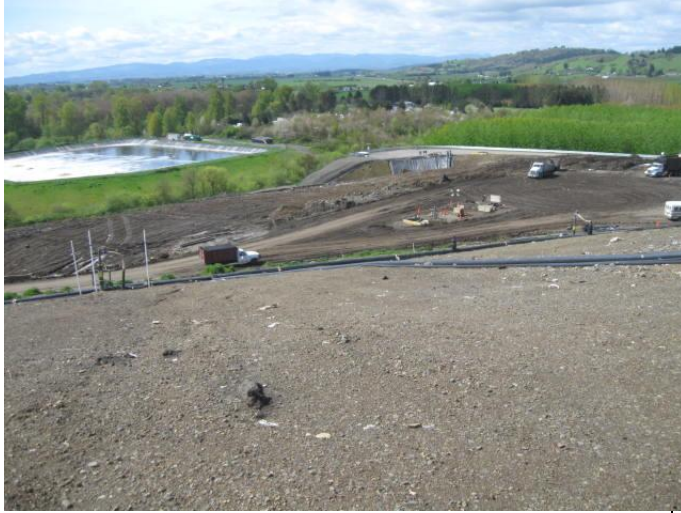
| III | FACILITY CONSTRUCTION | In Compliance | Not in Compliance | N/A for this Inspection | Follow-up required |
|---|---|---|---|---|---|
| | Notes: Waste is placed in module 9, following completion of a portion of the MSE berm. | | | | |

23. View of working face at module 9, looking west from top of landfill.

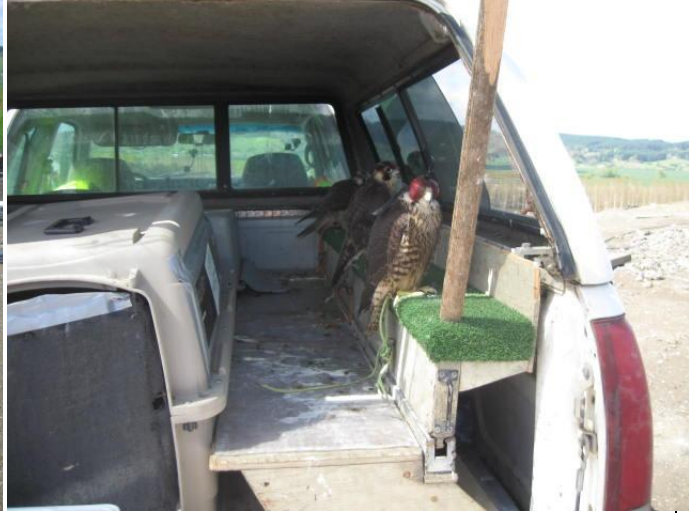
| I. | OPERATIONS | In Compliance | Not in Compliance | N/A for this Inspection | Follow-up required |
|---|---|---|---|---|---|
| | Notes: Number of birds observed was very low. This may be due in part to seasonal variation. Other potential factors: The active working face was much smaller than previously observed. Falconer was onsite with her birds. | | | | |

24. Falcons used for control of scavenging birds.
