State of Oregon  
Department of  
Environmental  
Quality

## DEQ Solid Waste Program

# LANDFILL INSPECTION

| <b>FACILITY:</b> | Riverbend Landfill | | |

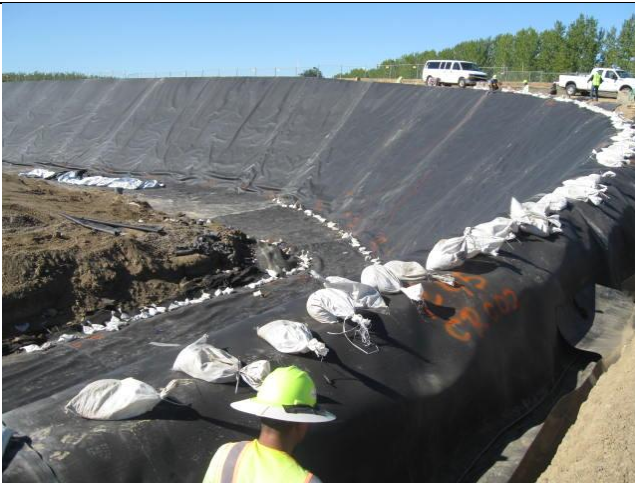
1. Installing liner over Phase 1B of the MSE berm (1 of 3).

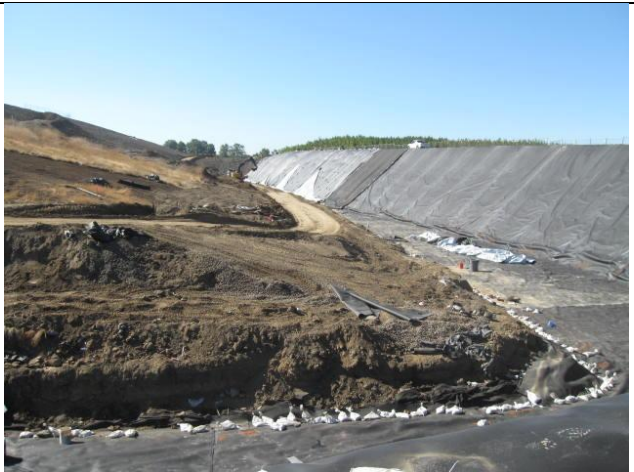
2. Installing liner over Phase 1B of the MSE berm (2 of 3).

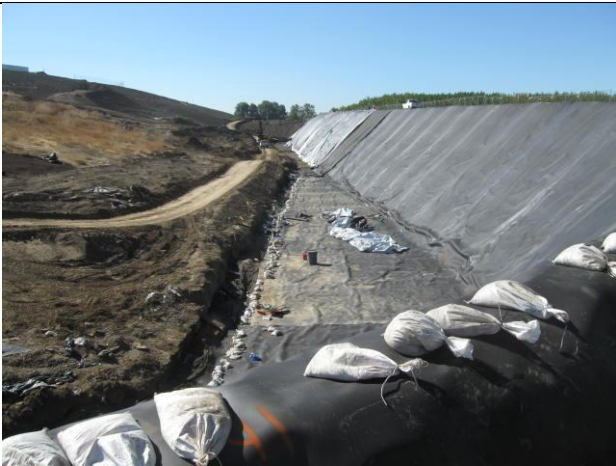
7. Installing liner over Phase 1B of the MSE berm (3 of 3).

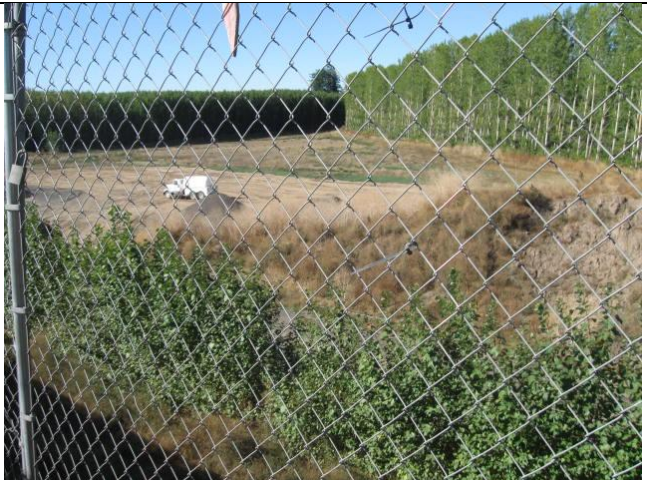
8. View of former north poplar field, where Waste Management plans to build a new landfill cell (Module 11). This photo shows the status of vegetation growth in this area.

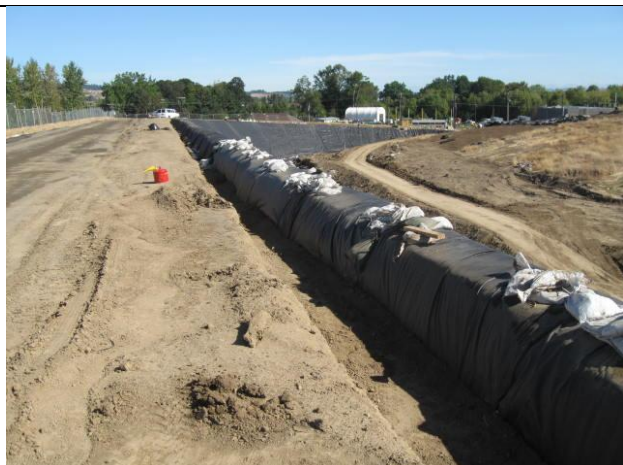
9. View of top of MSE berm phase 1B, looking north. Liner anchor trench is also shown.

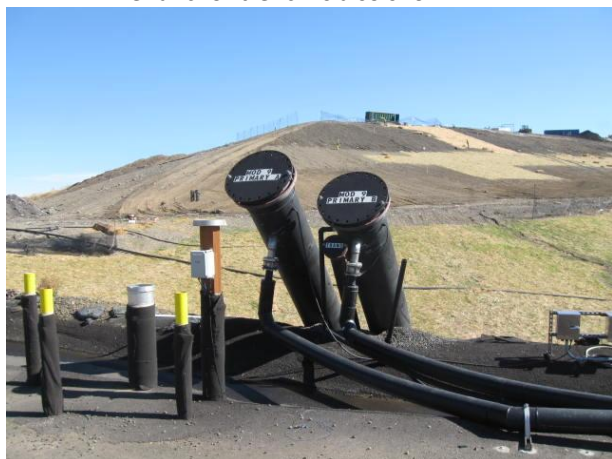
7. Leachate riser pipes for Module 9. Active working face is shown in the distance.

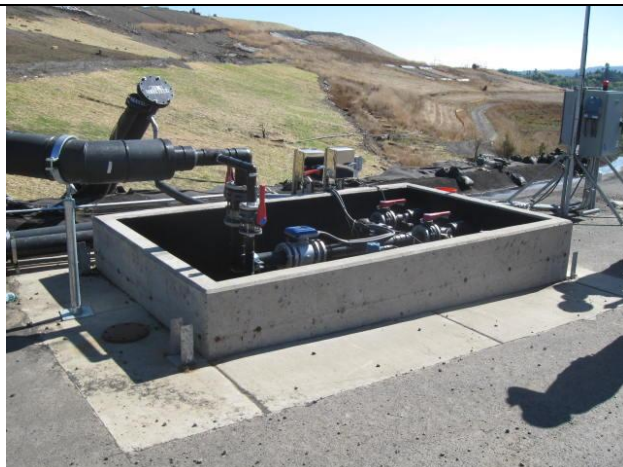
8. Valves for controlling flow of leachate from Module 9 sumps to leachate storage pond.

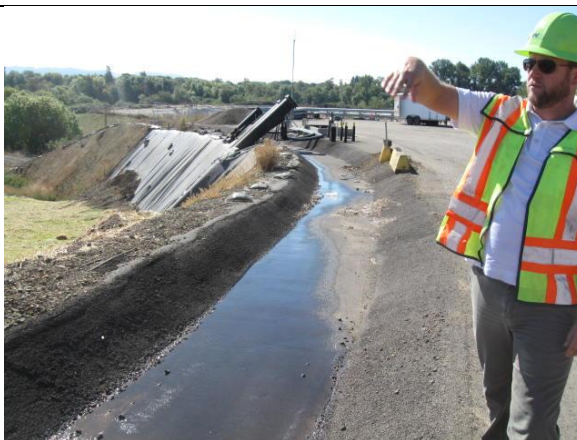
8. Riser pipes from leachate collection system for Module 9.

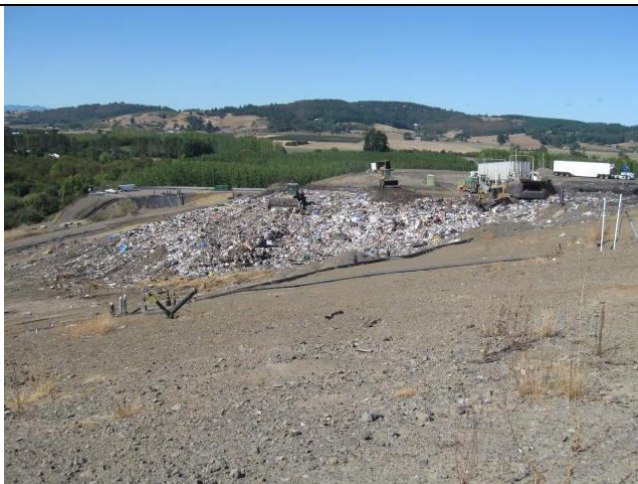
9. View of landfill working face, Module 9.

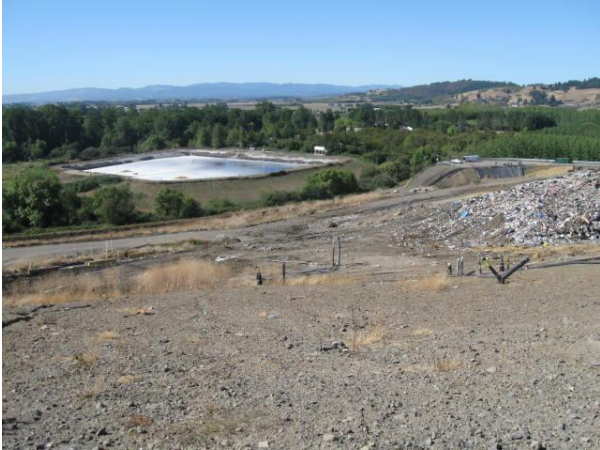
10. View from top of landfill, looking SW. Leachate pond at left, Module 9 berm at right, in the distance.

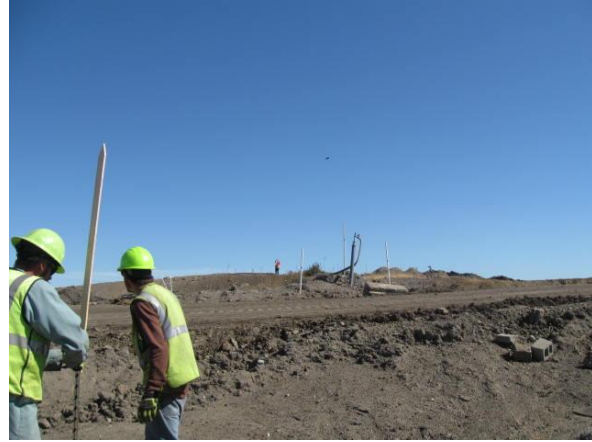
- 5. Birds.** The number of birds at the landfill was much lower than last year at this time. I suspect this may be due to the reduced size of the working face.

11. Falconer and falcon in the distance. The falcons are used to discourage scavenging birds.

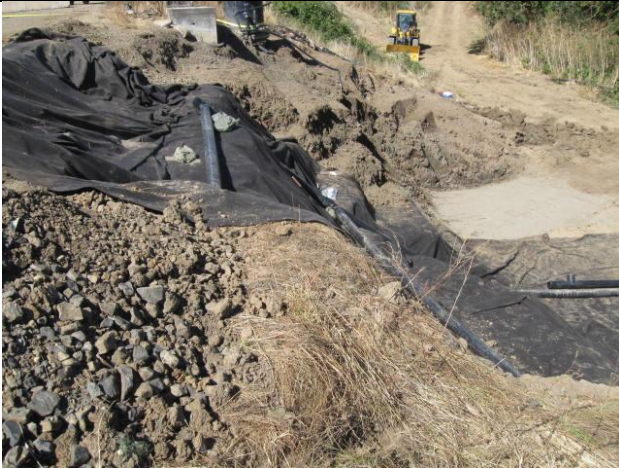
- 2. Repair of perimeter berm where soil sloughing was observed.** Soil sloughing was noted at two locations along the northern portion of the perimeter berm. Repair is being done at the western of these two spots. This work is based on recommendations made in a November 19, 2014 report by Geosyntec. Status of this work is documented in photo 12 below. Repair work in this area is expected to be completed within 1-2 weeks.

12. Repairs to the bottom of the landfill's north slope, where saturated soil had sloughed.

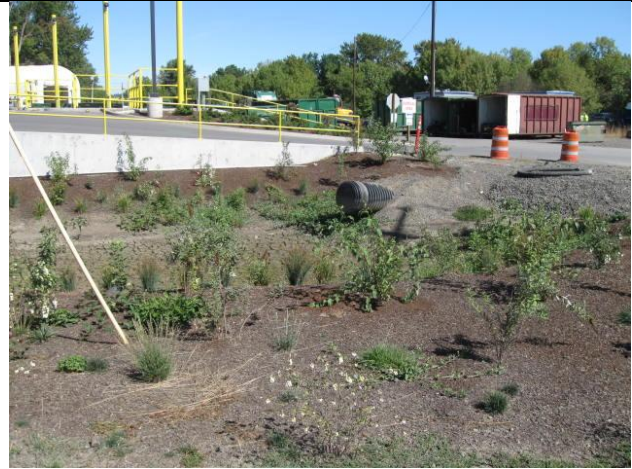
13. Stormwater pond. Because of erosion rills in the northwest portion of the landfill, stormwater coming off this part of the site is diverted from this stormwater pond to the leachate pond as a precaution. The pond's discharge pipe has been capped to prevent this water from leaving the site.
