State of Oregon  
Department of  
Environmental  
Quality

## DEQ Solid Waste Program

# LANDFILL INSPECTION

| <b>FACILITY:</b> | Riverbend Landfill | | |

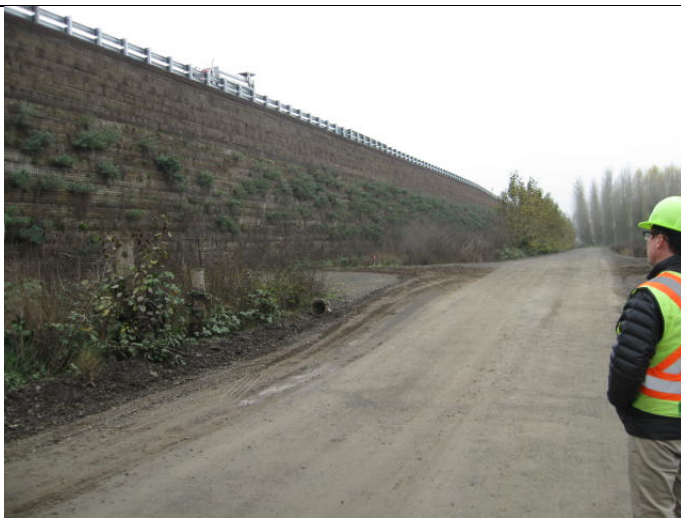
- 1. Phase 1B MSE berm.** Construction has been completed. See photo 1.
- 2. Repair of perimeter berm where soil sloughing was observed.** Soil sloughing had occurred at two locations along the northern portion of the perimeter berm. Repair work at these areas has been completed. See photo 9.

Photo 1. Completed MSE berm. Guard rail was recently installed.

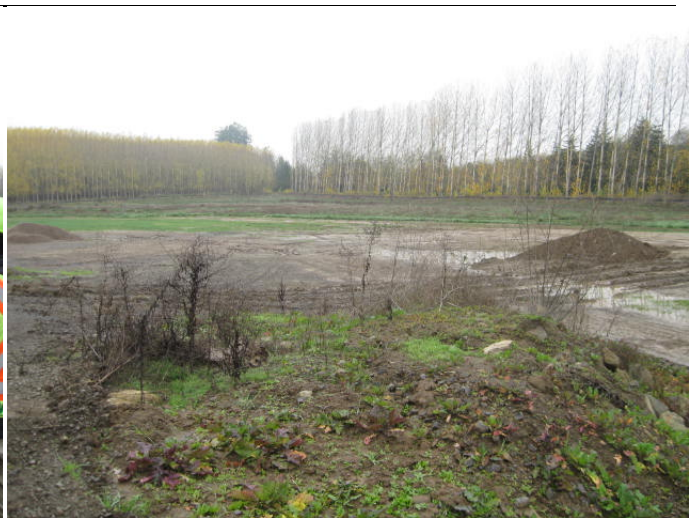
Photo 2. Soil stockpile area, looking southwest. This is the location of proposed Module 11.

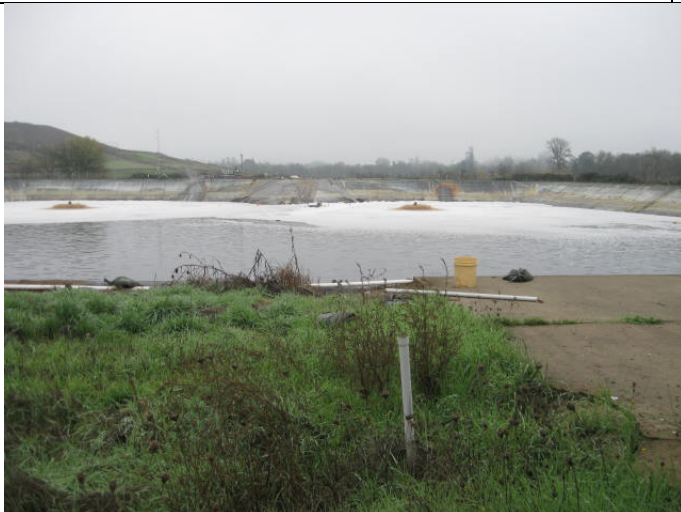
Photo 3. Leachate pond. There was approximately 10 feet of freeboard (vertical distance from top of berm to liquid) during the site inspection.

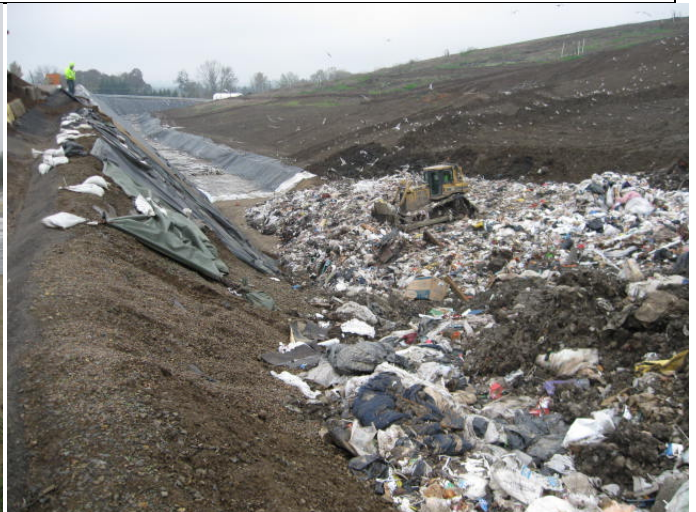
Photo 4. Waste disposal in Module 9. The landfill also had a working face closer to the top of the landfill, but landfill staff said they are planning to close this by the

end of the week and move all waste disposal operations to the bottom of Module 9.

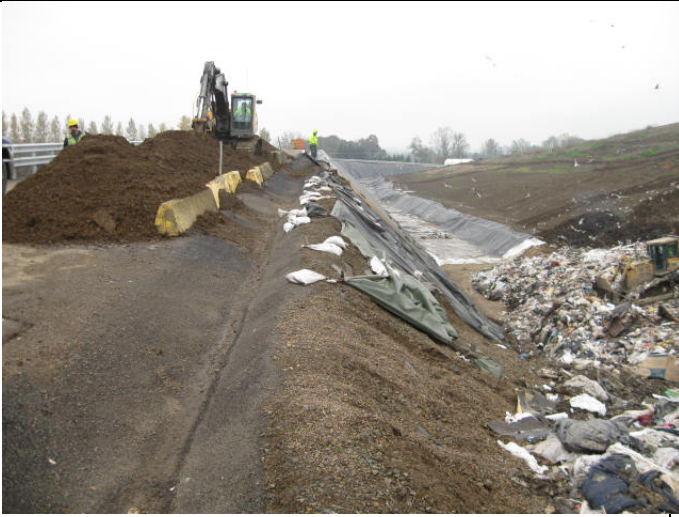
Photo 5. Placement of “operations layer” soil. Backhoe places soil on a sacrificial sheet of geomembranes. The sheet is removed before waste is placed on the soil layer.

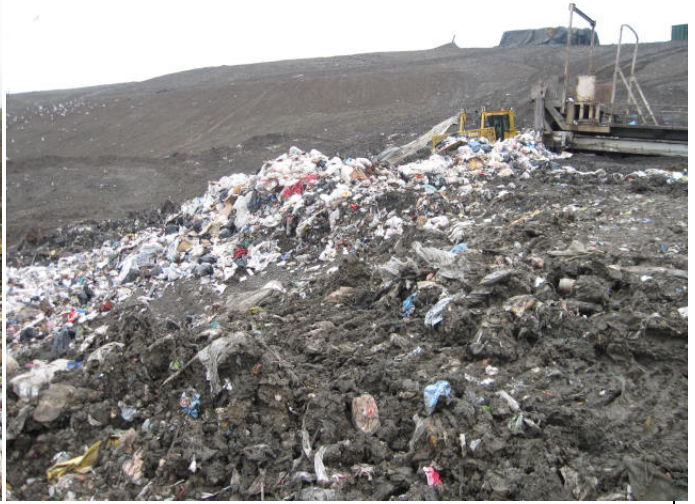
Photo 6. Second working face, closer to the top of the landfill.

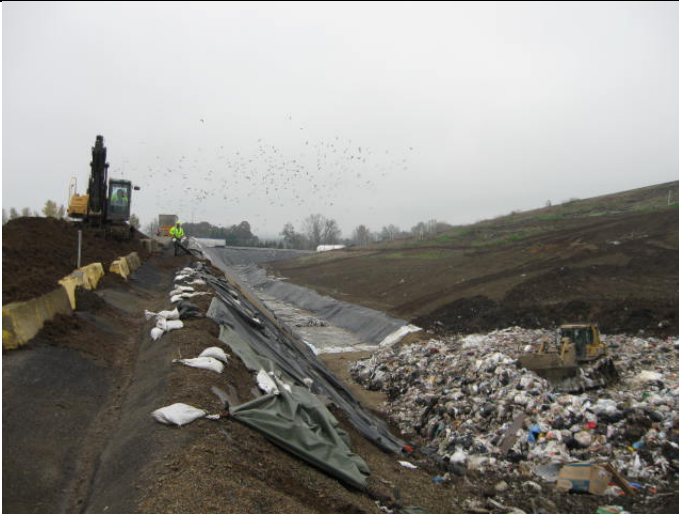
- 5. Birds.** The number of birds at the landfill was significantly higher than during previous inspections in 2015. See photo 7. Falconer was onsite today. Bird numbers were lower, however, than during fall visits in previous years. Bird numbers appear to be seasonal, and are greatest during harvest time.

Photo 7. Birds visible in background. Bird numbers are higher than previously observed in 2015. The amount of birds appears to be lower than this time last year. Late fall has been the time of greatest number of birds. This is presumably related to harvest time on nearby farms.

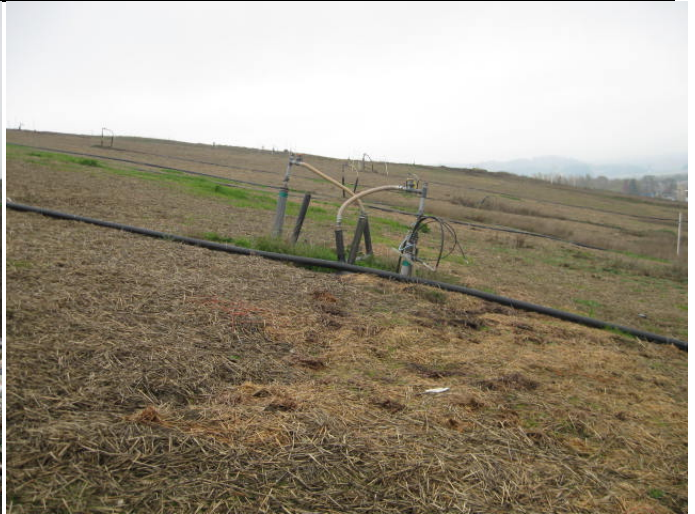
Photo 8. New gas wells installed along north side of landfill. These are more shallow (approx 50 feet deep) and smaller diameter (2 inches) than typical gas wells. These wells, which can be installed more inexpensively than typical wells, are intended to remove gas closer to the landfill surface, and are intended to complement the existing gas collection wells. Forty four such wells were installed, beginning in August 2015.

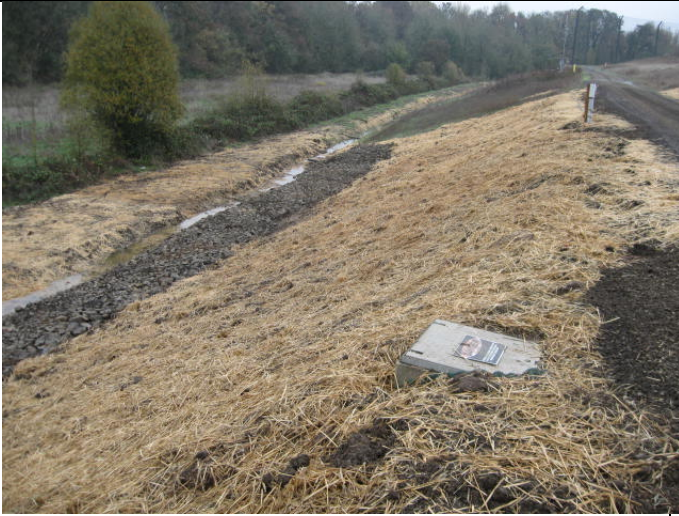
Photo 9. Area where soil sloughing was observed on north side of landfill. Soft soil was removed and replaced with compacted more granular soil. A rip-rap buttress was installed at the toe of slope.
