14 April 2023

**Subject: 2022 Annual Geotechnical Monitoring Report**  
**Riverbend Landfill**  
**McMinnville, Oregon**

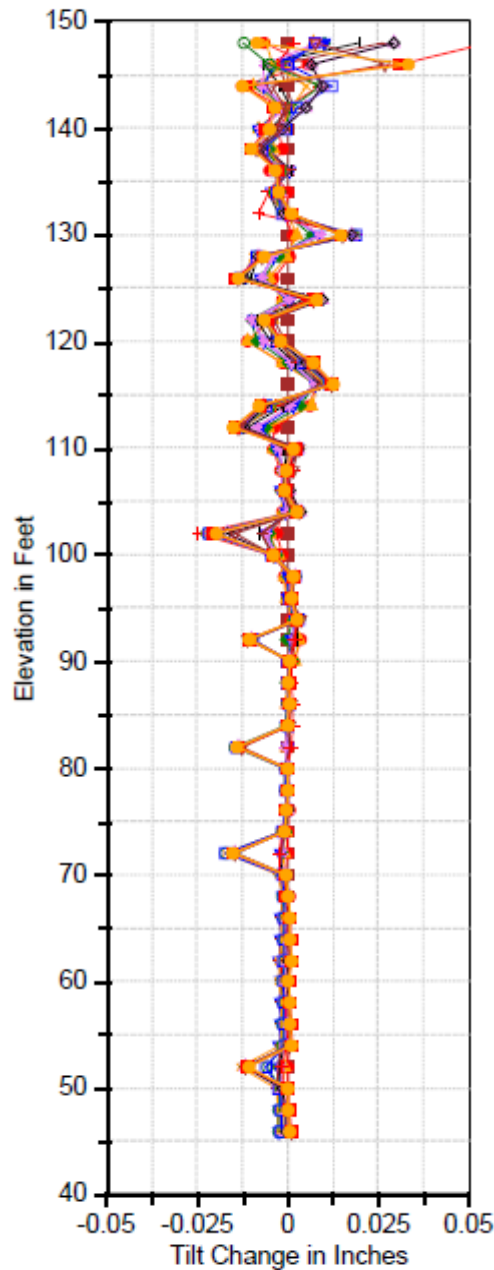
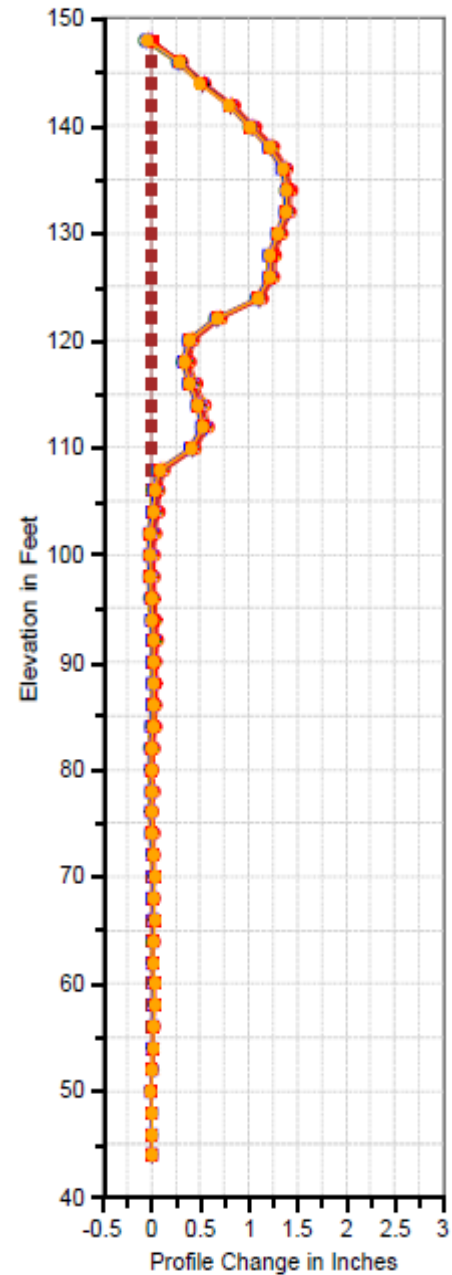
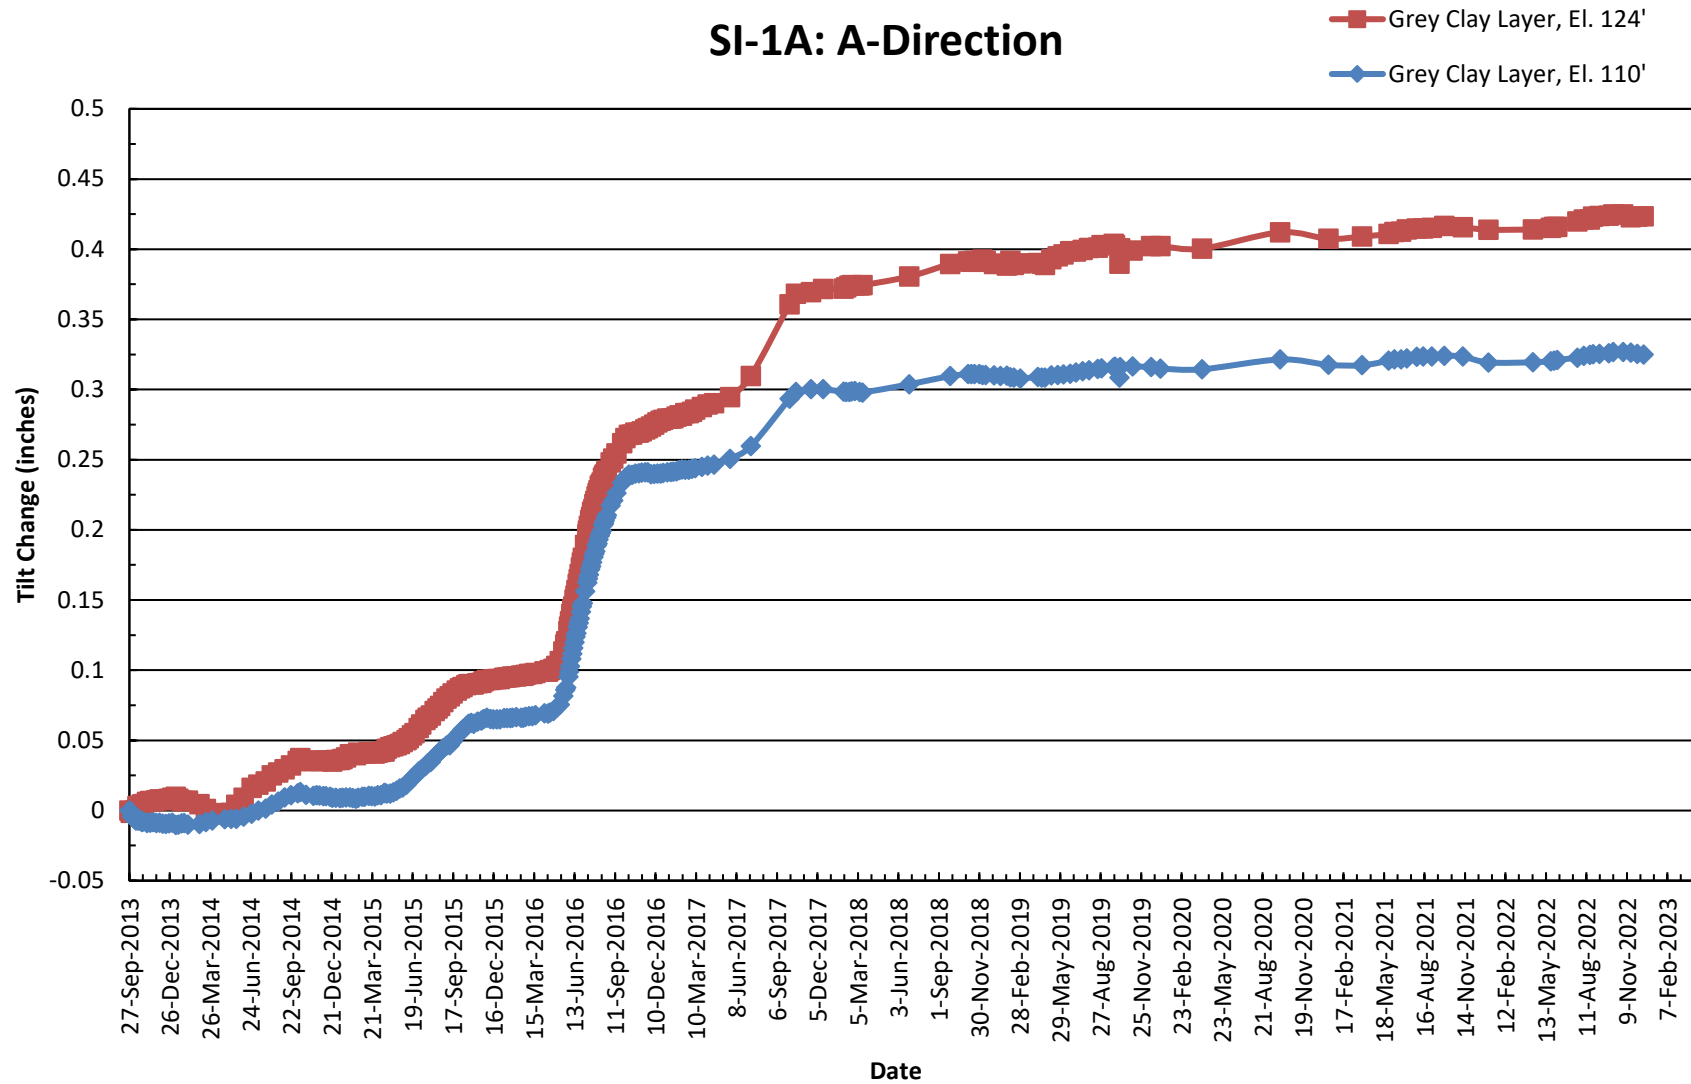
**RIVERBEND LANDFILL**  
**INCLINOMETER SI-1A**

The maximum incremental displacements and strains observed in each inclinometer since inclinometer installation are presented in Table 2. The largest incremental displacement observed was 0.012 inches in SI-1A in the A-Direction at an elevation of 124 ft, within the grey clay layer. This displacement was measured during and after construction activity within the zone of influence. Plots of incremental displacement (tilt change) versus time, presented for each inclinometer in Attachment A, were used to assess changes in the rate of displacement. Minor increases and decreases in displacement rate occurred throughout 2022.

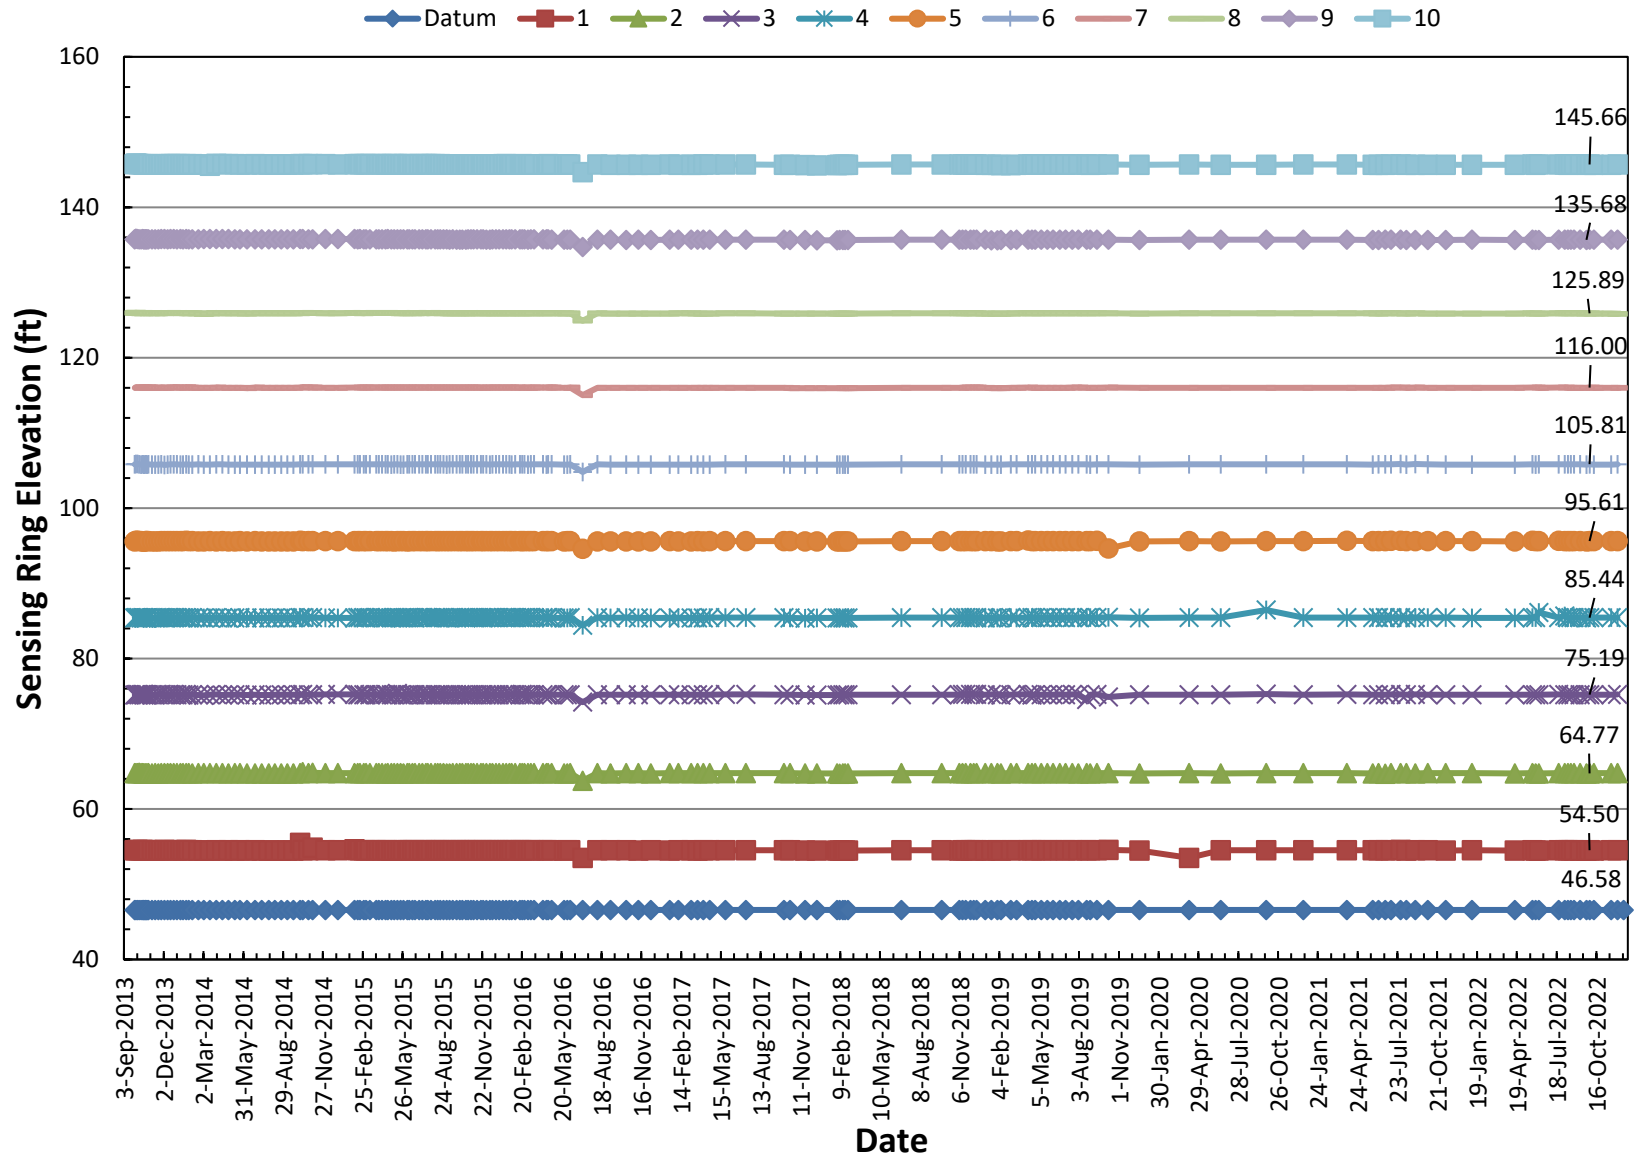
## EX-1A Extensometer Measurements

Positive displacement values represent downward displacement (i.e., settlement). The magnitude of vertical displacements since the extensometer installation range from 0.8 inch of upward displacement at EX-1A to 6.5 inches of downward displacement at EX-1B. The magnitude of vertical displacements in 2022 ranged from 0.2 inches of upward displacement at EX-1A to 0.5 inches at EX-2B.

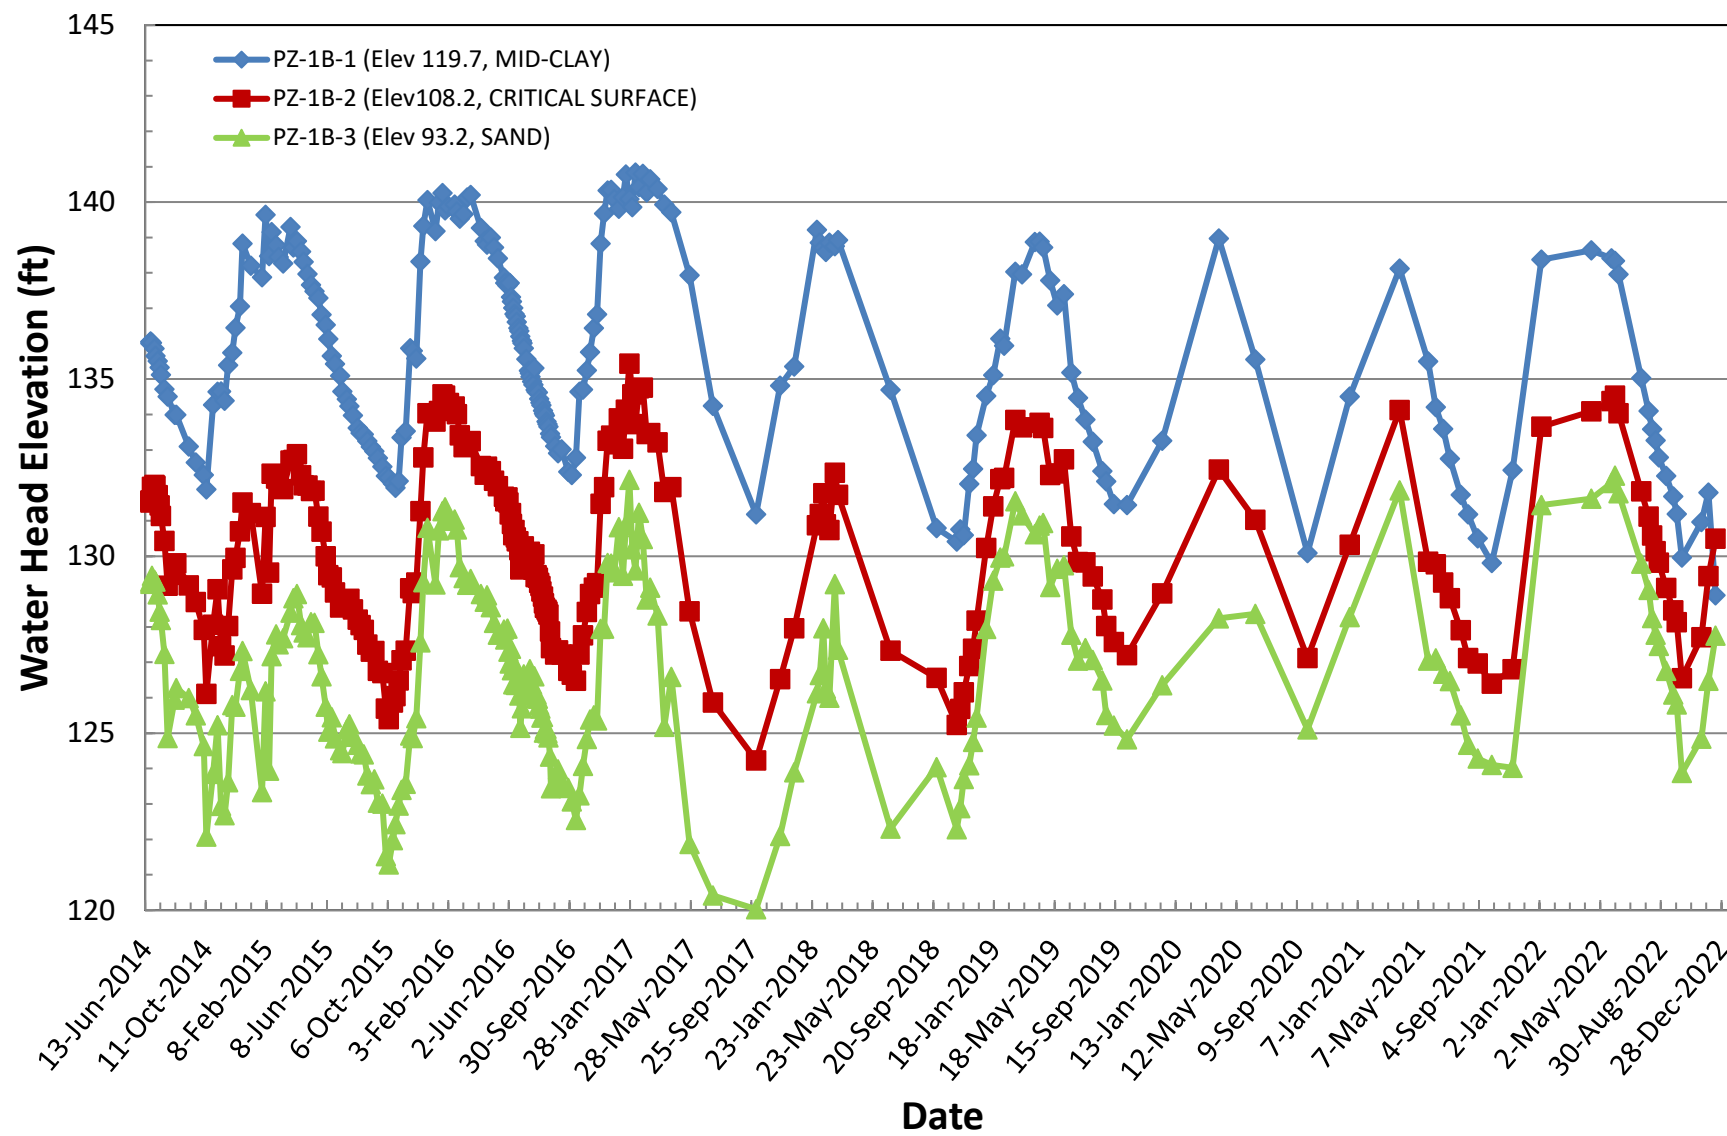
## PIEZOMETER PZ-1B RIVERBEND LANDFILL- MCMINNVILLE, OREGON

Vibrating wire piezometers were installed between 19 June and 23 June 2014 in the foundation soils at instrument clusters I-1B and I-2B. Piezometer measurements are presented in Attachment A. Three piezometers were installed at each location: (i) one piezometer was installed at the mid clay depth (PZ-1B-1 and PZ-2B-1) to assess consolidation induced pore pressures; (ii) one piezometer was installed at a critical surface (PZ-1B-2, and PZ-2B-2) to assess possible shear induced pore pressures in the underlying clay layer; and (iii) one piezometer was installed in the sand layer (PZ-1B-3 and PZ-2B-3) to assess changes in the phreatic groundwater elevation. Consolidation and shear-induced pore pressure cannot be distinguished directly through pore pressure measurements; however, in combination with the extensometer and inclinometer measurements, an assessment of the cause of the pore pressures can be made. Piezometers in the sand beneath the clay can be used to assess whether pore pressure changes measured in the clay are the result of loading or are due to changes in the groundwater table elevation. Piezometer measurements at I-1B and I-2B indicate fluctuations in pore water pressures in the clay and sand layers that are consistent with historic seasonal fluctuations observed at the Site.
