# Culvert Repair Programmatic Agreement 2018 Annual Report

Oregon Department of Fish and Wildlife | Oregon Department of Transportation  
January 2021

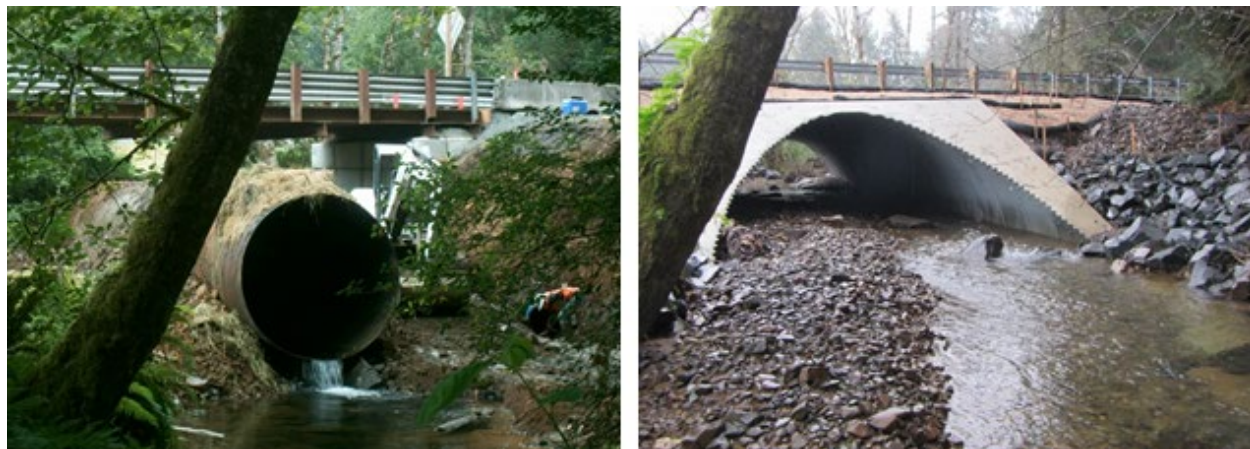
Figure 2: Joe Creek Culvert Replacement Project, Before and After

The Joe Creek culvert replacement project, Figure 2, completed by the ODOT Fish Passage Program, is one example of ODOT's commitment to improving fish passage and supporting the Oregon Plan for Salmon and Watersheds. The project replaced an undersized 8-foot diameter corrugated metal culvert with a 20-foot wide arch culvert. The Joe Creek fish passage project opened two miles of high-quality spawning and rearing habitat for coho and Chinook salmon and steelhead at the cost of \$1.6 million. The original culvert, installed in 1950, was undersized for the stream channel. This construction blocked anadromous fish from accessing the upstream habitat for more than half a century.

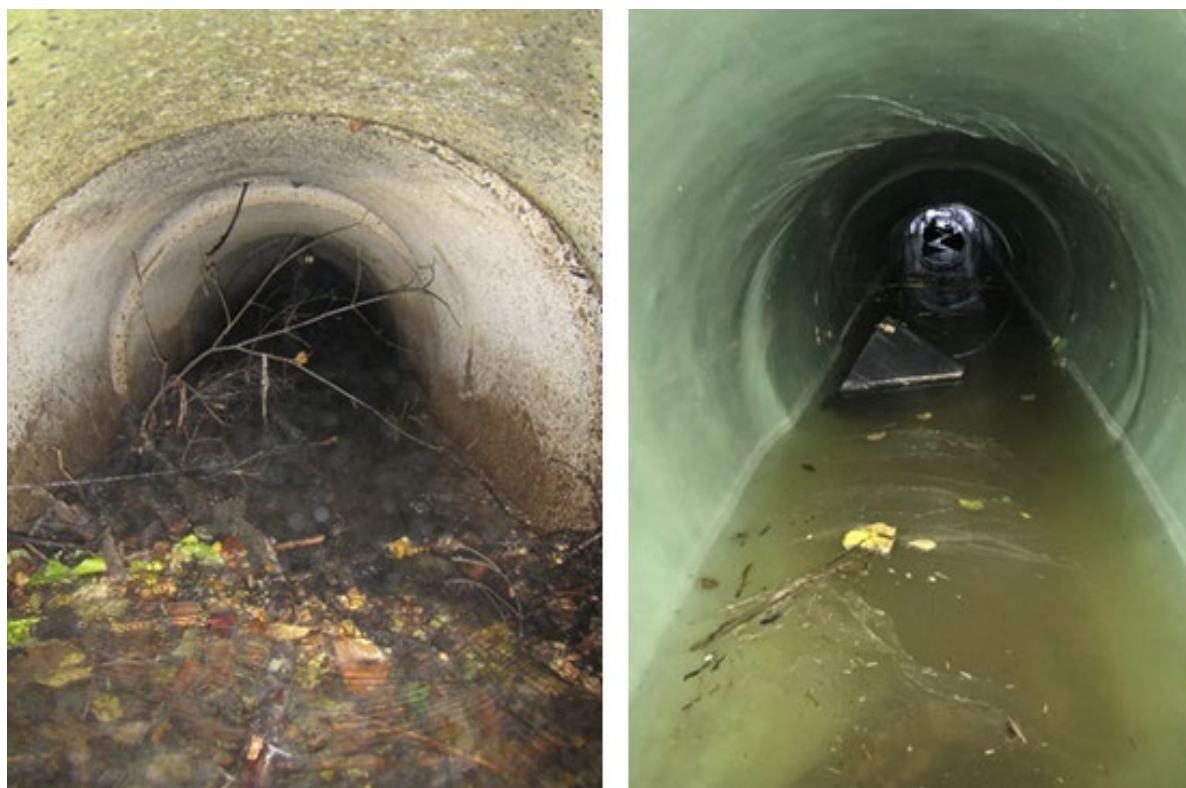
Figure 4: Unnamed Tributary to Pheasant Creek Culvert Repair Before and After

This 80-foot long culvert is a 36" diameter corrugated metal pipe (CMP), passing a stream with an estimated active channel width of 14 feet. The culvert's structural condition was considered poor, due to severe settlement and open joint issues. If left untreated, these issues could allow water to escape the culvert and erode the soil arch under the roadway, ultimately leaving the highway unsupported and unsafe. Hydraulic calculations show flow conditions at the culvert had velocities of 2.44 fps and flow depths as low as 1.5 inches (flows ranging between 5 percent and 95 percent of the daily exceedance stream discharge). This flow exceeded the ODFW fish passage criteria of 2 fps. Species using the habitat upstream of the culvert include cutthroat trout and possibly pacific lamprey. The culvert was a partial velocity barrier to these species, potentially blocking or delaying access to approximately 0.2 miles of habitat.

The degraded culvert was repaired with a cast-in-place pipe liner that sealed the joints and alleviated the settlement issues, keeping the water flowing inside the culvert. Fish passage was

improved with the addition of staggered one-piece polymer baffles with rounded edges. These baffles were placed to decrease the velocities within the culvert and offer ample hydraulic variation for NMF. The rounded edges of the baffles were an important fish passage detail due to the possibility of adult Pacific lamprey in the system. Post-treatment conditions were estimated to have velocities of 1.03 fps and flow depths of 6.7 inches, thus improving access to the approximate 0.2 miles of upstream habitat.

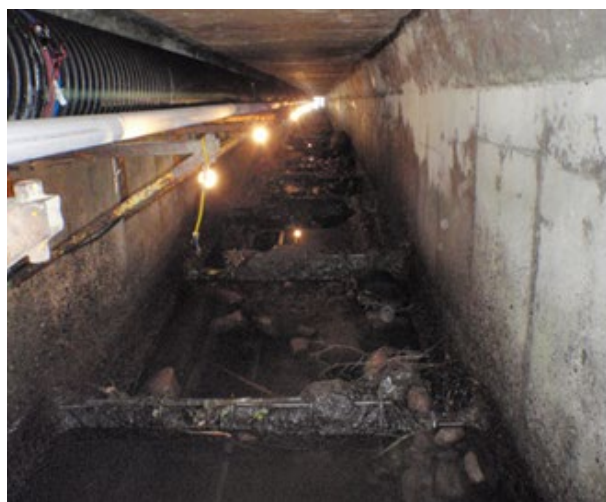
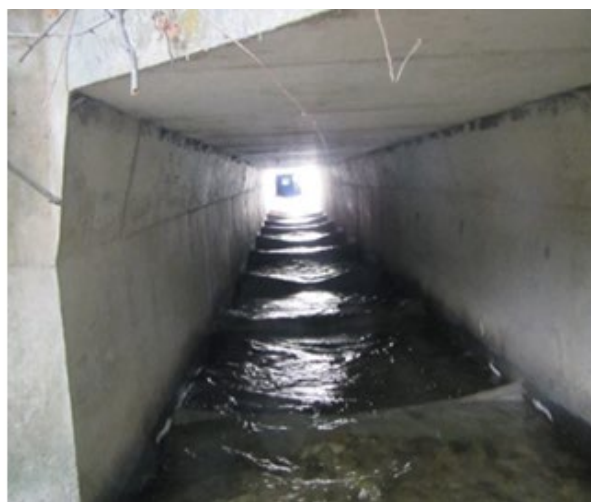
Figure 5: Neil Creek Culvert Repair Before and After

This concrete box culvert is 435 feet long, eight feet wide, and eight feet tall. The culvert's condition prior to repair was poor due to invert degradation. Invert degradation allows water to saturate the soil surrounding the culvert. It also erodes away the soil beneath the culvert and can lead to settling. If left untreated, these issues can lead to the roadway becoming unsupported and unsafe. The hydraulic conditions within the culvert presented numerous issues, including passage barriers of increased jump heights over the old concrete weirs and high velocities during high flow.

The culvert invert and concrete weirs were repaired, amending the invert degradation issue. The repair of the concrete weirs improved fish passage. These lowered the velocity in the culvert and allowed for variation of hydraulic conditions through the culvert to improve NMF passage conditions to the potential 8.9 miles of habitat upstream.

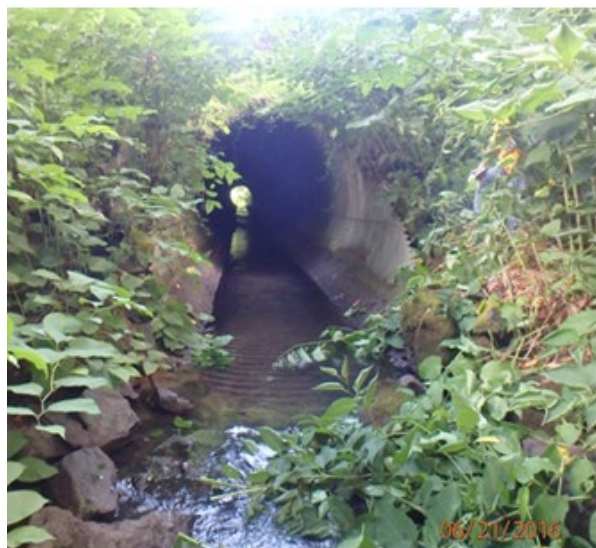
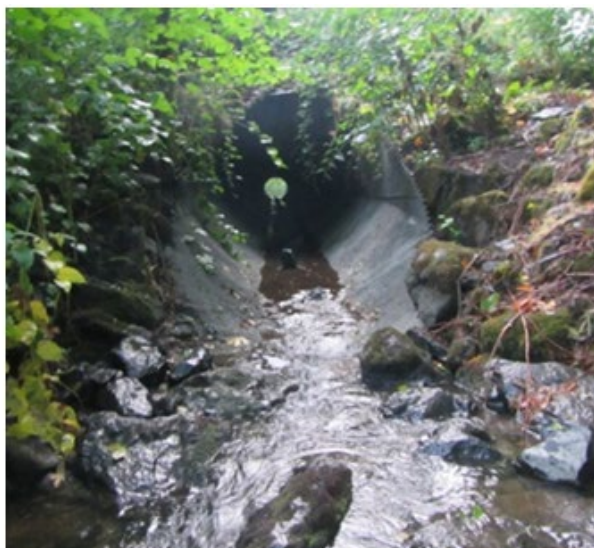
Figure 6: Pass Creek Culvert Repair Before and After

The 12-foot diameter CMP is 284 feet long and drains an area of 5.27 square miles. The culvert's surveyed condition was considered poor due to corrosion and a missing section of the invert. If left untreated, this could become a potential hazard to the traveling public due to water saturating and destabilizing the surrounding soil arch and roadbed, leading to settlement of the culvert that could leave the roadway unsupported.

The stream has an estimated active channel width of 15 feet. Water velocities during high flow conditions and shallow water depths during low flow conditions created a partial barrier for the upstream movement of fish through the culvert. Cutthroat trout, steelhead, rainbow trout, and ESA listed coho salmon were potentially blocked or delayed from accessing the approximately 4.89 miles of upstream habitat due to these conditions.

The culvert was repaired with a 6-inch paved invert treatment. This allowed for the degraded invert condition to be restored, keeping the water inside the barrel. Installing an 18-inch pre-cast concrete fish blocks at 10-foot intervals through the pipe improved fish passage. These blocks slow water velocities during high flow events, increase flow depth during low flow conditions, and create flow complexity within the culvert. The resulting conditions improve fish passage and increase access to the 4.89 miles of upstream habitat.

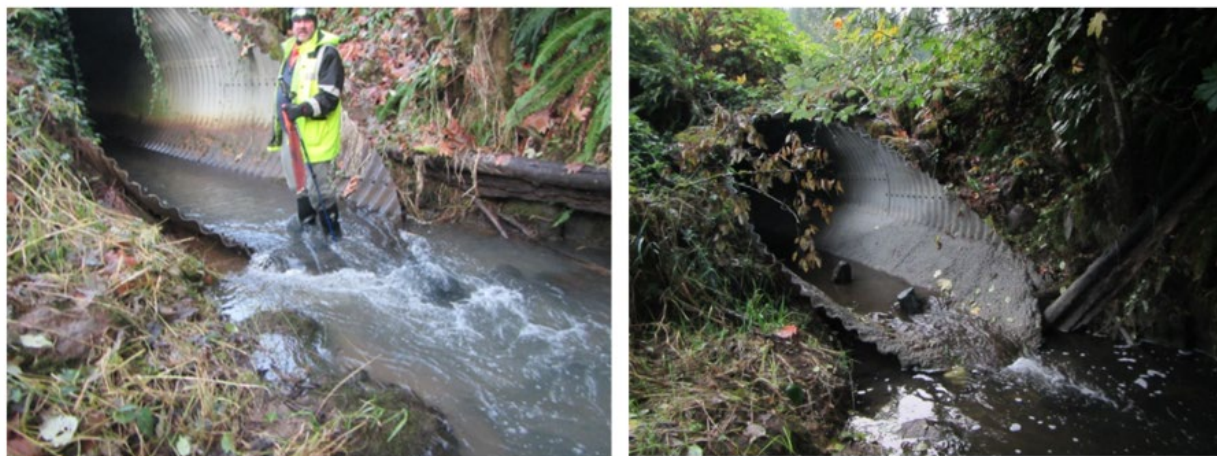
Figure 7: Pass Creek Culvert Repair Before and After

This culvert conveys Pass Creek under I-5 approximately 6.0 miles south-west of Cottage Grove in Douglas County, Oregon. Pass Creek is a tributary to Elk Creek in the Umpqua River basin. This culvert is an 8-foot circular CMP and is 234 feet long. In this location, Pass creek has an estimated active channel width of 15 feet. The culvert was considered to be in critical condition, mainly due to invert damage, water piping (water flowing on and around the outside or damaged sections of the pipe), and some end treatment issues that, if left untreated, could allow water to saturate the soil surrounding the culvert. This could cause the culvert to settle and the soil to erode, ultimately leaving the roadway unsupported.

Post-construction monitoring of the project documented that the specified rocks in the downstream weir were undersized, was not embedded into the channel, and not fully sealed, allowing water to flow through the rocks rather than maintaining surface flow. The following winter, a high water event displaced the rocks of the weir. Although subsequent high flow events recruited natural streambed material in the proximity of the original weir location, the ultimate backwater condition at the culvert outlet does not improve fish passage to the extent designed. Monitoring of the project continues to see how the natural recruitment of sediment will ultimately backwater the site. If the site does not backwater to the extent designed, a modification will be made during the applicable IWWP.

The culvert was repaired with a 6-inch paved invert. This restored the invert integrity, resolved the water piping issues, and improved the end treatment to help keep the water flowing through the culvert and not around it and in the surrounding soil. Installing 10- inch pre-cast concrete fish blocks at 5-foot intervals throughout the culvert improved fish passage. The fish blocks increase flow depths during low flow, create eddies and flow complexities within the culvert, and reduce velocities during high flow. A weir was constructed downstream of the culvert outlet to increase the outlet pool elevation and reduce the 6-inch perch, allowing for improved access to the 3.67 miles of habitat upstream.
