## DEQ Solid Waste Program

# LANDFILL INSPECTION REPORT

| <b>FACILITY:</b> | Riverbend Landfill | | | | |
| <b>INSPECTOR(S):</b> | Bob Schwarz | | <b>INSPECTION DATE:</b> | Jan 28, 2014 | |

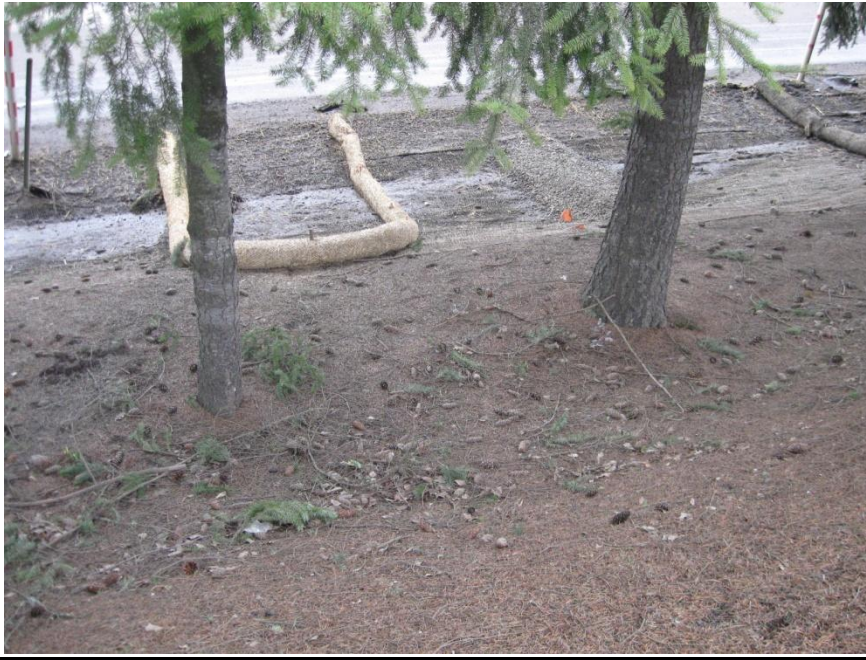
| <b><u>V</u></b> | <b><u>STORMWATER MANAGEMENT</u></b> | <b>In<br/>Compliance</b> | <b>Not in<br/>Compliance</b> | <b>N/A for this<br/>Inspection</b> | <b>Follow-up<br/>required</b> |
|---|---|---|---|---|---|
| | Notes: Wattles along Highway 18 have been replaced and supplemented with gravel check dams. These appear to be more effective at catching sediment. | | | | |

1. New stormwater wattles and gravel check dams in swale along Highway 18.

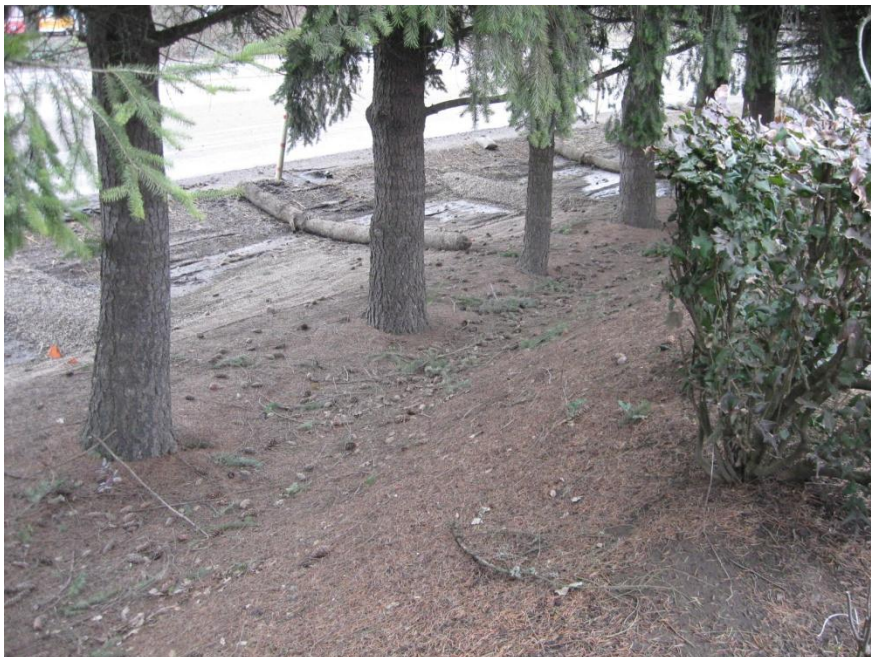
2. New stormwater wattles and gravel check dams in swale along Highway 18.

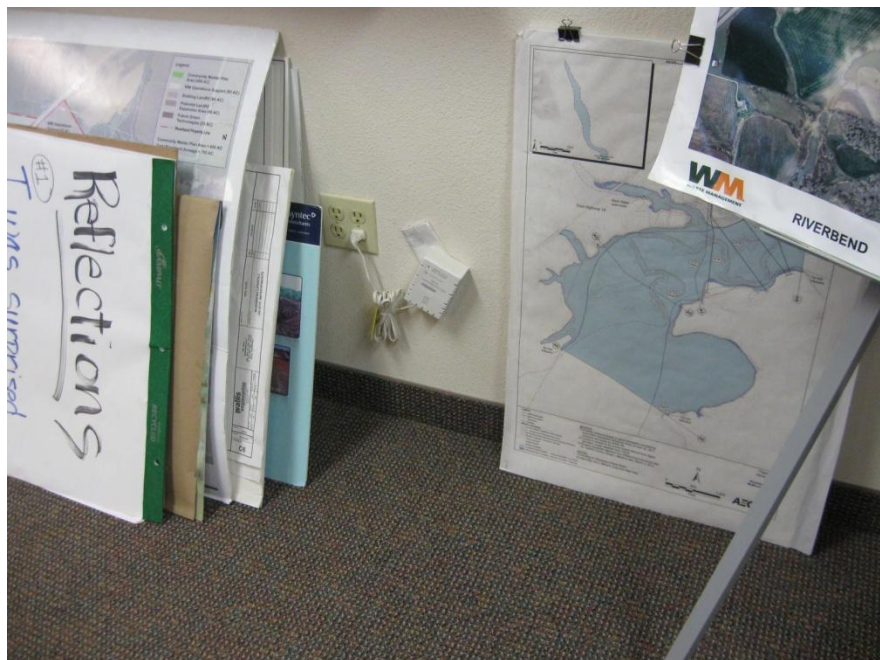
| VI | <b><u>LANDFILL GAS MANAGEMENT</u></b> | In Compliance | Not in Compliance | N/A for this Inspection | Follow-up required |
|---|---|---|---|---|---|
| | Notes: Office building, scale house and engine building all should have landfill gas sensors/alarms. Office and scale house each have one. Engine building has eight. | | | | |

3. Landfill gas detection/alarm in conference room in main office.

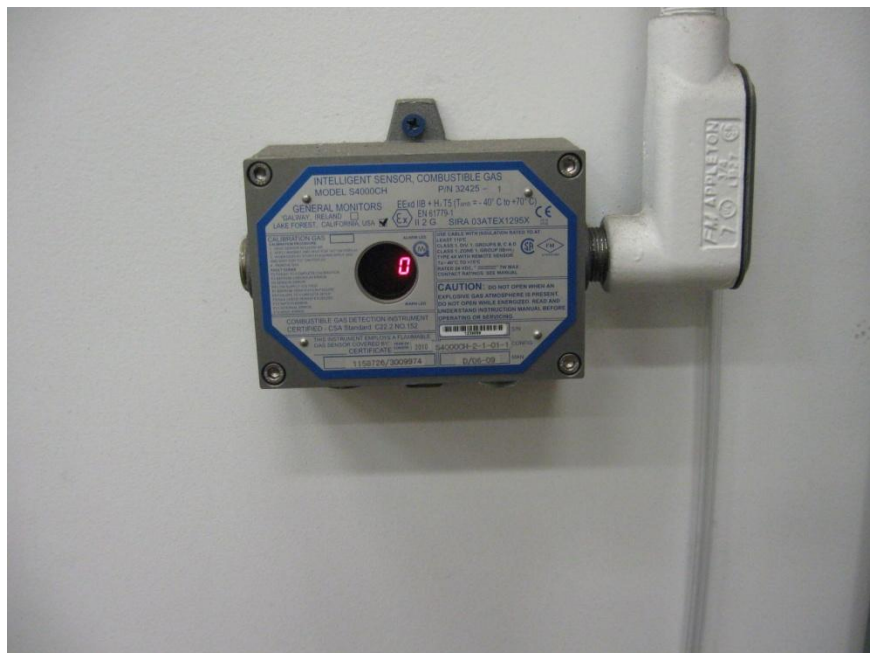
5. Landfill gas detection/alarm in engine building.

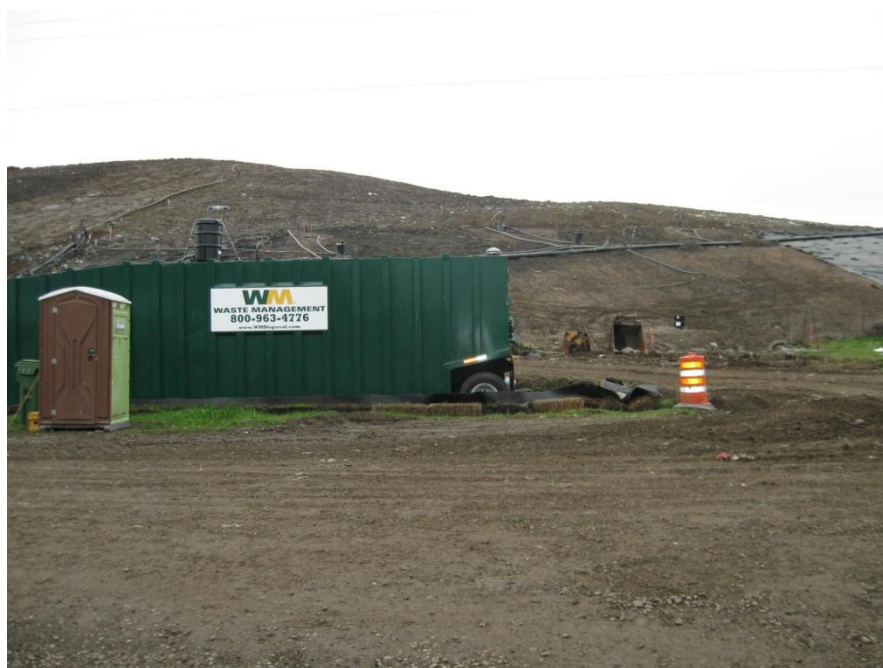
6. View of north slope, following completion of waste relocation for construction of north access road.

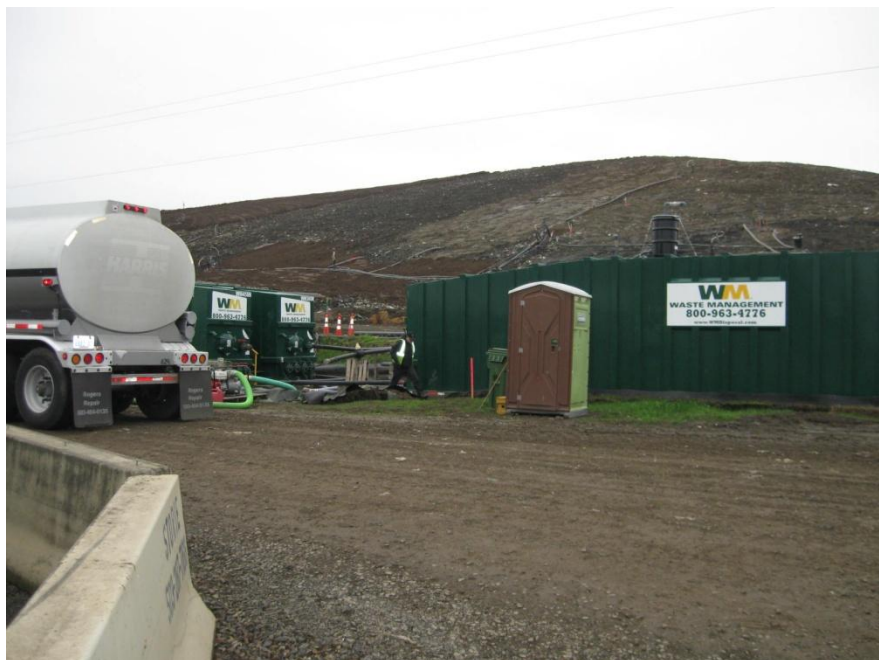
7. View of north slope, following completion of waste relocation for construction of north access road.  
Foreground: the three 21,000-gallon tanks for landfill gas condensate and related leachate.

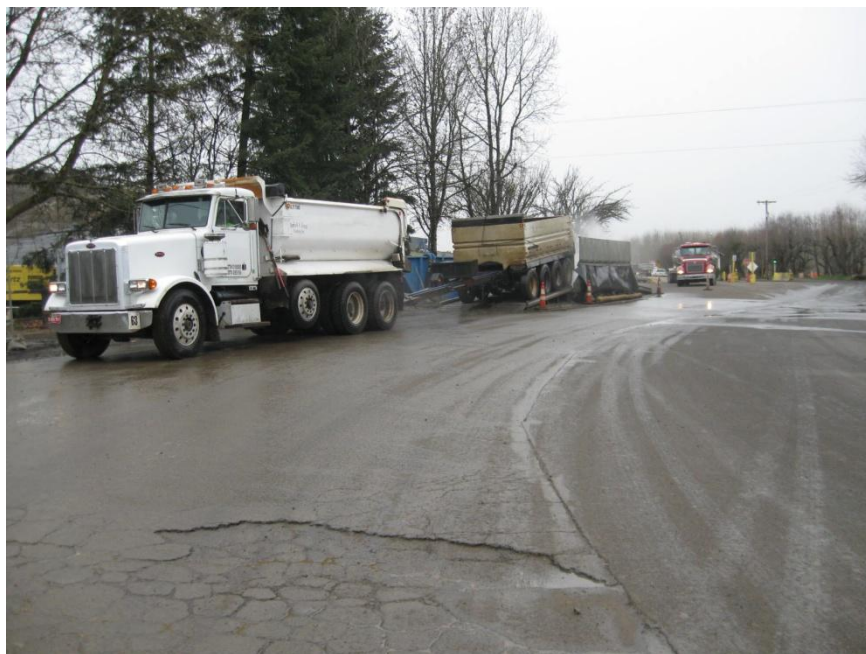
| <b><u>V</u></b> | <b><u>STORMWATER MANAGEMENT</u></b> | <b>In<br/>Compliance</b> | <b>Not in<br/>Compliance</b> | <b>N/A for this<br/>Inspection</b> | <b>Follow-up<br/>required</b> |
|---|---|---|---|---|---|
| | Notes: Mud from trucks is cleaned using a sweeper on landfill roads. A contractor sweeps Highway 18 twice daily. | | | | |

8. Wheel wash for removing mud from trucks and tires before trucks leave the site.

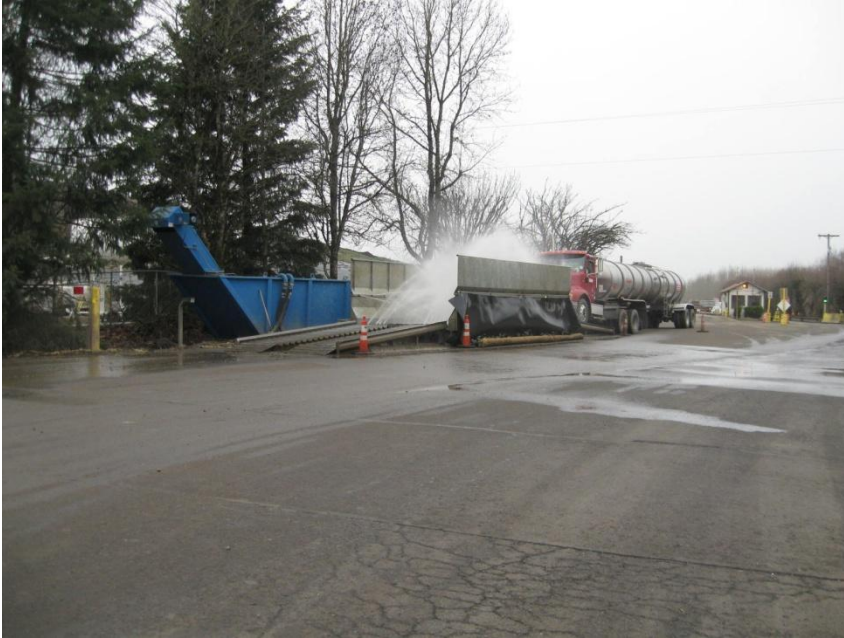
9. Wheel wash for removing mud from trucks and tires before trucks leave the site.

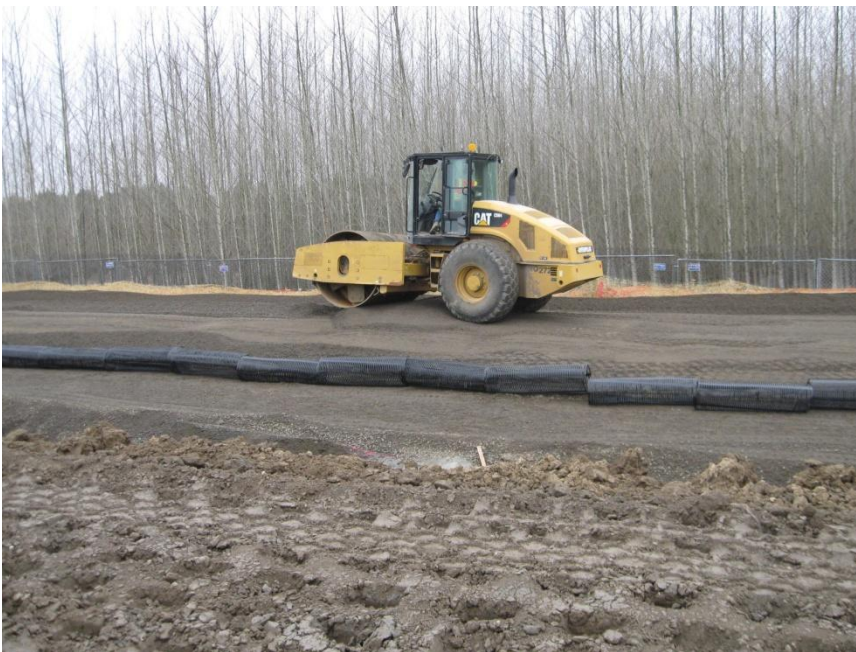
10. Smooth drum roller compacting granular soil for exterior portion of the mechanically stabilized earthen (MSE) berm. In midground: rolls of uniaxial geogrid used to reinforce this soil.

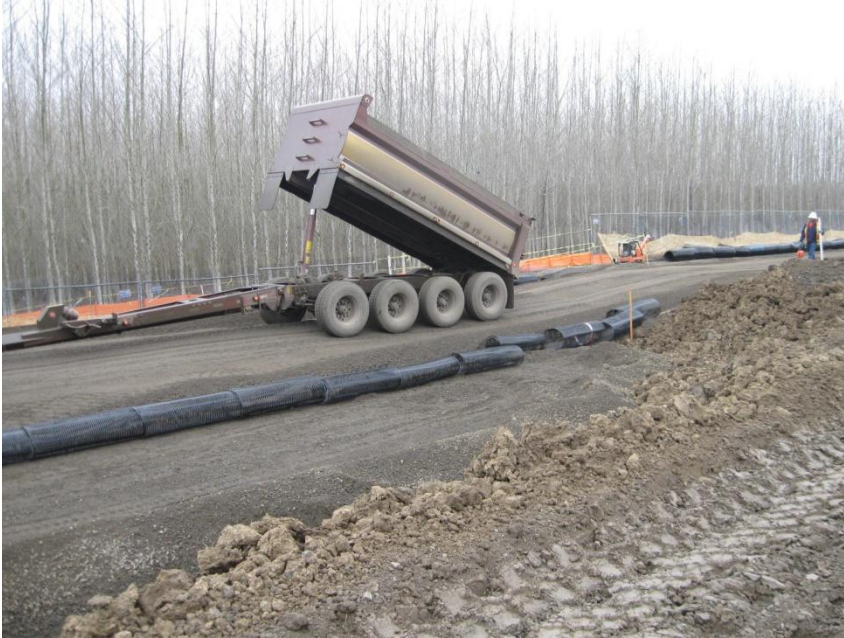
11. Unloading granular soil for reinforced fill zone of MSE berm.

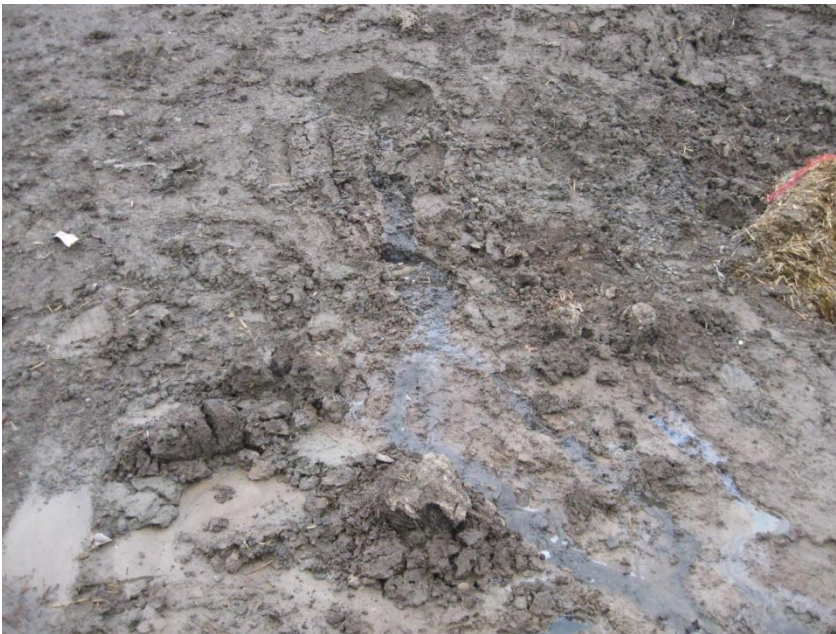
| <b>INSPECTION SUMMARY/KEY ITEMS:</b><br><br><p><b>Leachate seep.</b> Leachate was observed trickling through stormwater diversion berm on north side of landfill. Some of this leachate crossed the perimeter road along the northern edge of the landfill and flowed down to the grassy area north of the landfill.</p> <p><b>Odors.</b> Odors were much reduced from my last visit, when waste on the north side of the landfill was still being moved to allow construction of the north access road. Gary Andes met me at the site around noon. We drove through different parts of the community to check for odors. We did not smell any at any location.</p> <p><b>Roadside litter.</b> In light of recent complaints about roadside litter, I again monitored litter quantities along highway 18, beginning 13 miles north of landfill. Litter was seen periodically all along the highway. At approx 6 miles north of the landfill, two people were picking up litter. Right near the landfill, another litter crew (hired by the landfill) was doing the same. Amount of roadside litter near the landfill was high.</p> <p><b>Gas flare.</b> Landfill personnel report that enclosed flare is running normally.</p> <p><b>Gas detectors/alarms.</b> I checked that all buildings that should have methane detectors/alarms have them. These buildings are: main office, scale house, engine building. Office and scale house each have one; the engine building has eight.</p> | | | | | |

| IV | LEACHATE MANAGEMENT | In Compliance | Not in Compliance | N/A for this Inspection | Follow-up required |
|---|---|---|---|---|---|
| | Notes: Leachate seeps observed along north side of landfill (Module 8) | | | | |

Leachate weeping through stormwater diversion berm near northern edge of landfill.

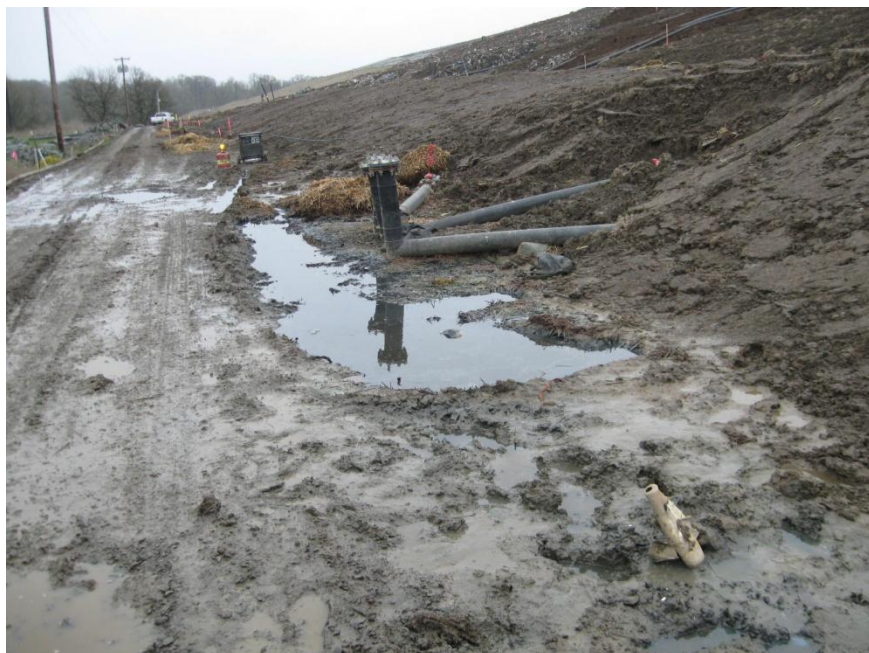
Ponded water, containing leachate, along northern road around landfill (looking east). In midground, this liquid is running across the road and into the grassy area to north of the landfill.

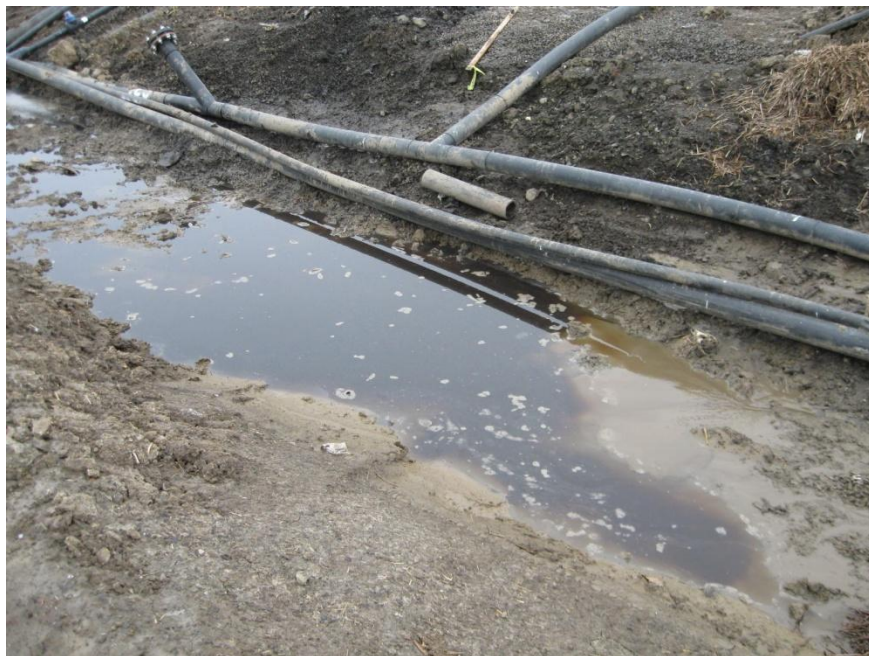
Leachate ponding on interior side of stormwater swale.
