State of Oregon  
Department of  
Environmental  
Quality

# LANDFILL INSPECTION REPORT

| <b>FACILITY:</b> | Riverbend Landfill | | | | |
| <b>INSPECTOR(S):</b> | Bob Schwarz | | <b>INSPECTION DATE:</b> | Apr. 30, 2014 | |

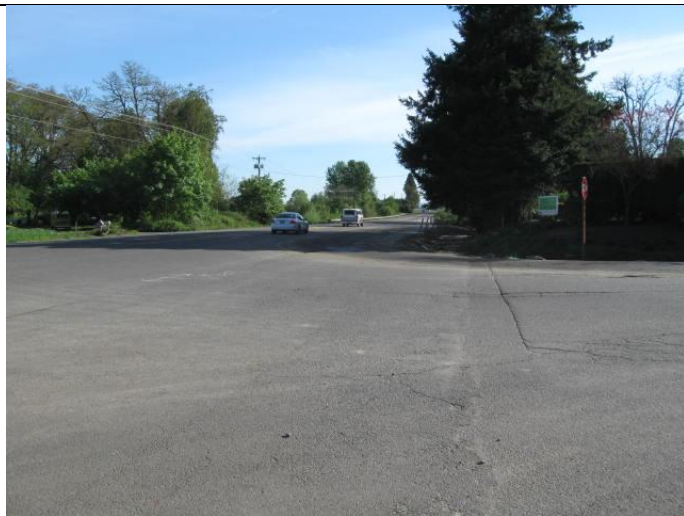
Road cleanliness. At 8:30 am, dirt on road was causing vehicles to raise dust clouds. Sweep Rite comes to the site at approximately 9 am, 1 pm, 4 pm and late at night. Road was inspected again at 9:45 am after the first sweeping of the day. Conditions were greatly improved.

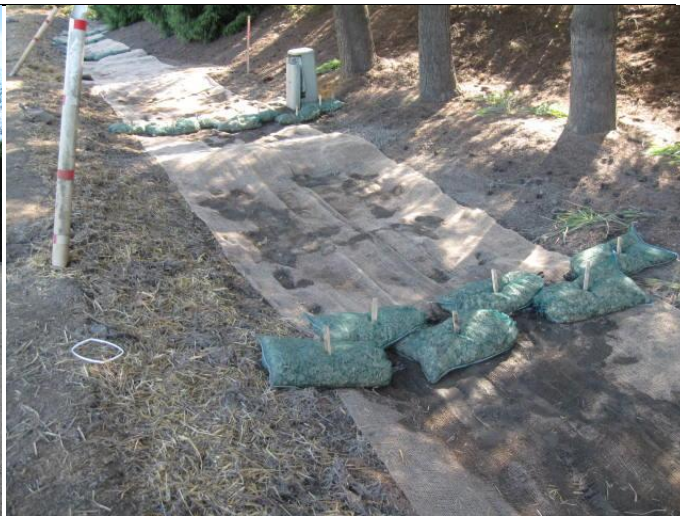
Erosion control features in swale along landfill side of Hwy 18. Mulch bags are staked into ground. Jute mesh lines the swale. Mulch bags are above, gravel check dams are beneath.

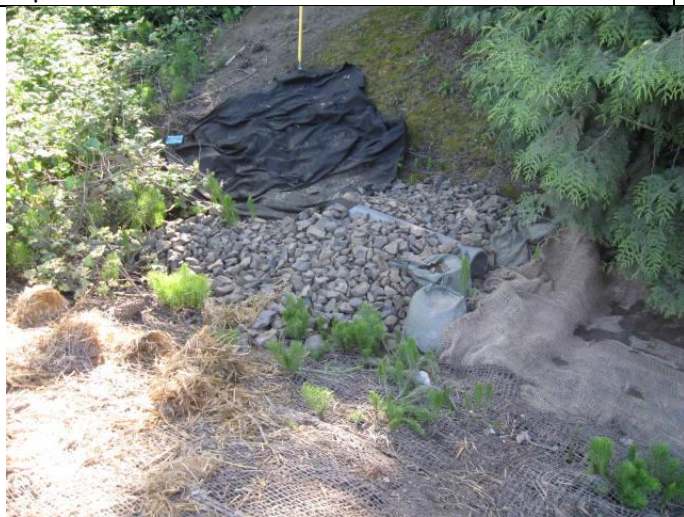
Downstream end of jute mesh, where swale leads to creek. Outlet is filled with gravel and a steel pipe, the end of which is covered by geotextile to filter sediment out of discharging water.

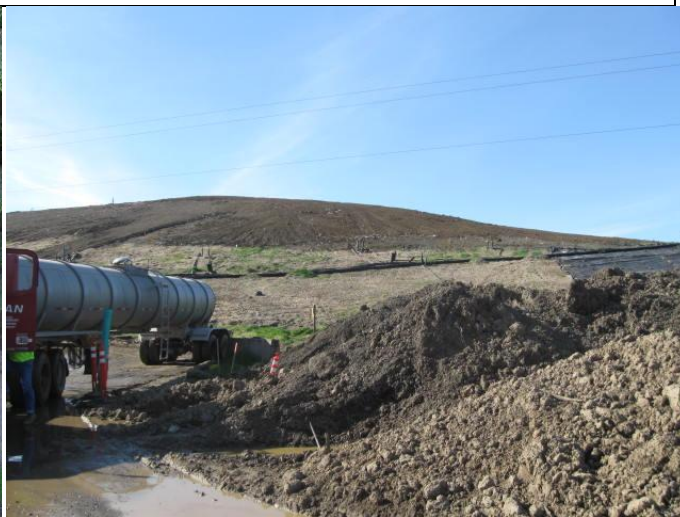
View of NW slope of the landfill. WM plans to add additional soil on this area to complete the 18" intermediate cover

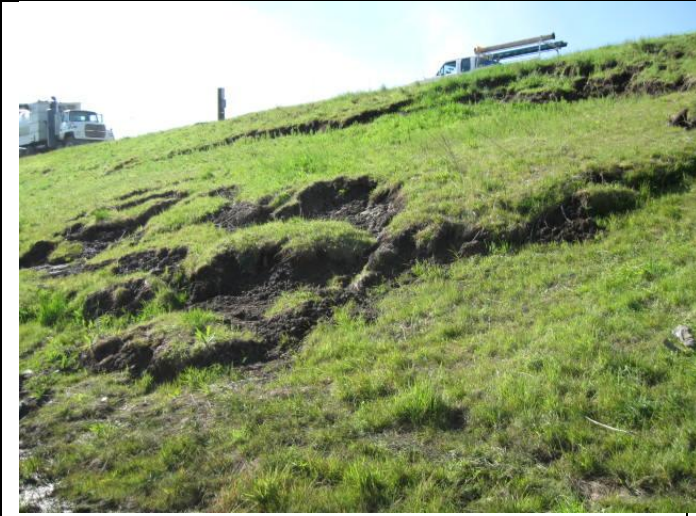
Soil sloughing on north slope. Geosyntec will submit plans by June to repair this area. The repair work will be done in late summer, when conditions are driest.

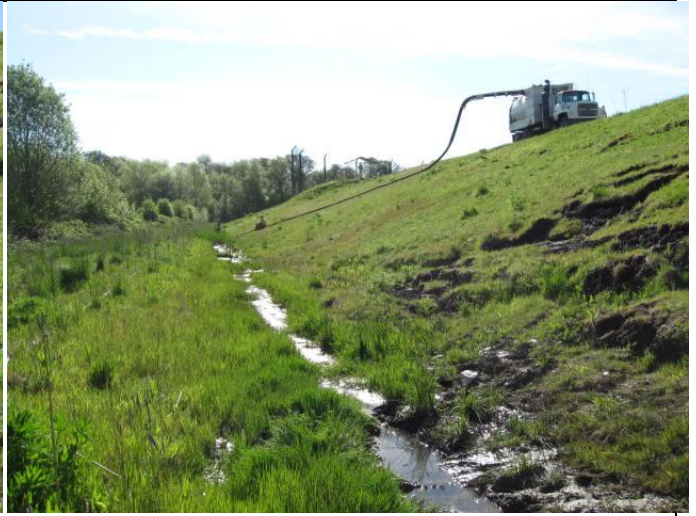
Soil sloughing area. Also shown is vac truck removing stormwater from base of slope, to reduce potential for further sloughing.

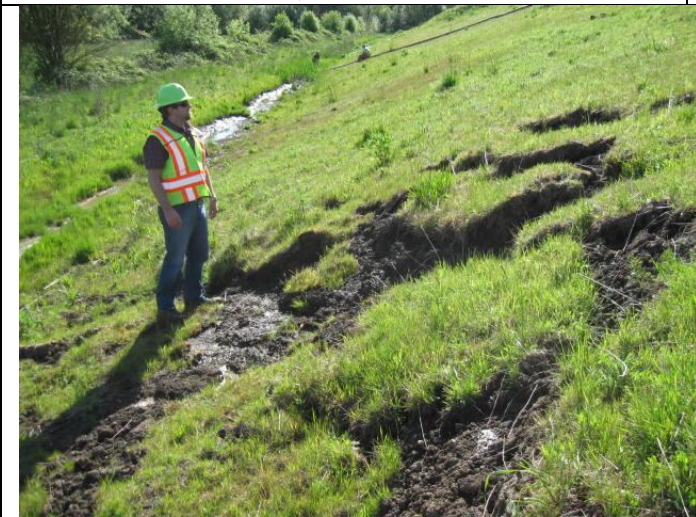
Close up view of area with sloughing soil.

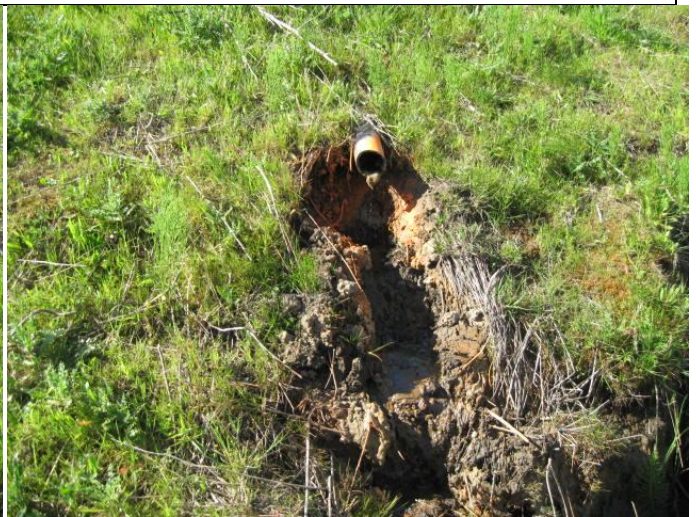
Drain pipe installed during cell construction. These are contributing to sloughing problem, and will be evaluated by Geosyntec.

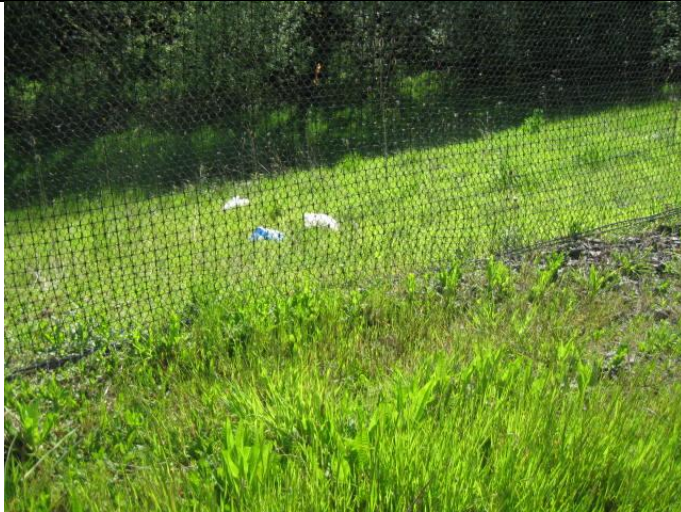
Tall litter fence on NE side of landfill. Some plastic litter was observed outside the fence. Holes in fence noted during April 8 inspection have been repaired.

| I. | OPERATIONS | In Compliance | Not in Compliance | N/A for this Inspection | Follow-up required |
|---|---|---|---|---|---|
| | Notes: I observed 10-15 bags outside the tall litter fence on the north and east sides of the landfill. WM personnel collected these at my request. The tall litter fence placed there had several very large holes during my previous inspection. These have been repaired. | | | | |

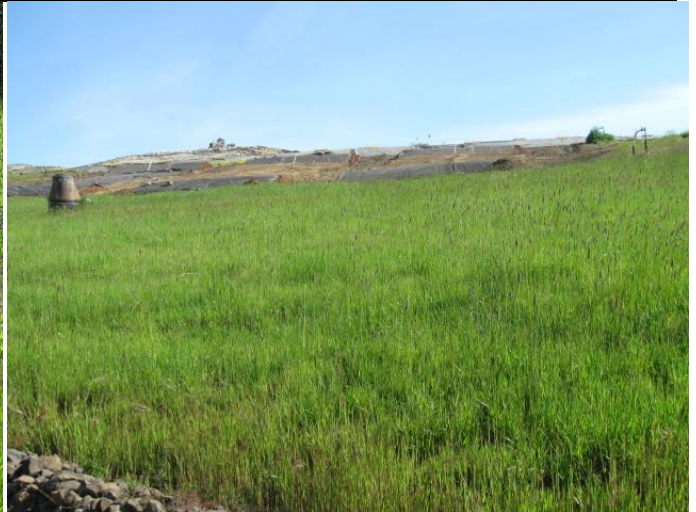
View of working face on top of landfill.

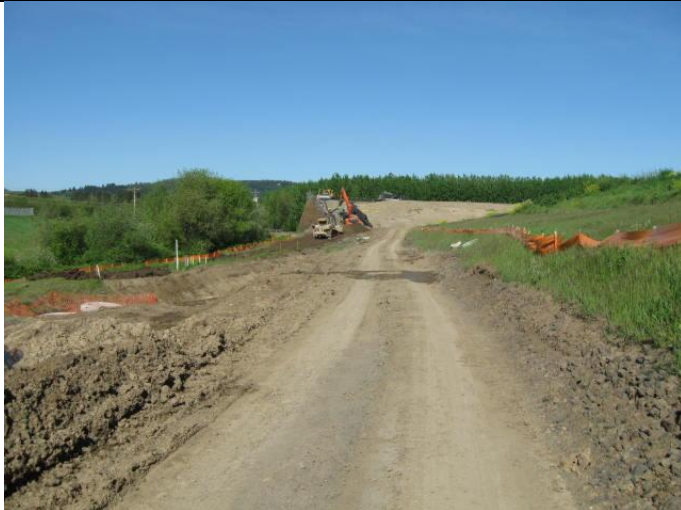
View of MSE berm, looking west from south side of landfill.

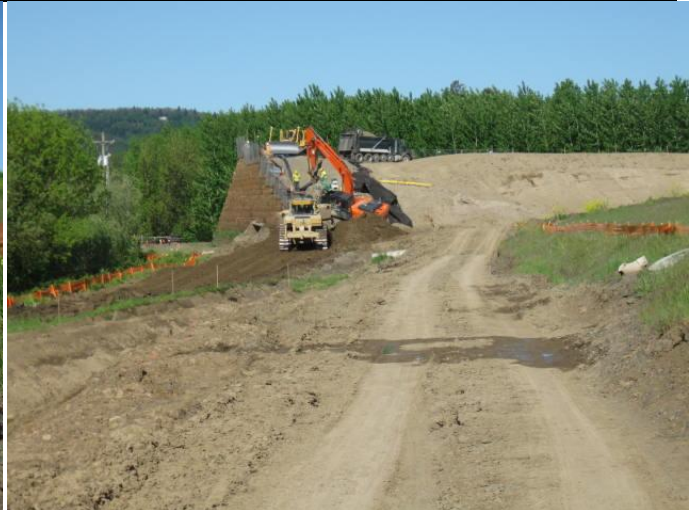
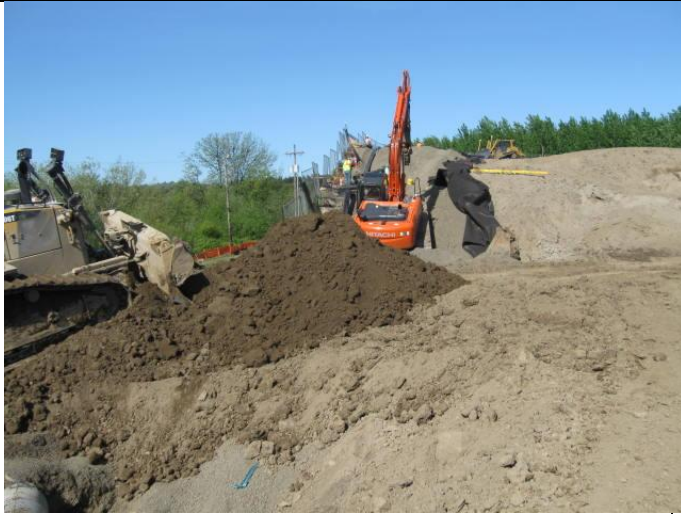
Building the south end of the MSE berm.

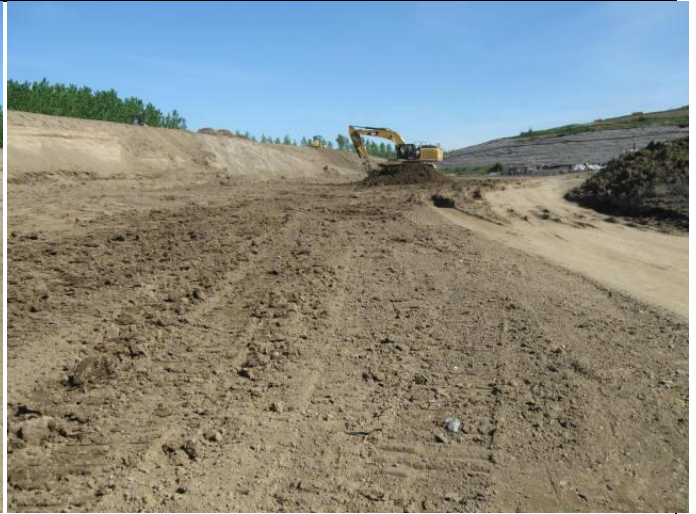
Clay stockpile for MSE berm. Clay is blended with cement at 5 percent to dry it and increase its strength. In the lower, wider berm lifts, clay is placed and then blended with cement. In these upper berm lifts, which are narrower, the clay is blended with cement away from the berm and then the clay/cement mixture is hauled to the berm for compaction.

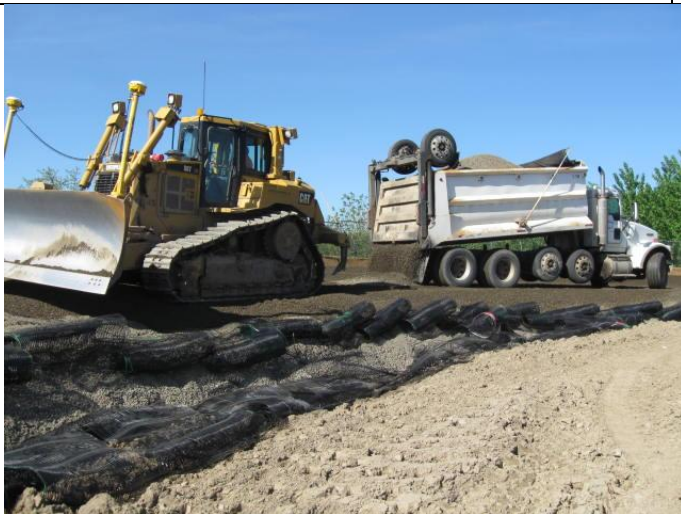
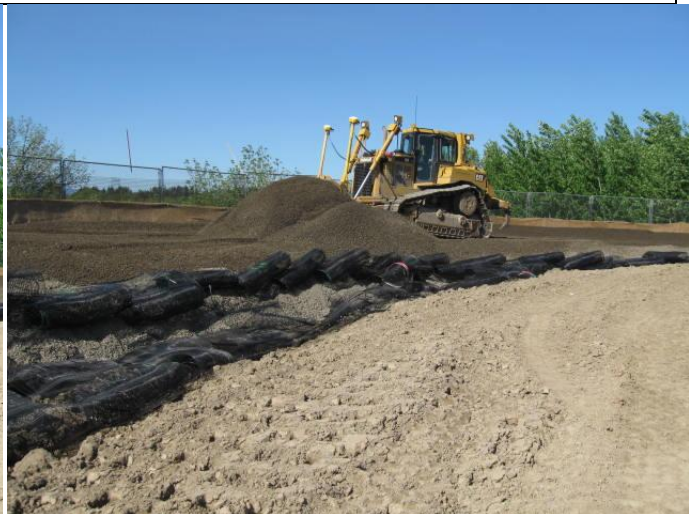
Placing and spreading granular soil in the reinforced fill zone (outer half of the MSE berm).

Placing and spreading granular soil in the reinforced fill zone.

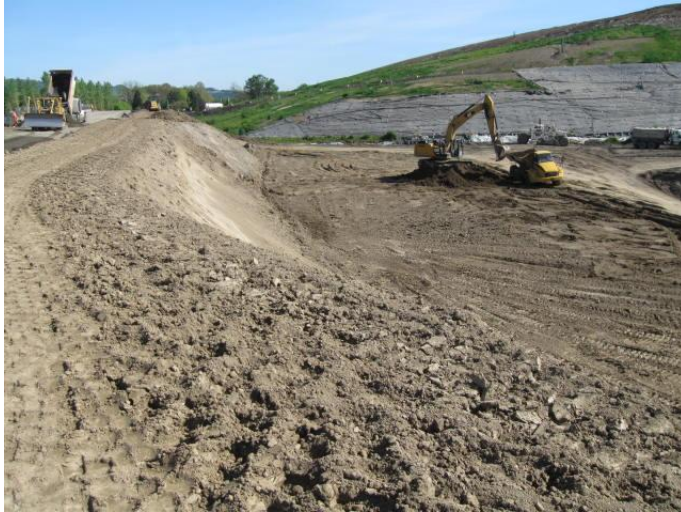
View of the MSE berm's inner, clay slope, from the top of the berm.

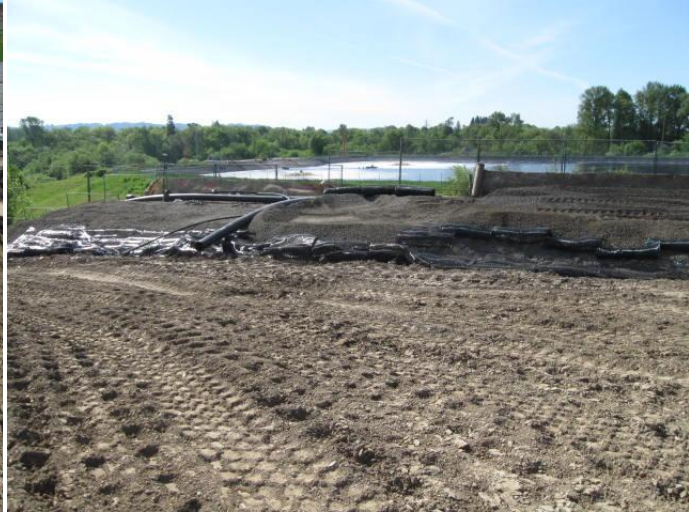
View of leachate storage pond. Liquid level is higher than usual due to heavy spring rains. Freeboard is approximately 8 feet (minimum allowable is 3 feet).

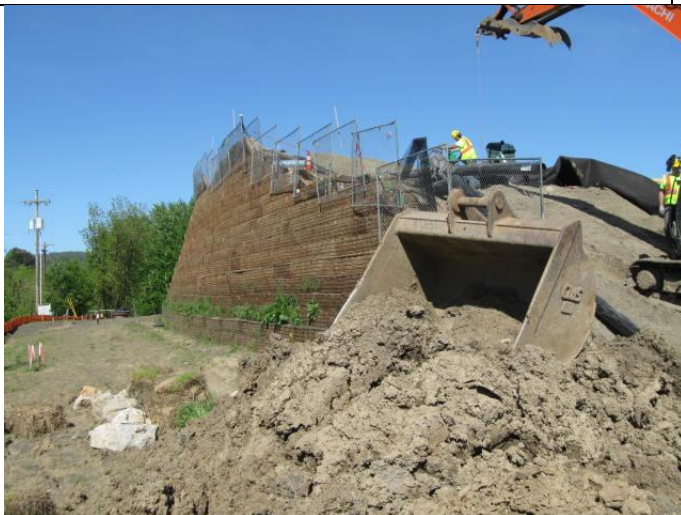
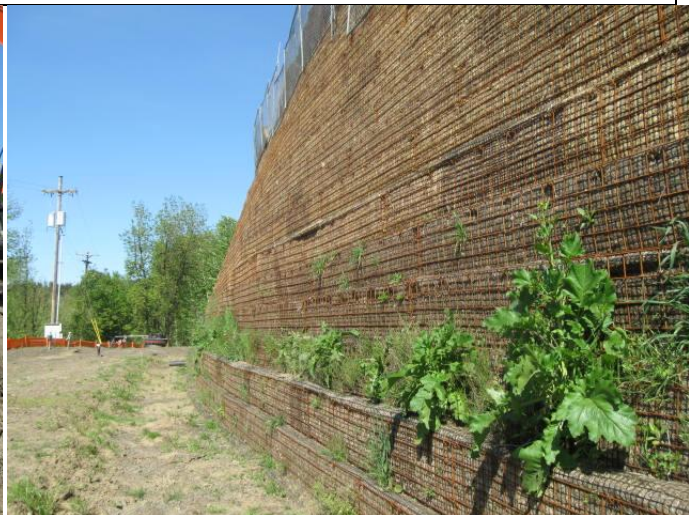
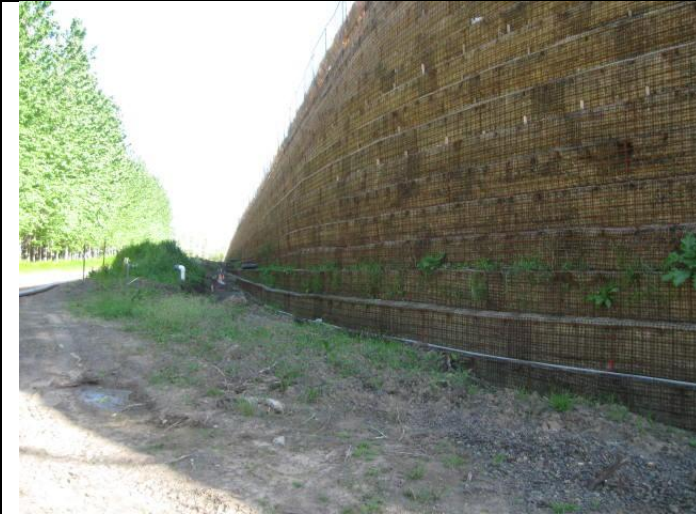
View of MSE berm exterior face. Welded wire cages are placed along the outside of each 18-inch lift to hold topsoil until vegetation is established. The exterior will be hydroseeded after the berm construction is complete.

MSE berm exterior face.

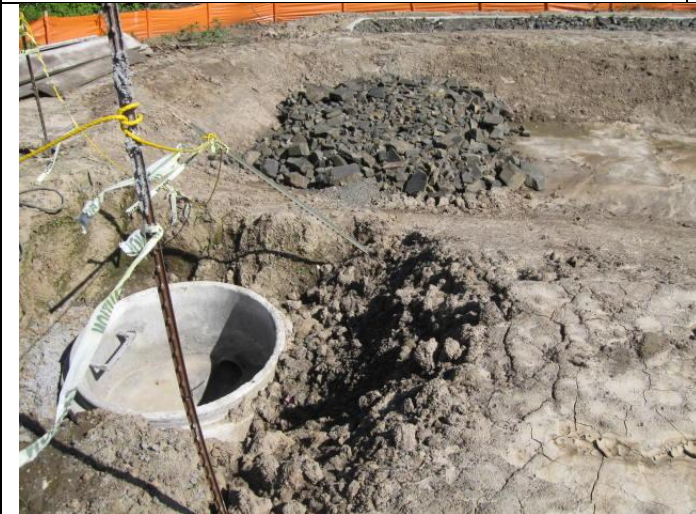
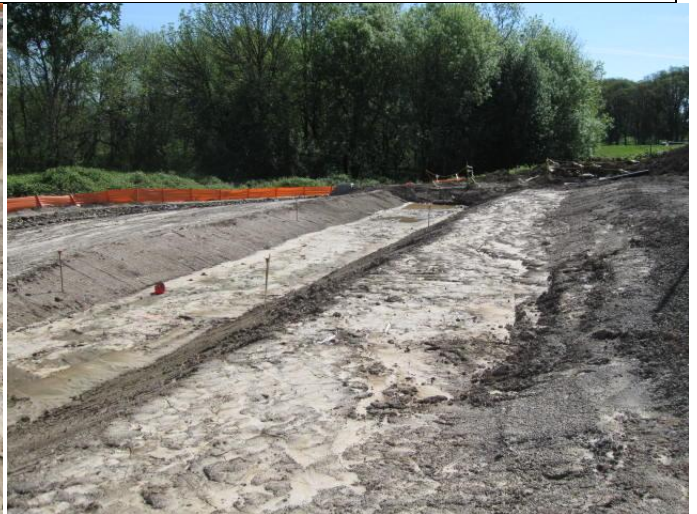
Stormwater retention basin for the front entrance area.
