# Structural Standard Exhibit

Oregon Energy Facility Siting Council

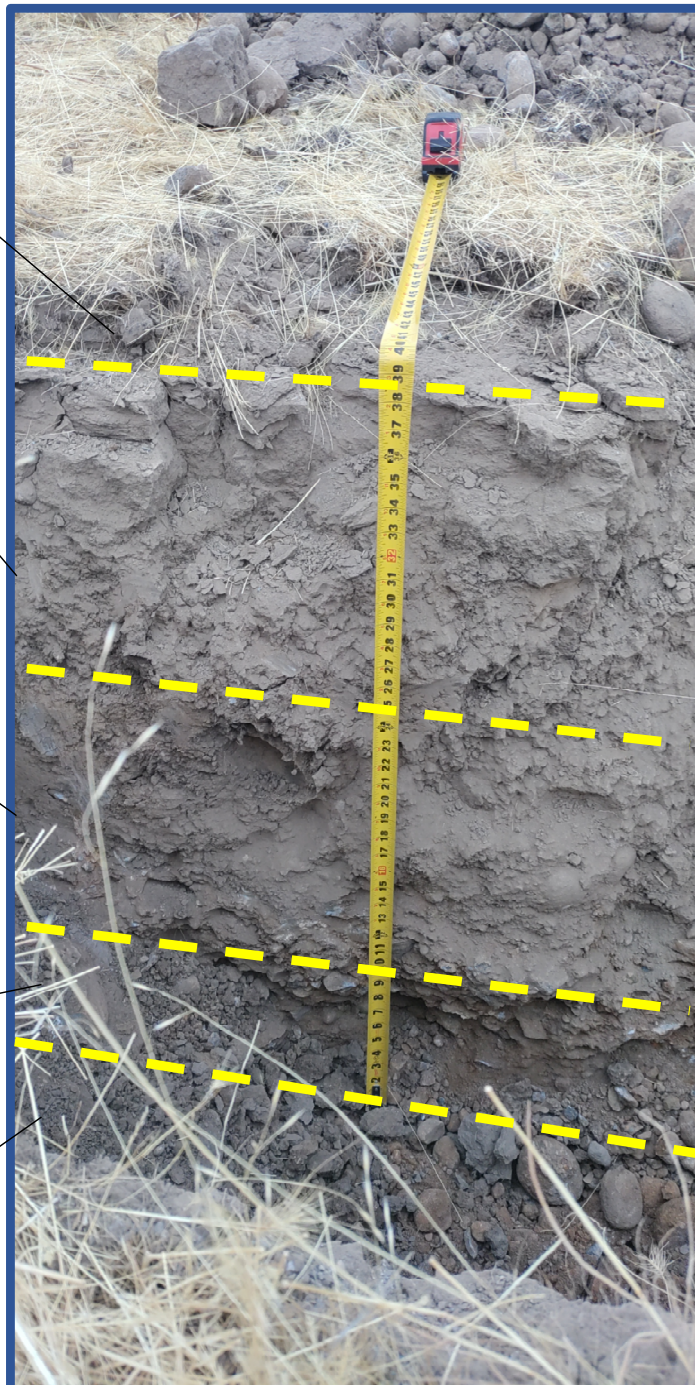
**29 - 39 "**  
Cobbles infilled with reddish brown CLAY, some Silt, little coarse to fine Gravel, little coarse to fine Sand, moist (CL)

**> 39 "**  
Solid Bedrock

\* The dash lines depicted in the photograph are solely intended to serve as a visual aid to demonstrate the differing encountered soil compositions, and as such, are not intended to represent factual or calculated depths for each soil.

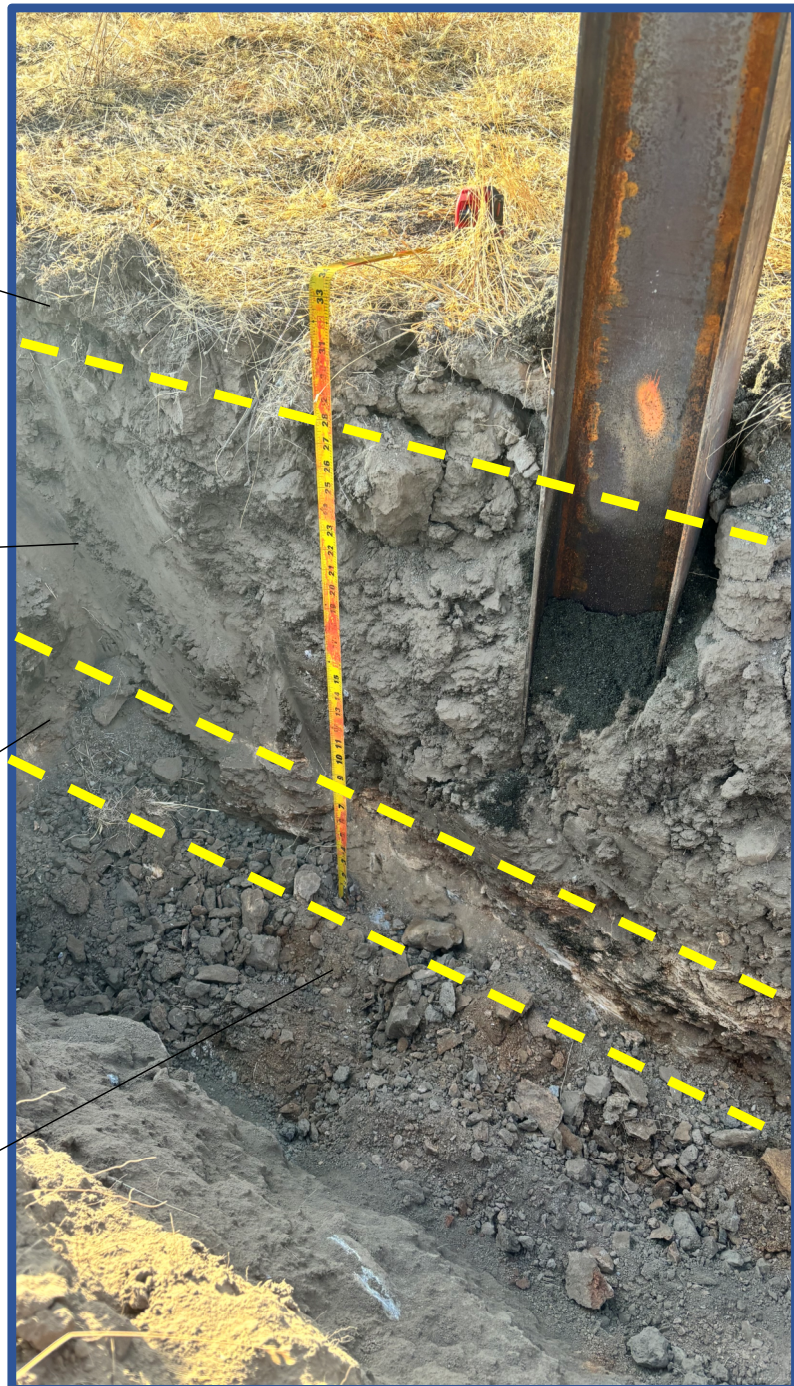
**25 - 34 "**  
Cobbles and Boulders infilled with brown to brownish yellow coarse to fine SAND, some Clay, little coarse to fine Gravel, moist (SC)

**> 34 "**  
Solid Bedrock

\* The dash lines depicted in the photograph are solely intended to serve as a visual aid to demonstrate the differing encountered soil compositions, and as such, are not intended to represent factual or calculated depths for each soil.

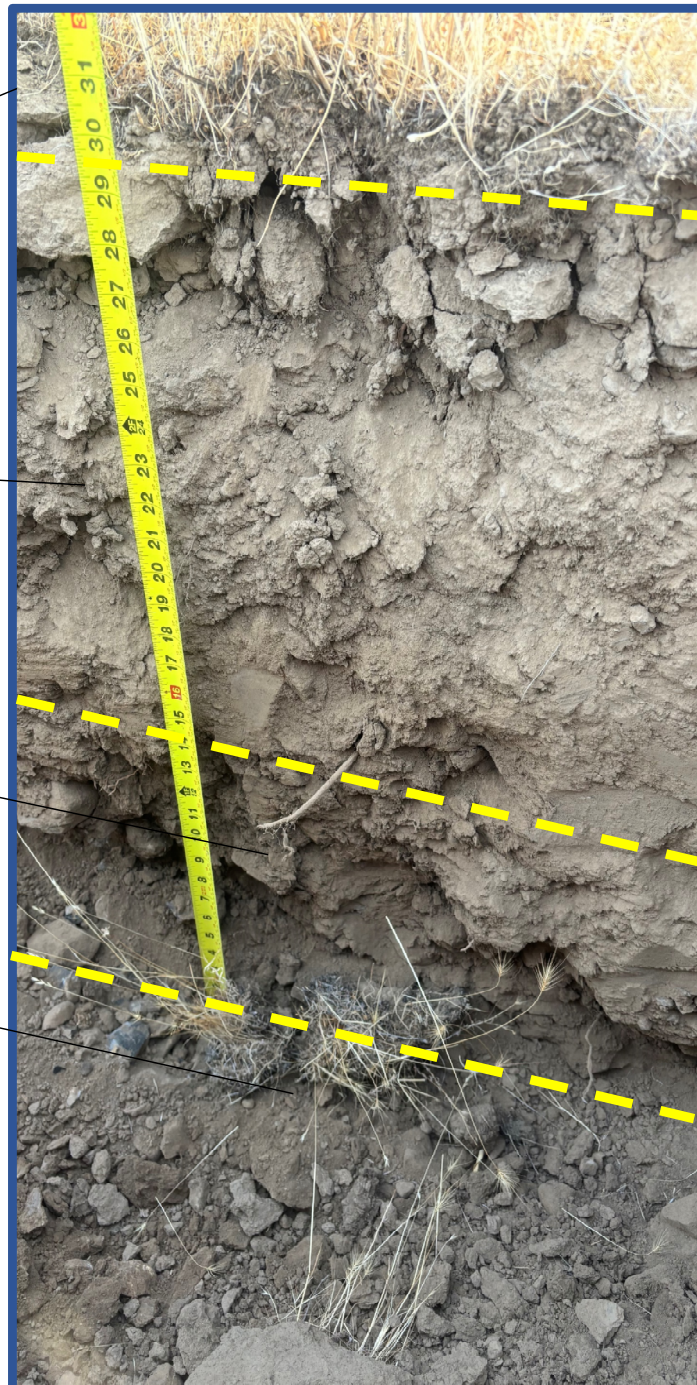
**24 - 34 "**  
Cobbles infilled with brown Clayey coarse to fine SAND, little coarse to fine Gravel, moist (SC)

**> 34 "**  
Solid Bedrock

\* The dash lines depicted in the photograph are solely intended to serve as a visual aid to demonstrate the differing encountered soil compositions, and as such, are not intended to represent factual or calculated depths for each soil.

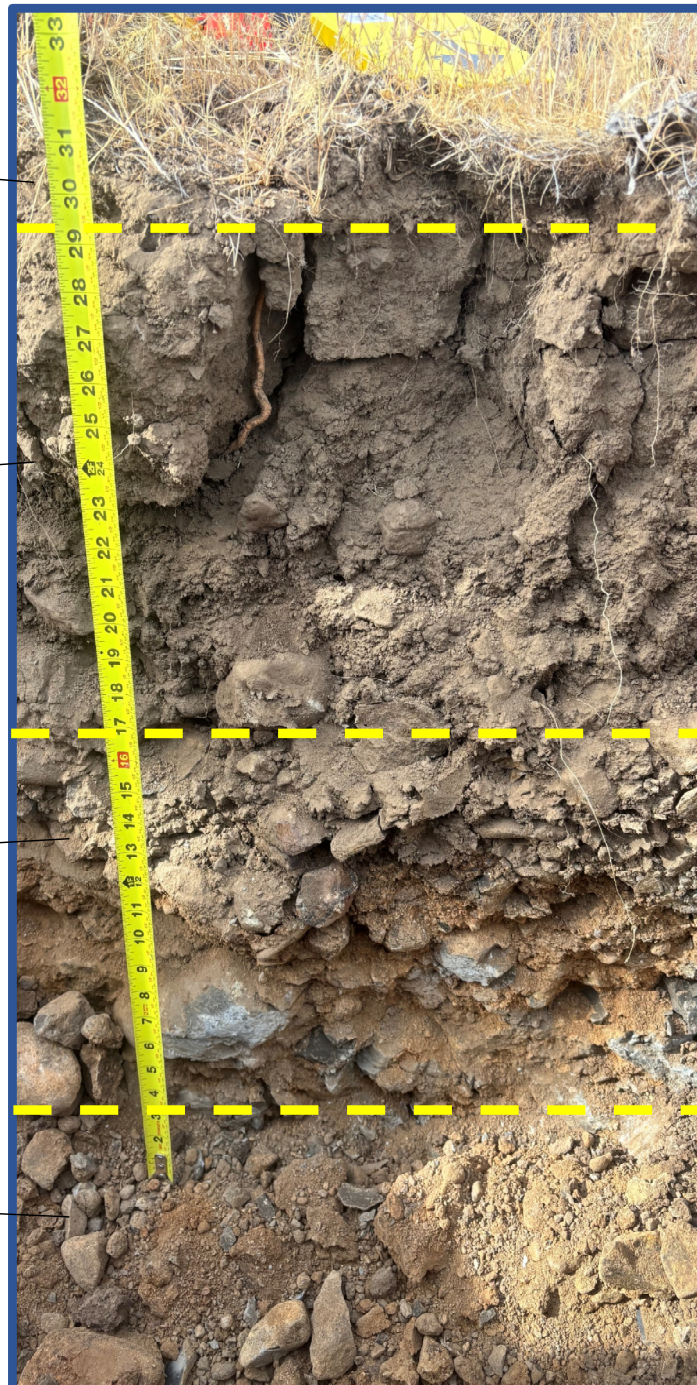
**18 - 33 "**  
Cobbles and Boulders infilled with brown to reddish brown Clayey coarse to fine SAND, little coarse to fine Gravel, moist (SC)

**> 33 "**  
Solid Bedrock

\* The dash lines depicted in the photograph are solely intended to serve as a visual aid to demonstrate the differing encountered soil compositions, and as such, are not intended to represent factual or calculated depths for each soil.

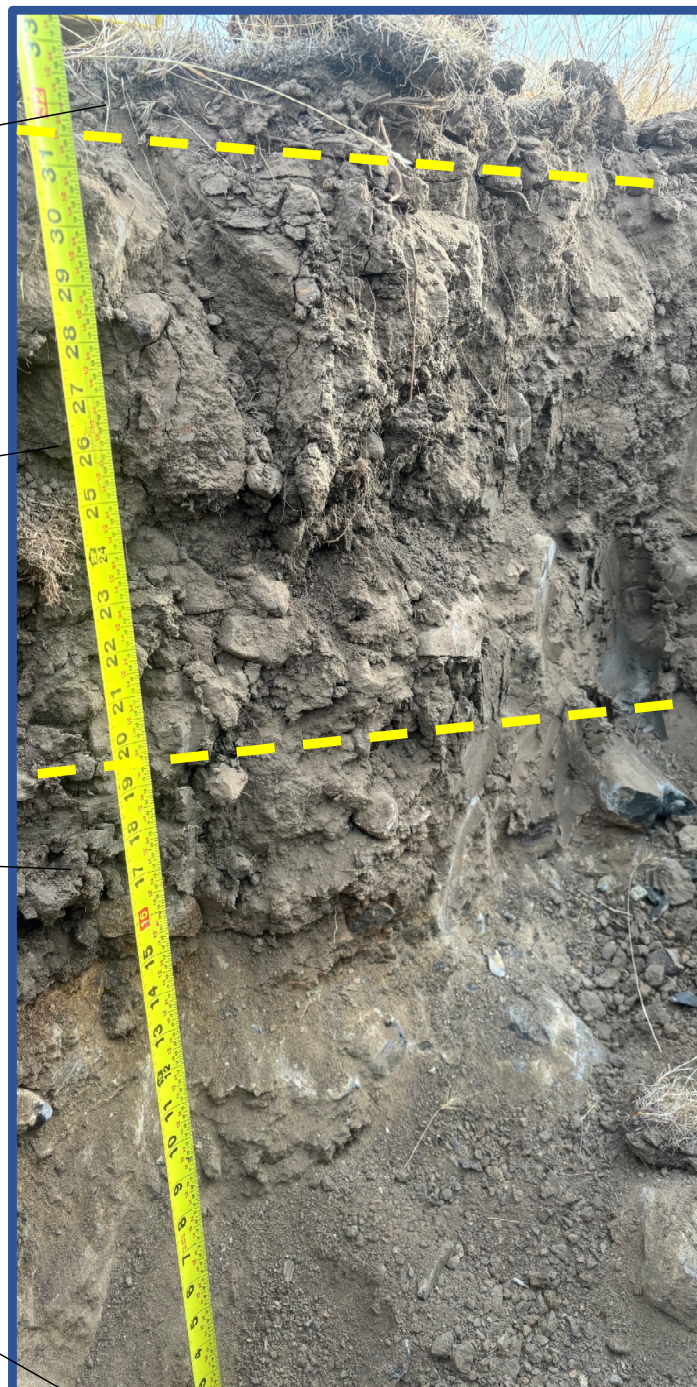
**19 - 34 "**  
Cobbles infilled with brown to brownish yellow Clayey coarse to fine SAND, little fine Gravel, moist (SC)

**> 34 "**  
Solid Bedrock

\* The dash lines depicted in the photograph are solely intended to serve as a visual aid to demonstrate the differing encountered soil compositions, and as such, are not intended to represent factual or calculated depths for each soil.

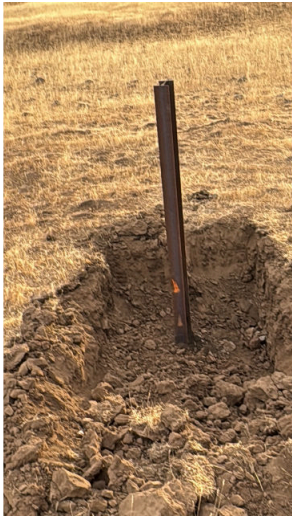
| Media 11: PLT-13 had to cut pile off at top of rock at 32" | | Media 12: | |

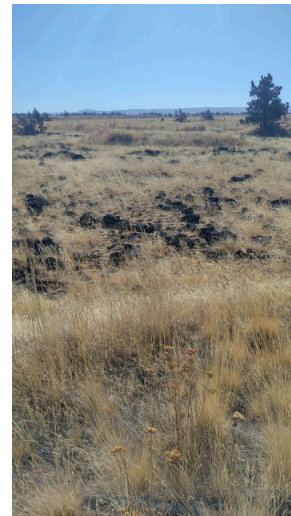
Media 63: PLT-02 Field Conditions (Rock Hollows Present)

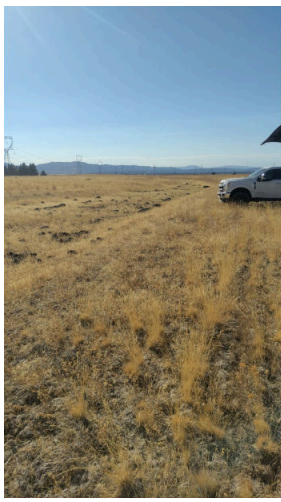
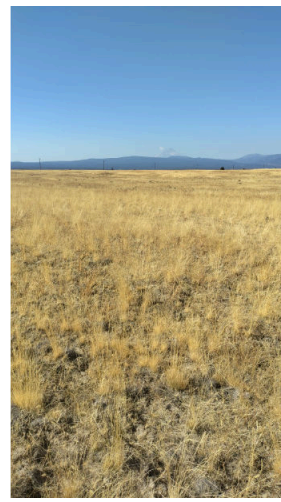
Media 77: PLT-01 Field Conditions (basalt rocks beds are relatively prevalent in this area)

Media 78: PLT-01 Field Conditions (basalt rocks beds are relatively prevalent in this area)

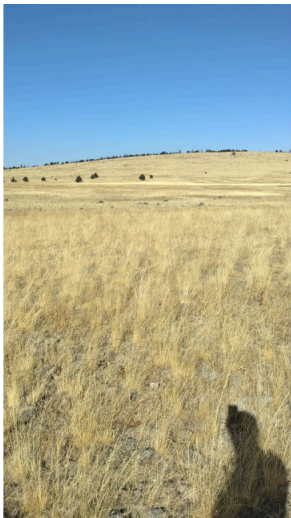
Media 79: PLT-01 Field Conditions (basalt rocks beds are relatively prevalent in this area)
