14 April 2023

**Subject: 2022 Annual Geotechnical Monitoring Report**  
**Riverbend Landfill**  
**McMinnville, Oregon**

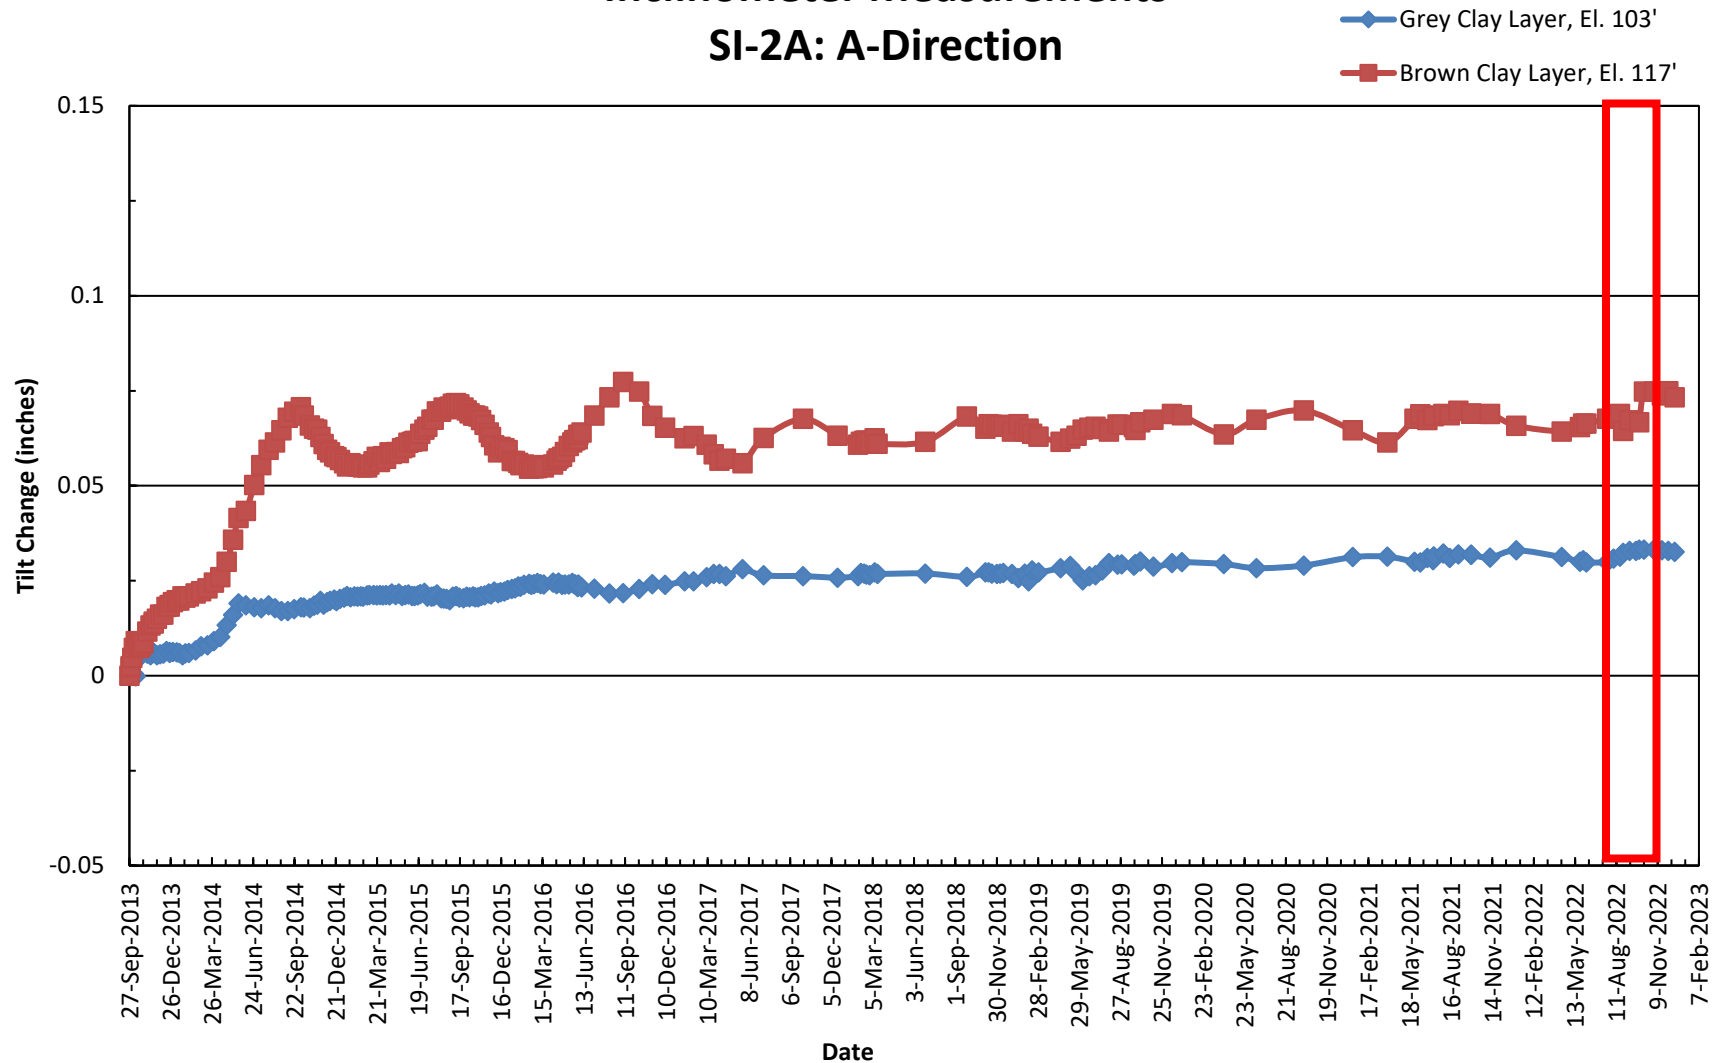
# Riverbend Landfill Inclinometer Measurements SI-2A: A-Direction

Displacement rates increased at SI-1A, SI-2A, and SI-2B during final cover construction. However, displacement rates in 2022 were significantly less than those observed during periods of waste placement (e.g., in 2016). Geosyntec compared the incremental displacement rates in 2022 to the recommended alert thresholds provided in Geosyntec's 11 October 2016 memorandum *Recommendations Regarding Recent Slope Stability Measurements*. Exceedances of these thresholds would indicate elevated displacements and trigger additional monitoring or operational action. The measured displacement rates in 2022 did not exceed the thresholds, and Geosyntec did not observe significant changes in the inclinometer displacement rates.
