# Soil Protection Exhibit

Cascade Renewable Transmission

*Wasco, Hood River, and Multnomah Counties, Oregon*

December 2025

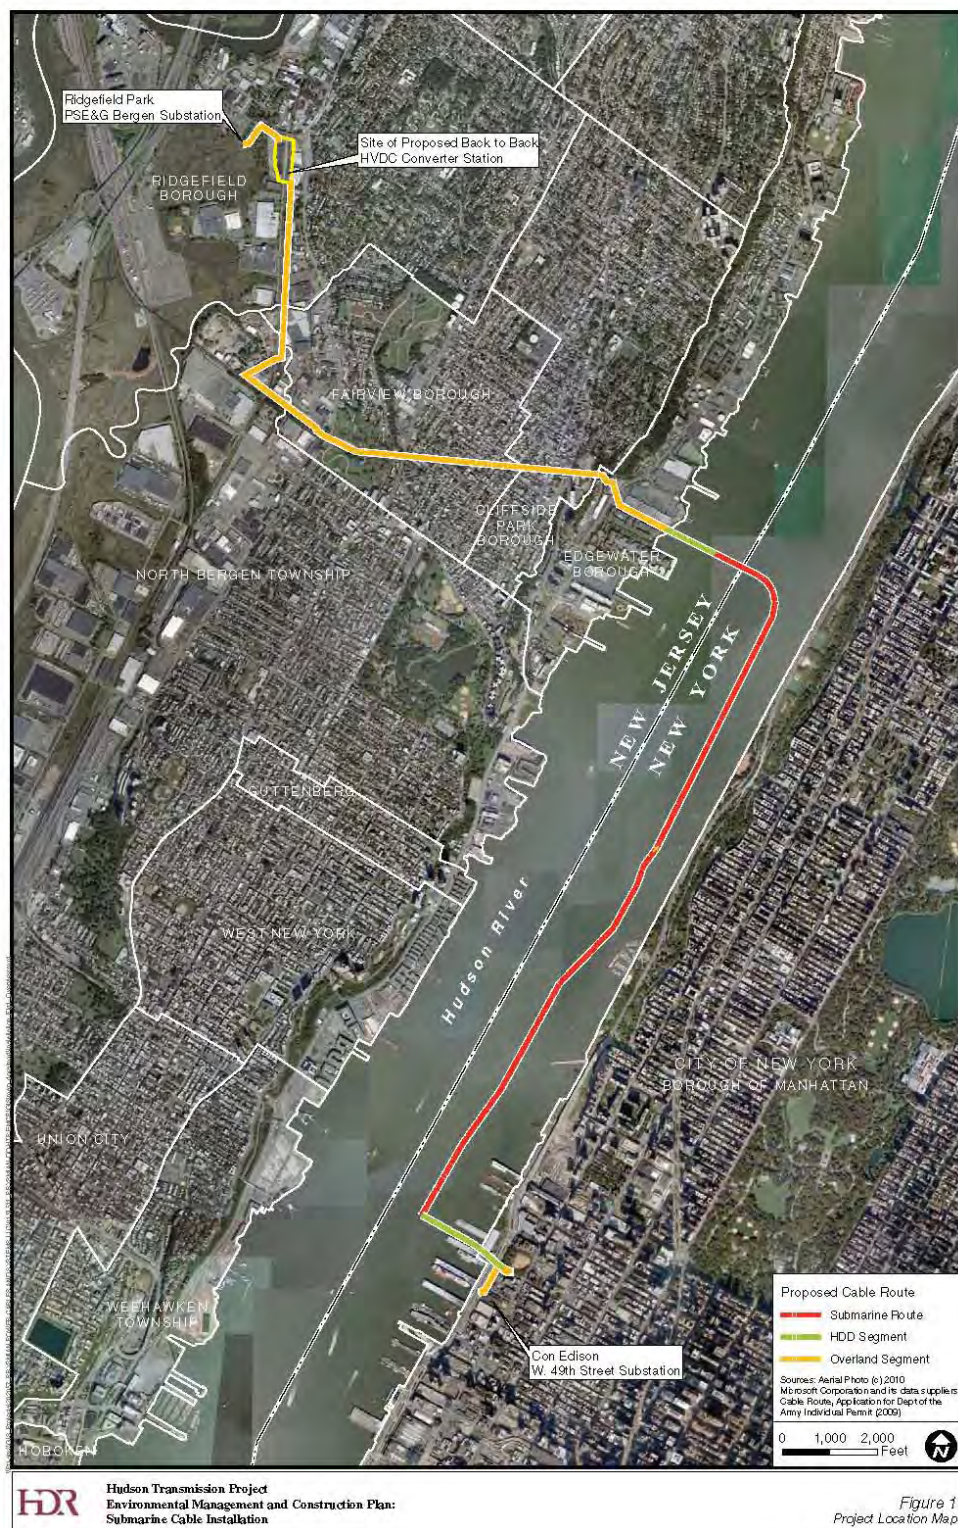
**Figure 1: Project Location Map**

There, the power line enters the Hudson River at the southwestern corner of the Edgewater Commons Shopping Center parking lot. Prior to entering the river, the upland cable transitions to submarine cable via an underground transition vault system built within the parking lot which leads to an underground pressurization vault across the street. At the pressurization vault, the power cable becomes oil-filled. The submarine cable continues from this point and extends across and down the Hudson River approximately four miles south to a landfall point in New York. The oil-filled cable is buried a minimum of ten feet below the present river bottom. The cable crosses an existing federal navigation channel roughly parallel to West 75th Street in Manhattan, then proceeds southward down the river on the New York side for about three miles before turning toward the landfall point between Piers 92 and 94 in Manhattan. The submarine cable transitions to land-based underground cable at this point, and continues to West 52nd Street, just east of 12th Avenue (West Side Highway). From this underground pressure/transition point, the cable is no longer oil-filled. It then runs under the eastern sidewalk of 12th Avenue and ends at the Consolidated Edison Company of New York West 49th Street substation.

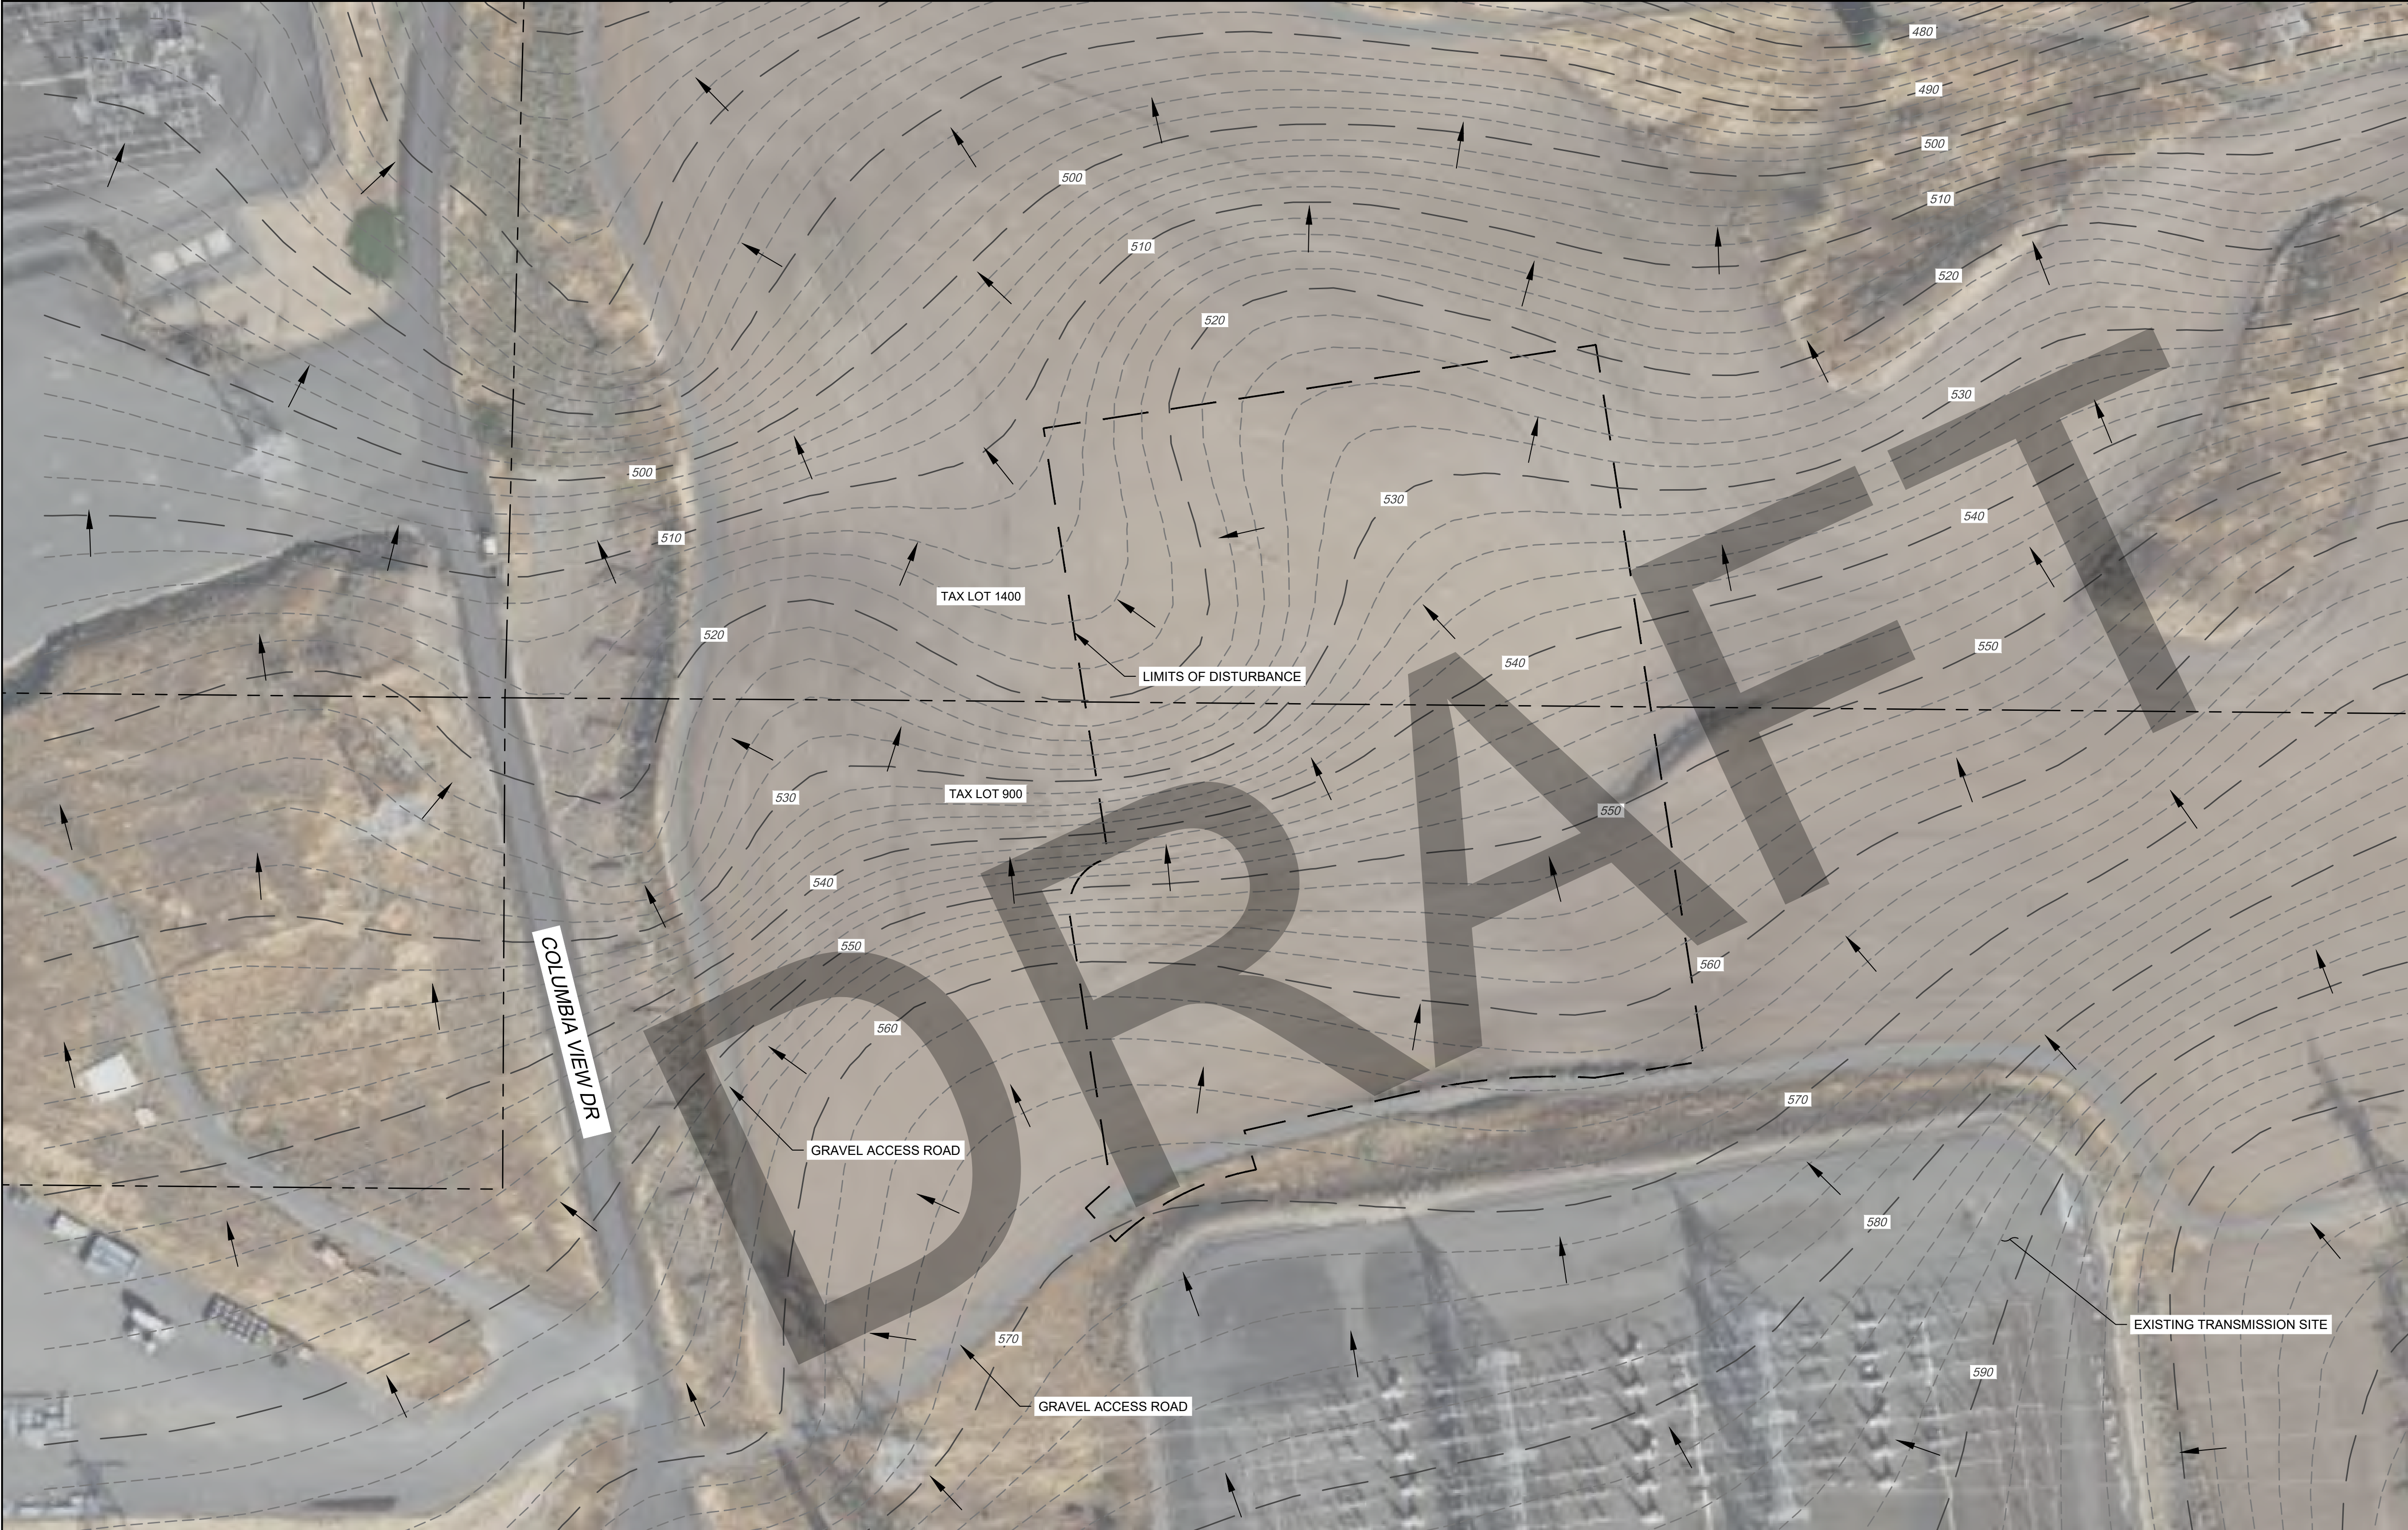
- LEGEND:**
- PROPERTY LINE
  - EASEMENT
  - EXISTING 10' CONTOUR LINE
  - EXISTING 2' CONTOUR LINE
  - LIMITS OF DISTURBANCE
  - DIRECTION OF RUNOFF

NOTE: SURFACE BASED ON 10-METER  
RESOLUTION LIDAR DATA PUBLISHED  
BY THE STATE OF OREGON. ONLINE  
DATASET ACCESSED ON 10 MAY 2024.

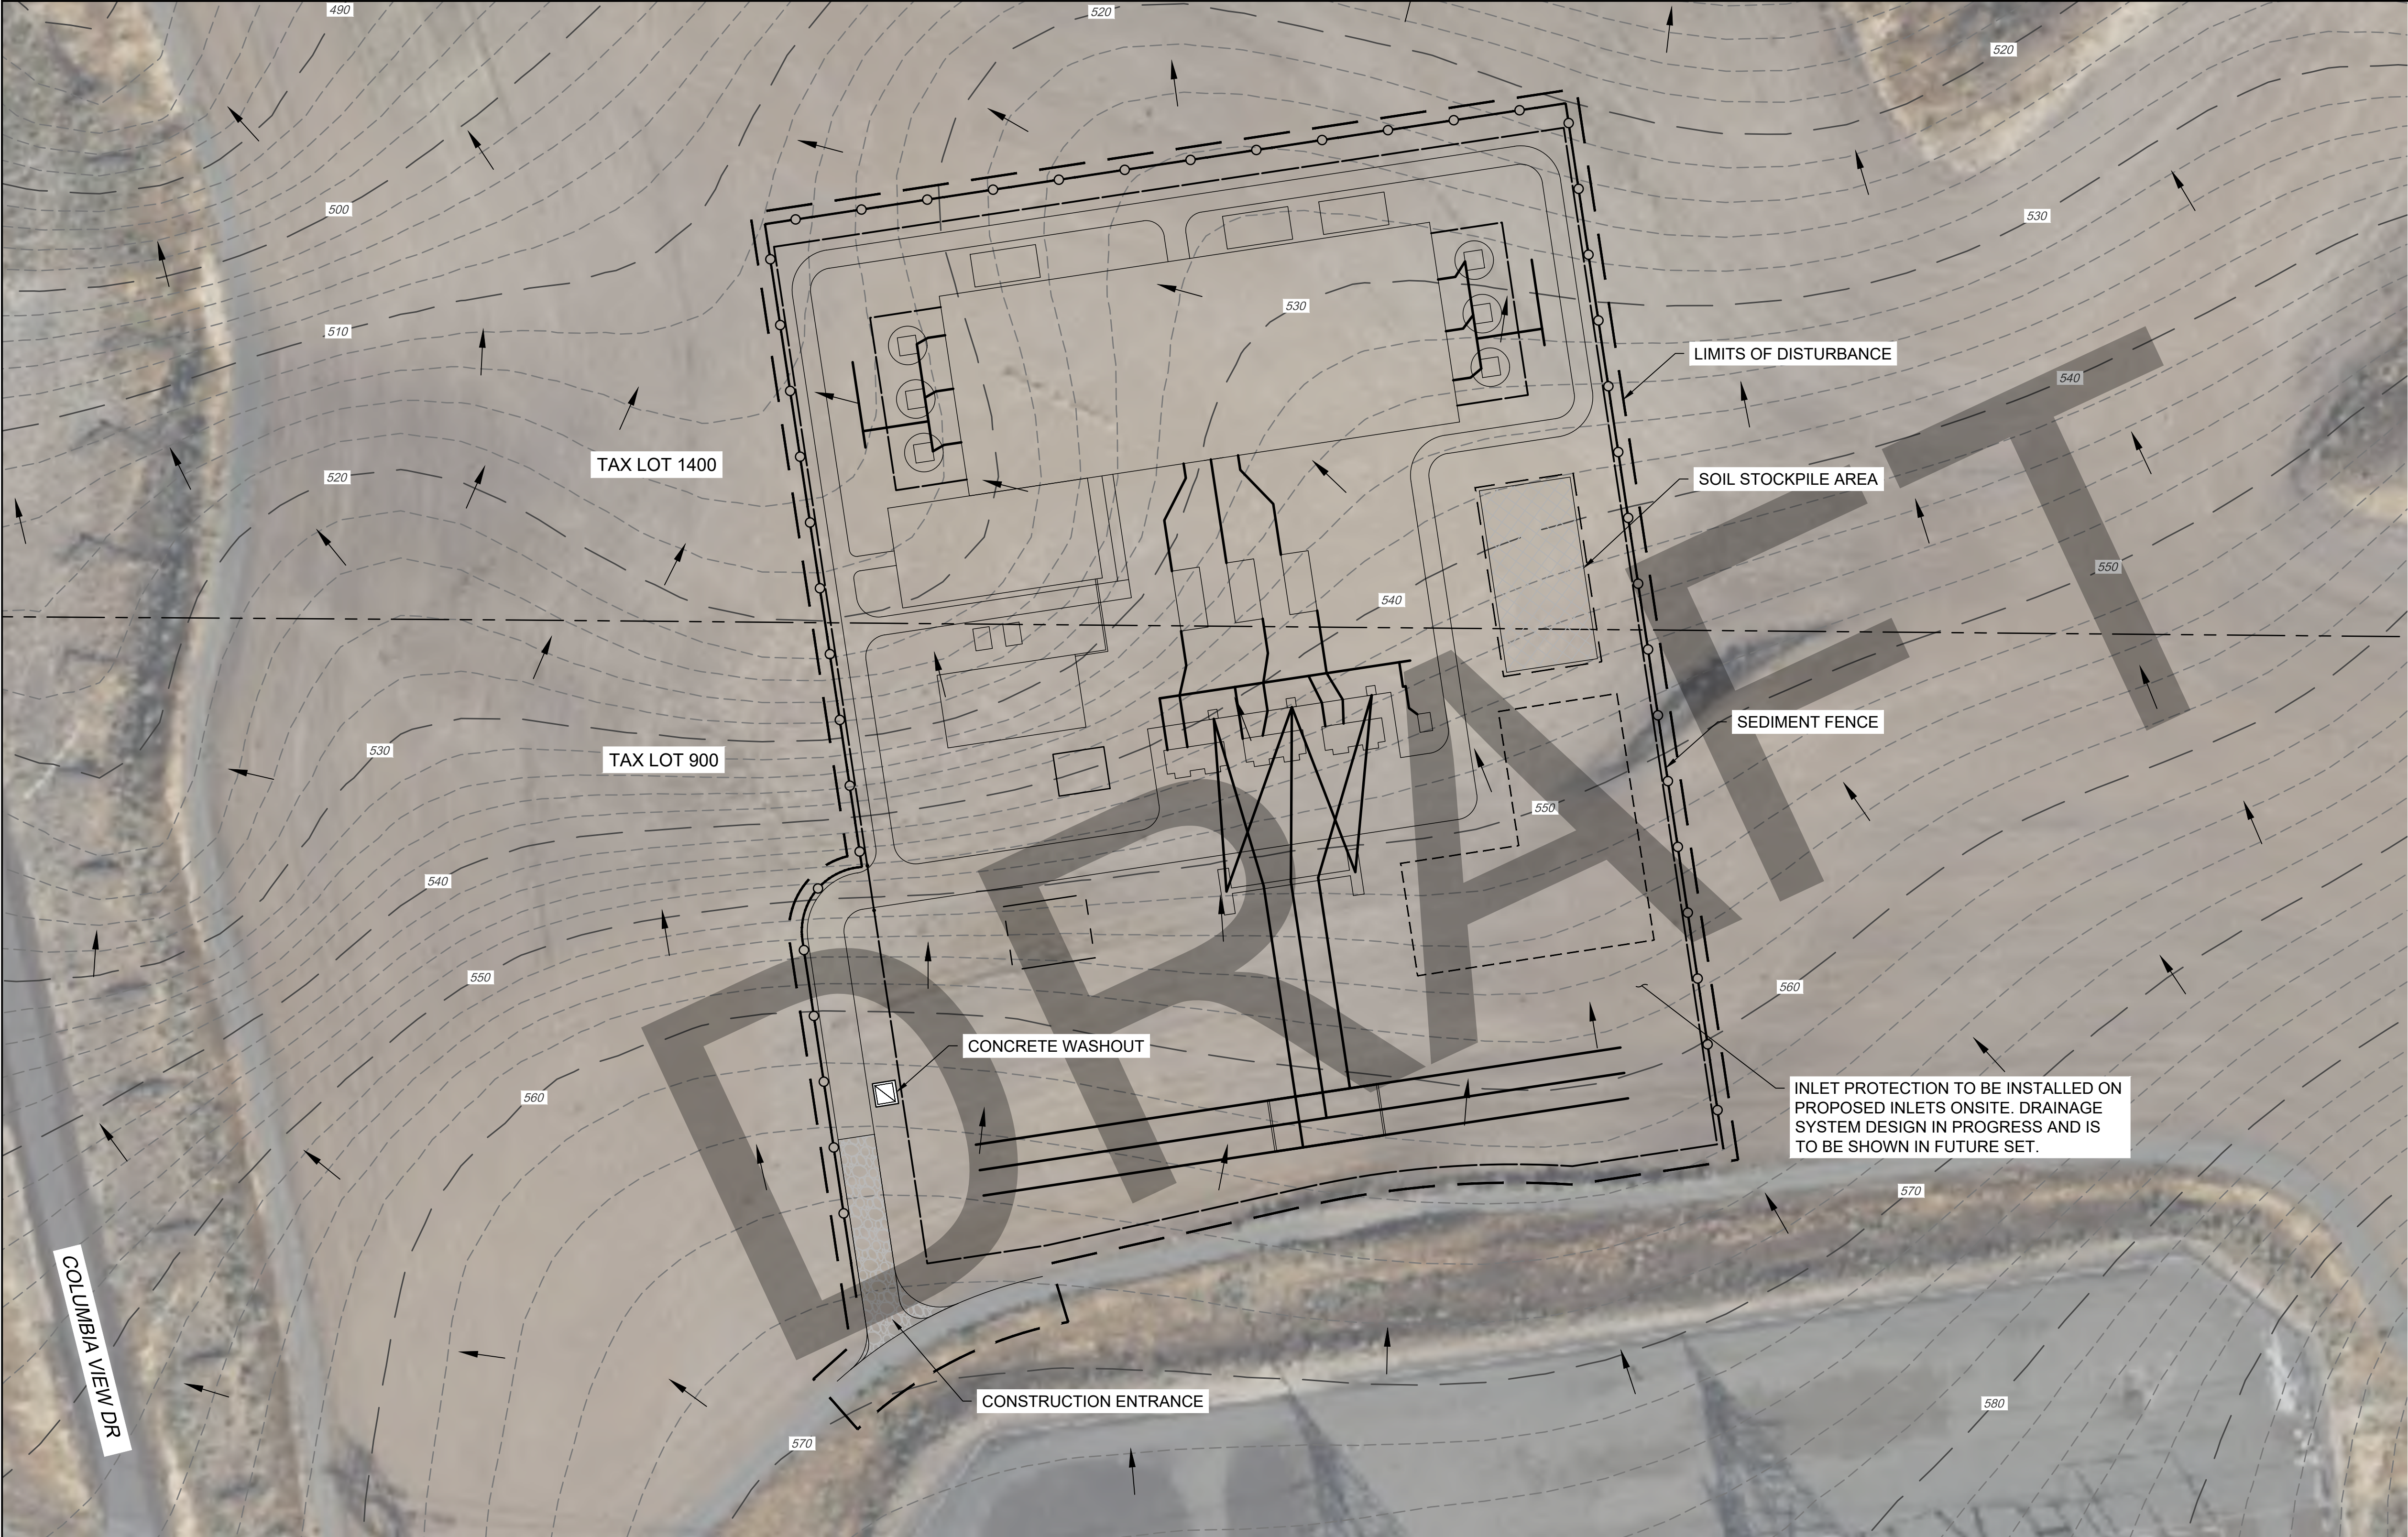
- PROPERTY LINE
- EASEMENT
- CONDUIT ALIGNMENT CENTERLINE
- EXISTING 10' CONTOUR LINE
- EXISTING 2' CONTOUR LINE
- LIMITS OF DISTURBANCE
- SEDIMENT FENCE PER DETAIL RD1040 / 8
- SOIL STOCKPILE AREA WITH SLOPE MATTING PER DETAIL RD1055 / 8
- STABILIZED CONSTRUCTION ENTRANCE PER DETAIL RD1000 / 8
- WHEEL WASH PER DETAIL RD1070 / 8
- INLET PROTECTION PER DETAIL RD1010 / 8 - TO BE SHOWN IN FUTURE SET

- GRADING PHASE INFORMATION:**
- ONSITE SOIL TYPES:
    - A) WATO VERY FINE SANDY LOAM - HYDROLOGIC SOIL GROUP B - 100%
  - EXISTING VEGETATION YET TO BE SURVEYED.
  - CUT AND FILL DATA:
    - CUT: TBD
    - FILL (1.20 FACTOR): TBD
    - NET ADJUSTED: TBD
  - ONSITE FILL MATERIALS:
    - NATIVE SOIL
    - CRUSHED ROCK

- GRADING PHASE NOTES:**
- PROPOSED SITE DRAINAGE DITCHES SHALL BE PERMANENTLY STABILIZED AS SOON AS POSSIBLE AFTER EXCAVATION.
  - STRAW MULCH AND/OR HYDROSEED SHALL BE USED FOR TEMPORARY STABILIZATION OF EXPOSED SOILS AFTER EXCAVATION (INCLUDING SOIL STOCKPILES IF SLOPE MATTING DOES NOT WORK).

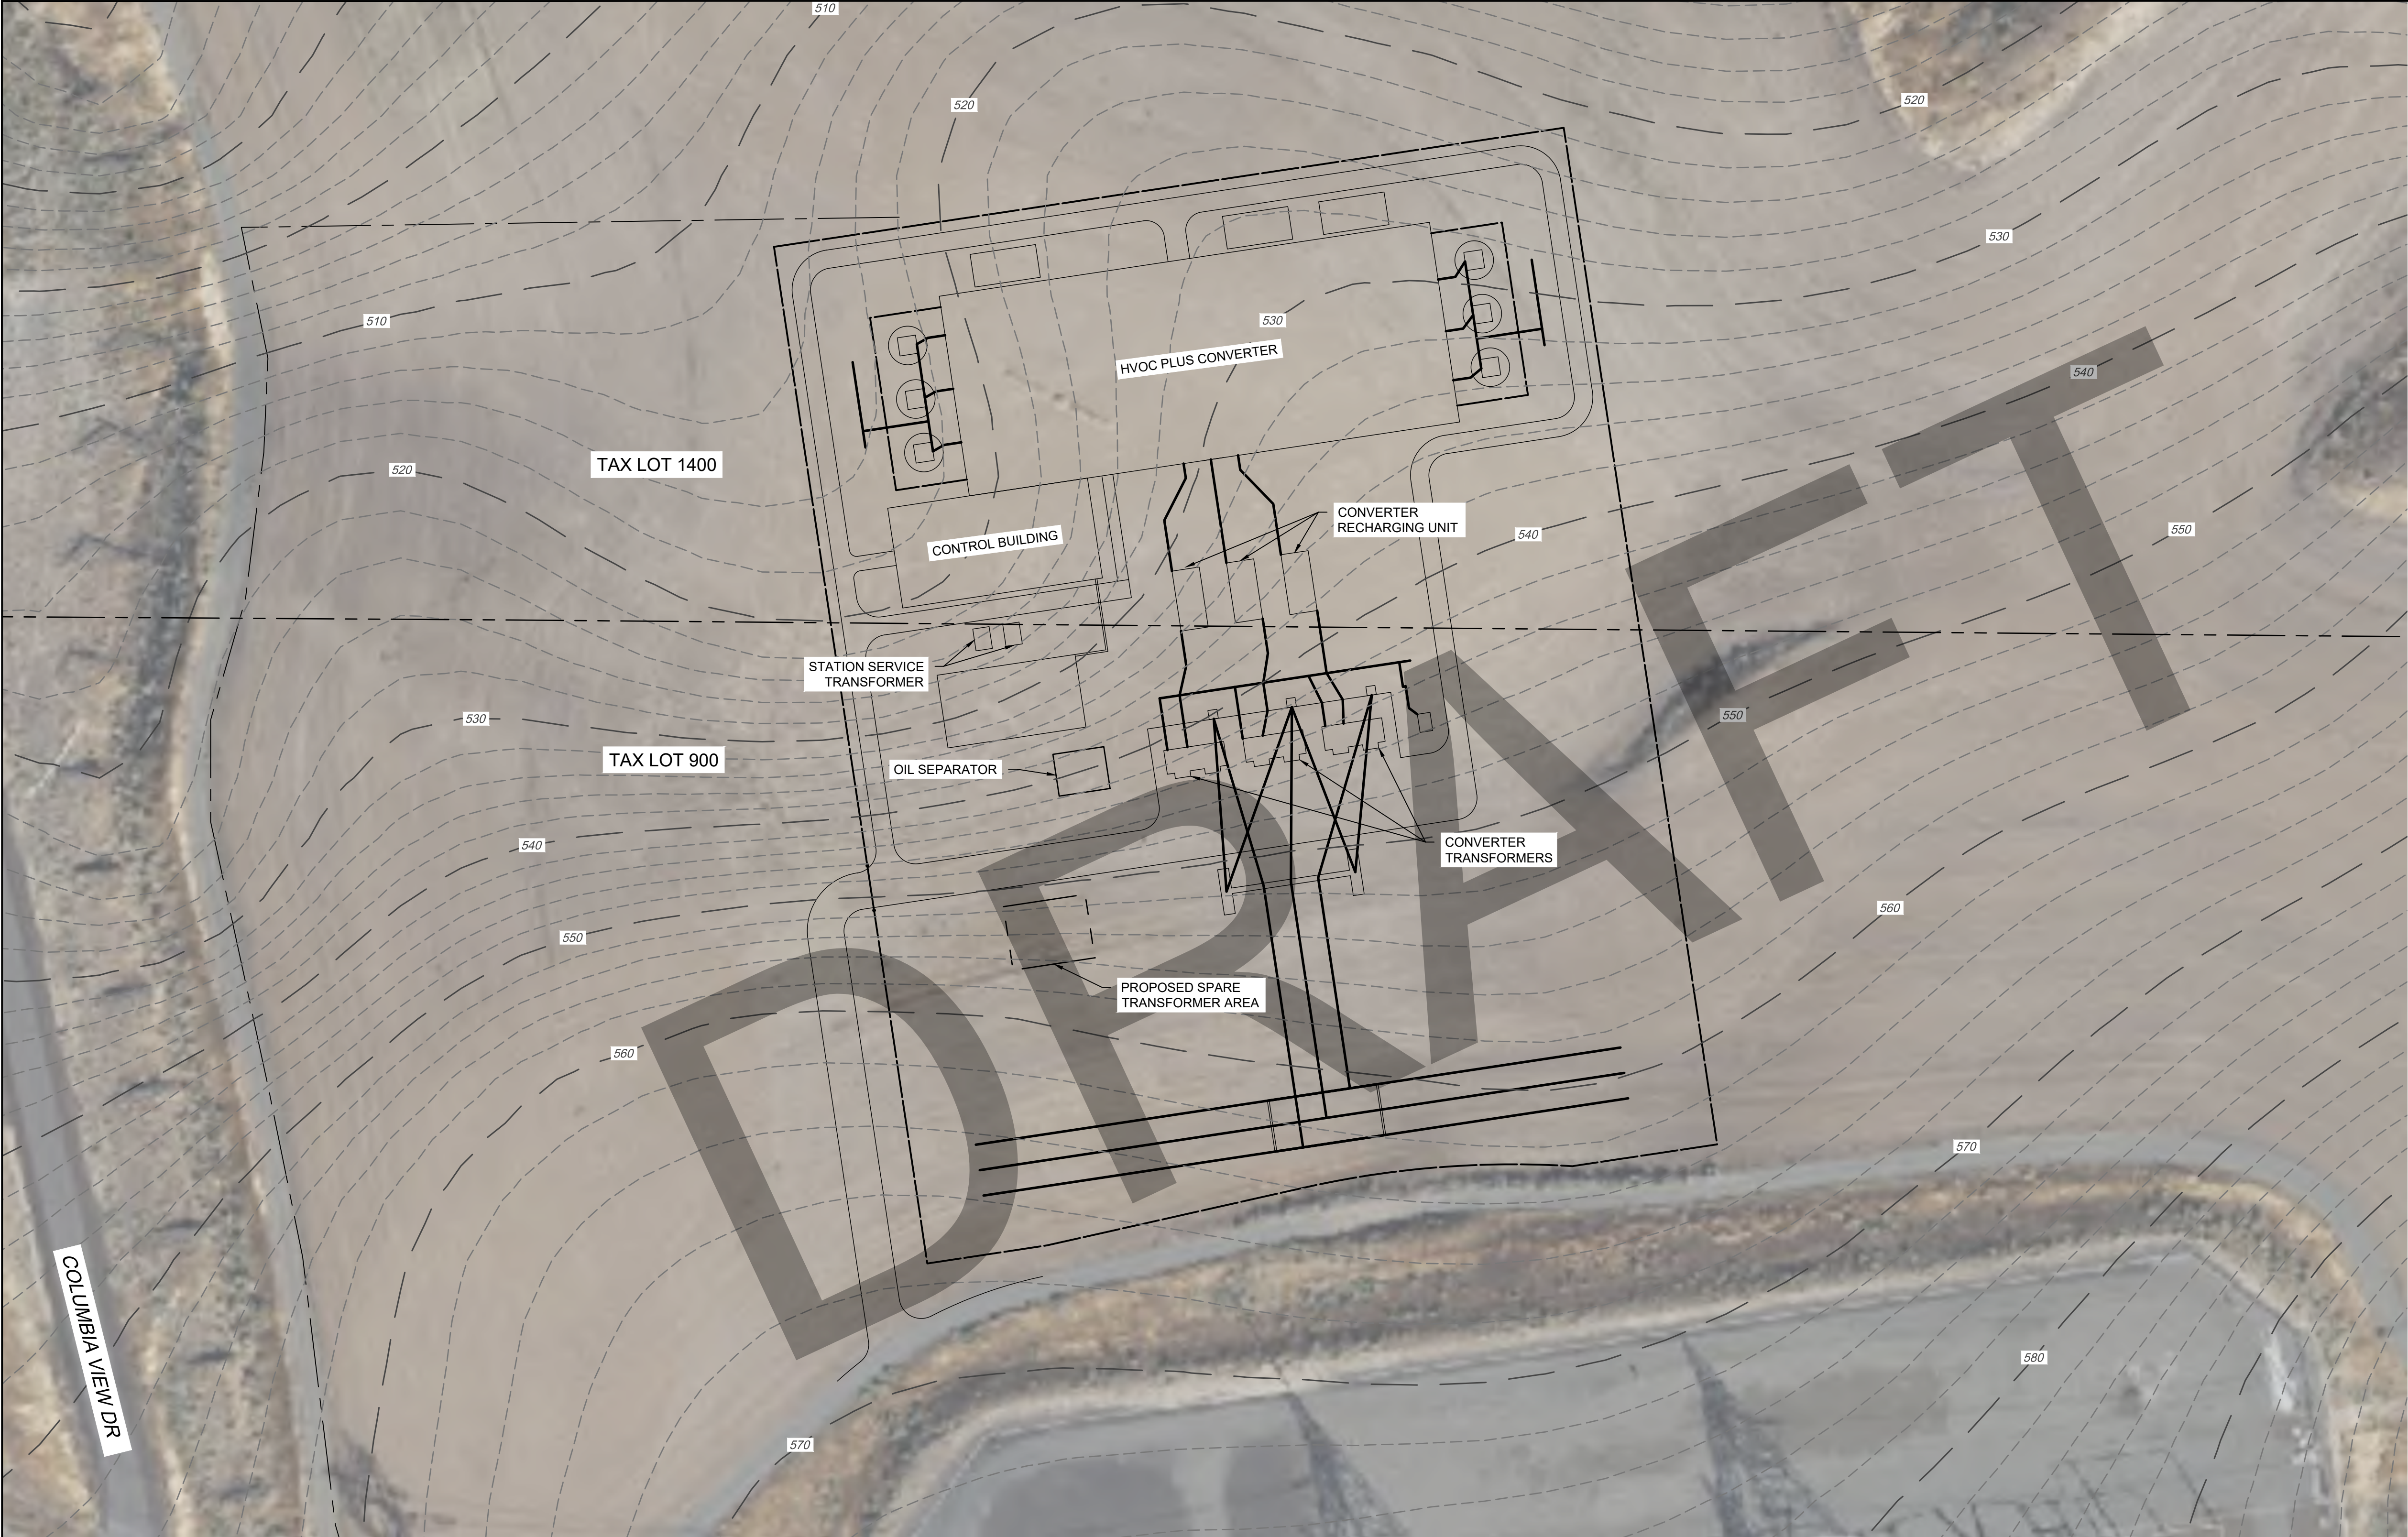
- LEGEND:
- PROPERTY LINE
  - EASEMENT
  - CONDUIT ALIGNMENT CENTERLINE
  - EXISTING 10' CONTOUR LINE
  - EXISTING 2' CONTOUR LINE

- FINAL STABILIZATION PHASE INFORMATION:
- PHASE SCHEDULE:  
START: TBD  
FINISH: TBD
