# LAVA BUTTE WILDLIFE CROSSING EFFECTIVENESS

## Final Report 2015-2017

**Joel Thompson, Brian Moser, and Leigh Ann Starceвич**  
**Western EcoSystems Technology, Inc.**  
2725 Northwest Walnut Boulevard  
Corvallis, Oregon 97330

**November 6, 2018**

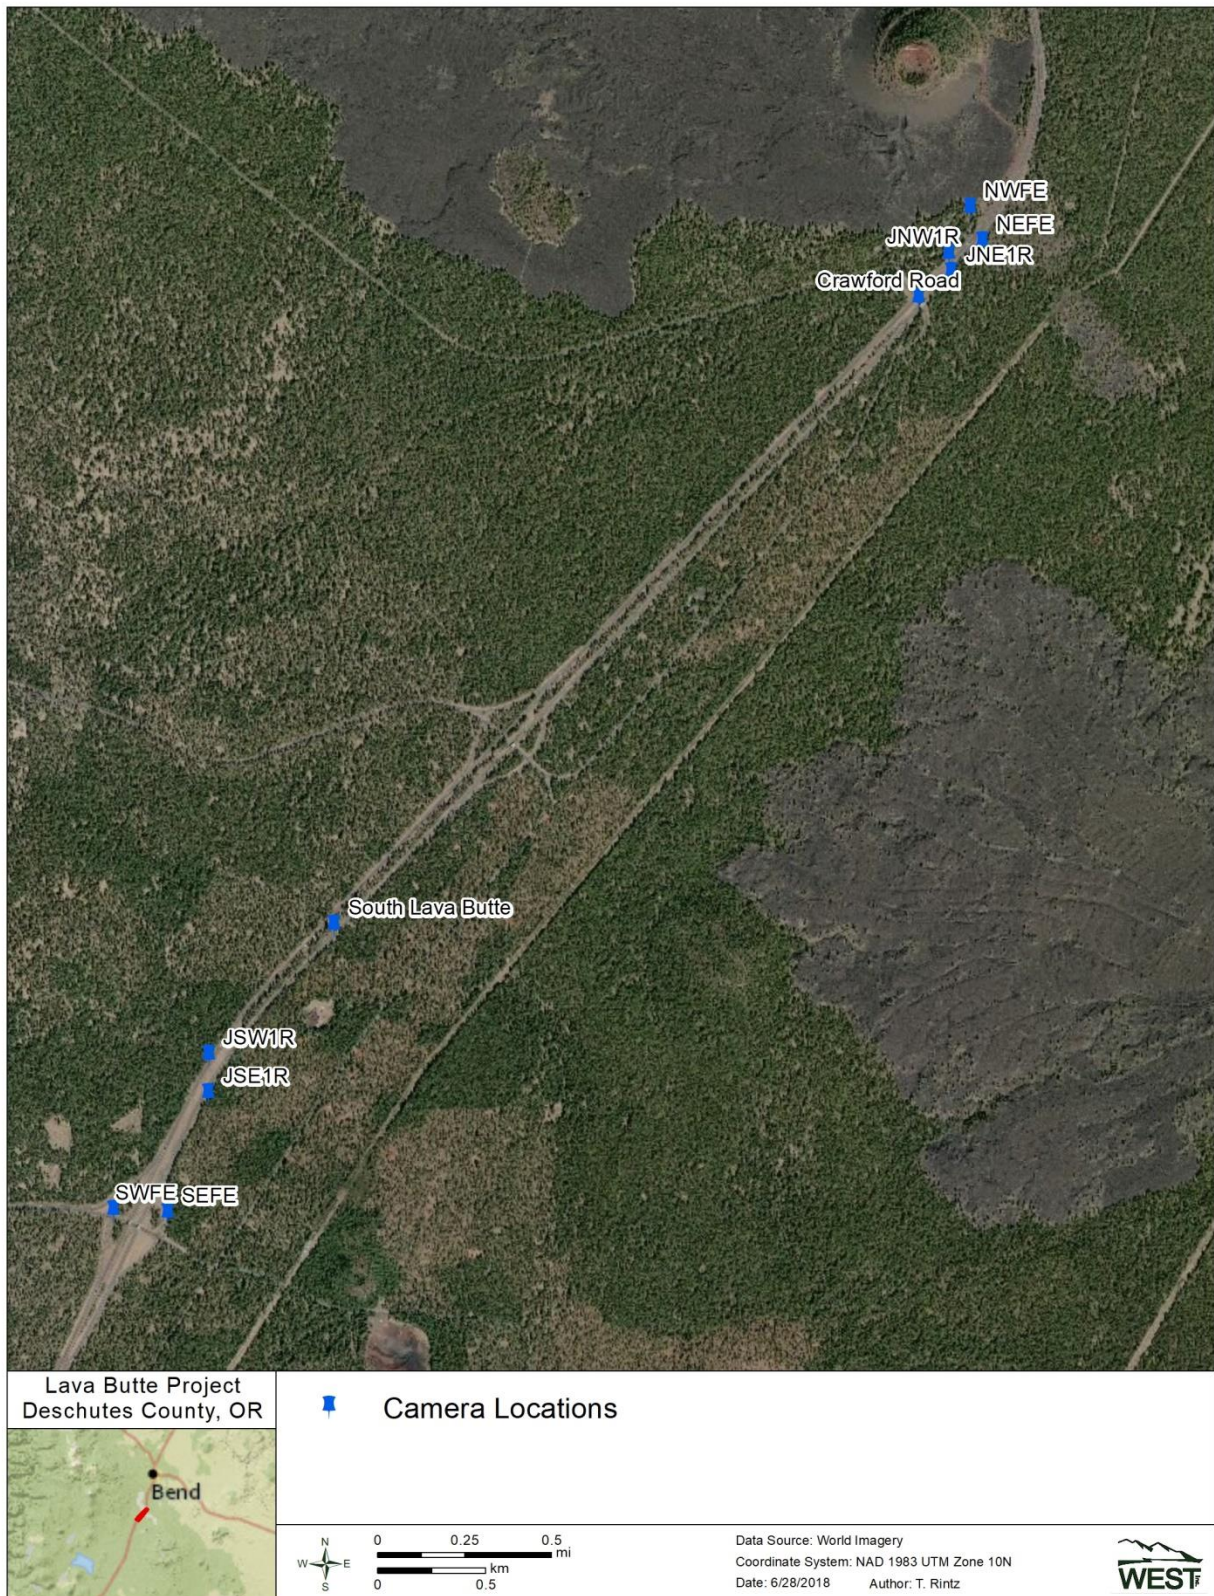
Figure 2.1. Location of wildlife crossing structures and exclusion fence ends along US Route 97 between Sunriver and Lava Butte, Deschutes County, Oregon.

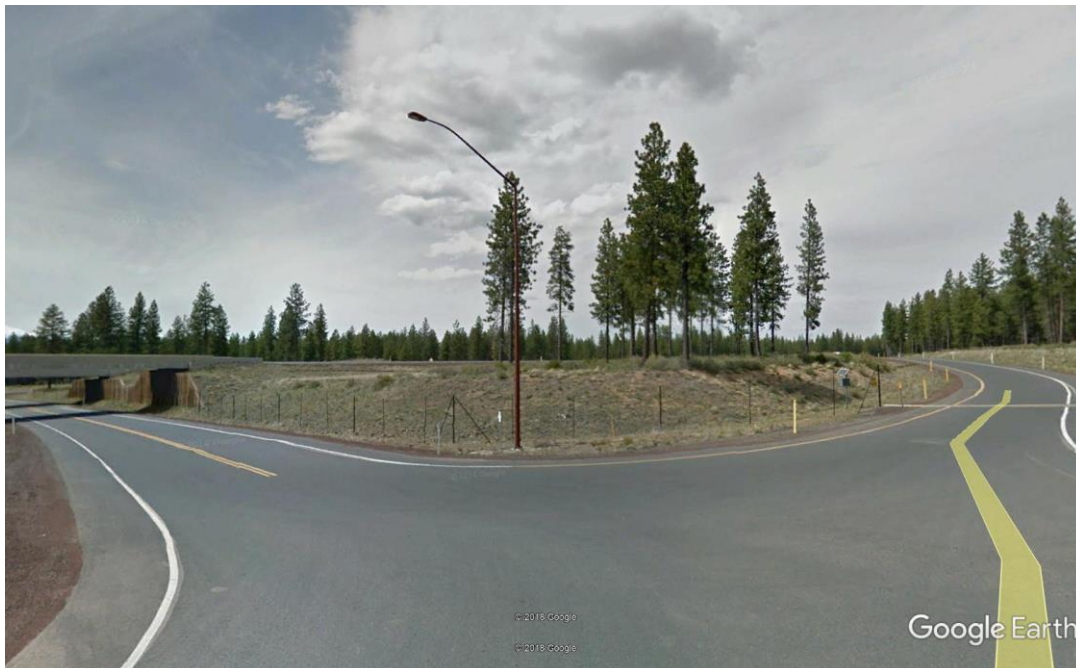
**Figure 4.1. South end of exclusion fence as it crosses northbound onramp from South Century Drive and abuts the overpass abutment under U.S. Route 97.**

All but one of the 30 mule deer crossing events documented at fence-end cameras occurred at the northeast fence-end camera (NEFE), with 17 (56.7%) of the crossings being individuals travelling from the forest-side to the road-side of the exclusion fencing (Table 4.3; Appendix A4). However, although mule deer actually crossing the fence-end were more often entering the road corridor than exiting the corridor, the NEFE camera documented more individuals travelling along the forest-side of the fence than the road-side of the fence, suggesting the majority of deer are remaining on the forest-side of the fence outside of the roadway. Only one crossing was detected at the northwest fence-end camera (NWFE; Table 4.3). This fence-end is also the location of high human-activity with hikers and vehicles actively moving through the area (see Appendix A4). Additionally, this fence-end terminates next to a large lava flow which likely further serves as a barrier. This human activity and relative position to the lava flow may deter deer from crossing at this junction, as would be suggested by the low overall number of deer detections at this camera. The majority (93%) of trigger events at the SEFE camera were of mule deer travelling on the forest side of the exclusion fencing whereas the SWFE camera documented similar occurrences of individuals inside and outside of the fencing (Table 4.3). This result is not surprising given the position of the cameras relative to roads and off- and on-ramps for Route 97. The SEFE camera documented the only elk observed at the fence-end cameras, which was moving south on the inside of the exclusion fence. Unfortunately, it was not possible to evaluate if this or other individuals on the road-side of the fence were able to exit via the ElectroMat™ setup across the on/off-ramps on the south end of the project, as there were no cameras setup to document activity at the ElectroMat™ locations. As noted above, these animals on the road-side of the fence at the SEFE and SWFE had no clear way to exit the roadway without returning north to the jump-outs or north fence-ends, crossing the overpass over South Century Drive, or navigating over the ElectroMat™ to escape via the on/off-ramps.

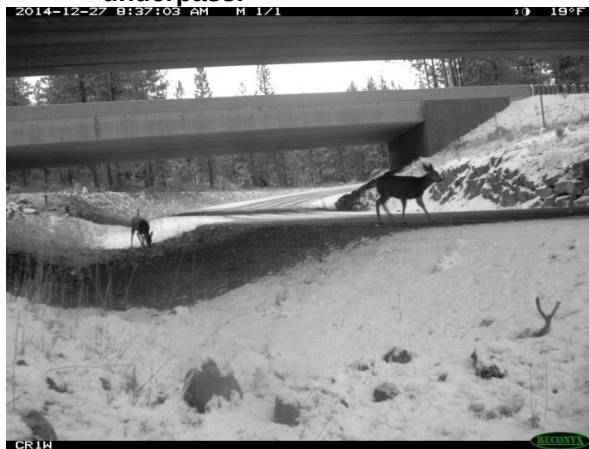
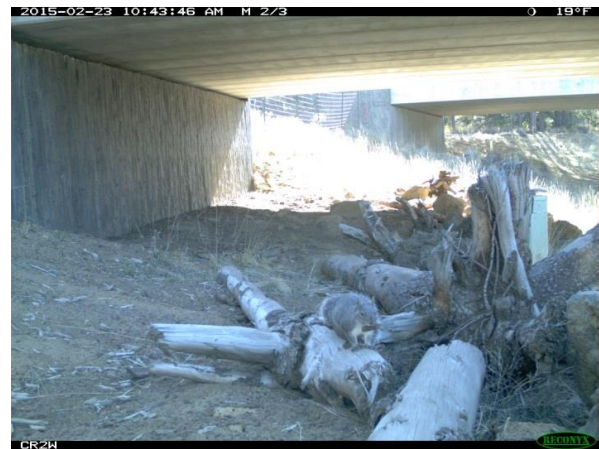
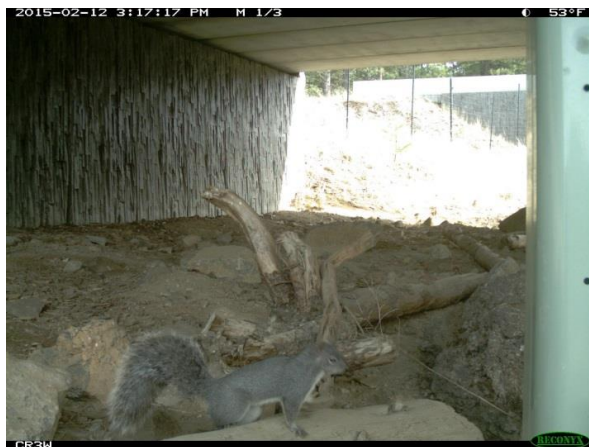
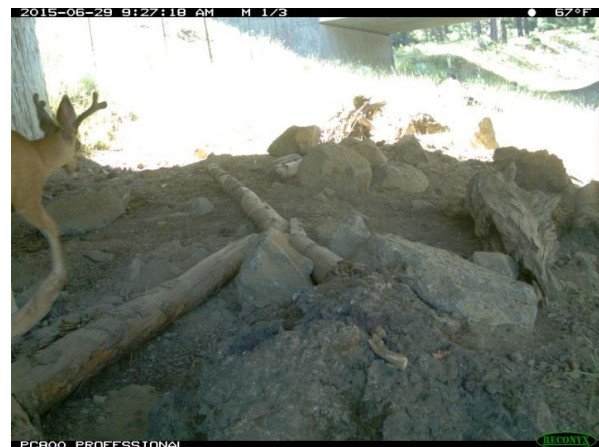
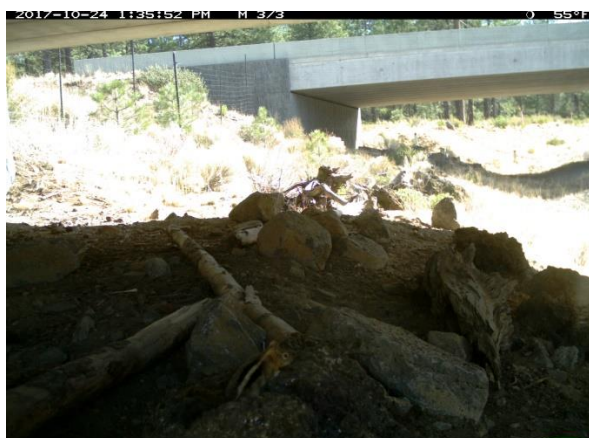
Appendix A1. Views from remote cameras at the multi-use Crawford Road (CR) wildlife underpass on U.S. Route 97. Photos are labeled with the camera ID. Photos 1a-e represent views from cameras situated on the west side and 1f-i represent cameras on the east side of the underpass.

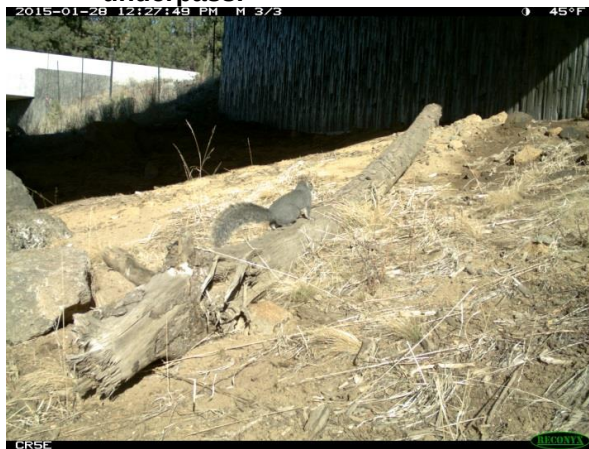
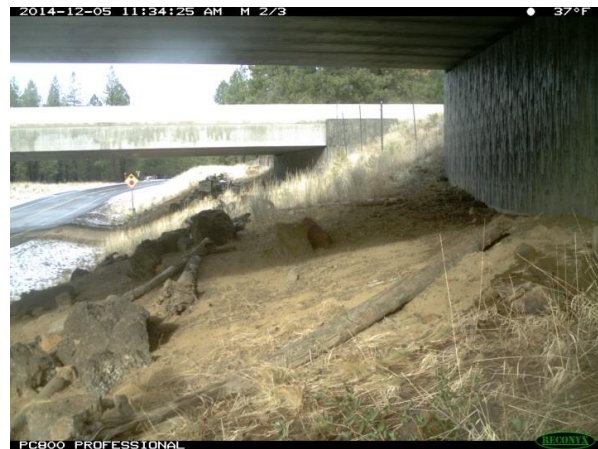
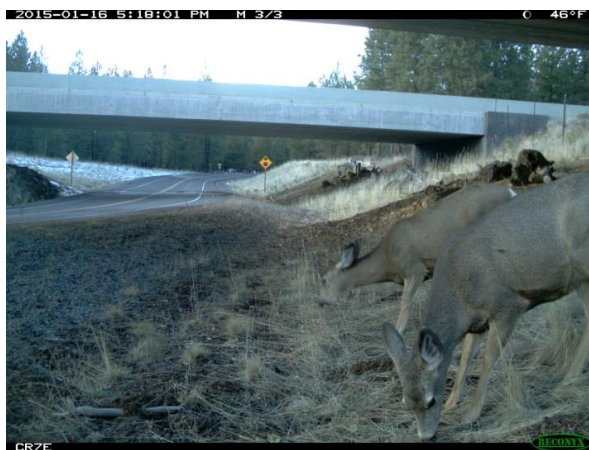
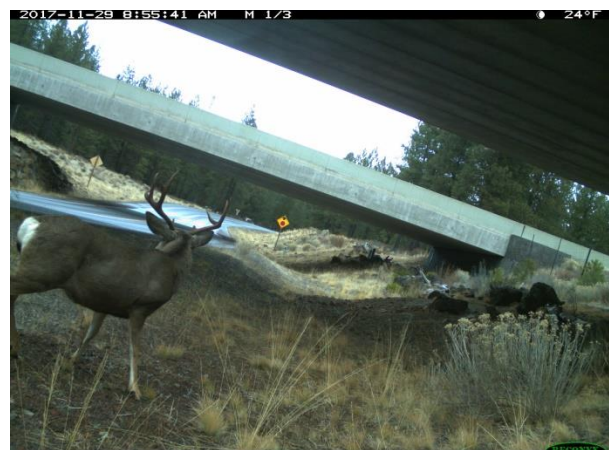
Appendix A1. Views from remote cameras at the multi-use Crawford Road (CR) wildlife underpass on U.S. Route 97. Photos are labeled with the camera ID. Photos 1a-e represent views from cameras situated on the west side and 1f-i represent cameras on the east side of the underpass.

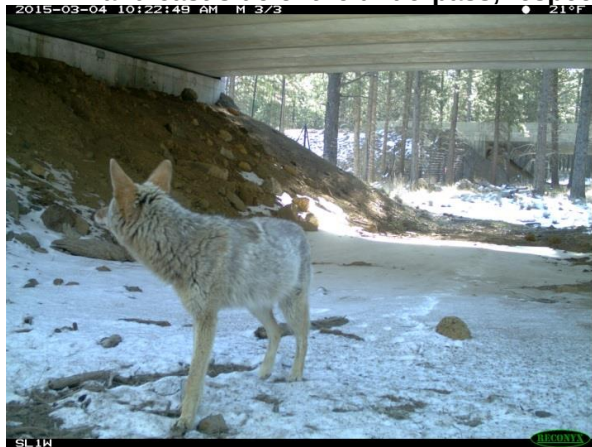
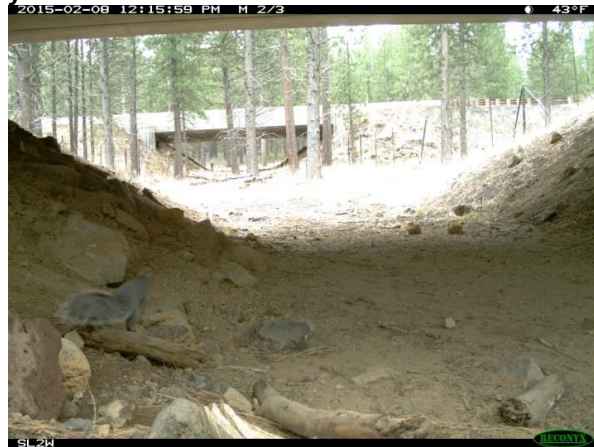
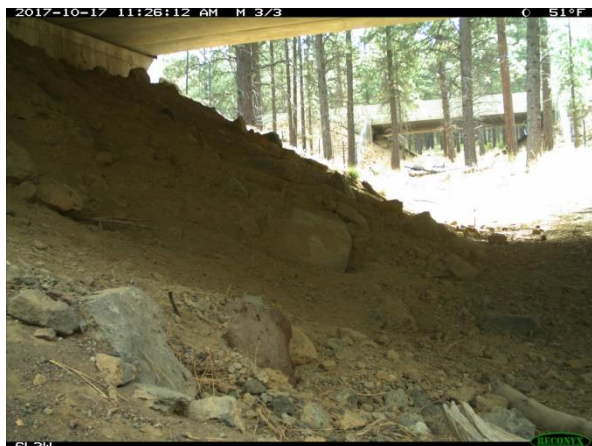
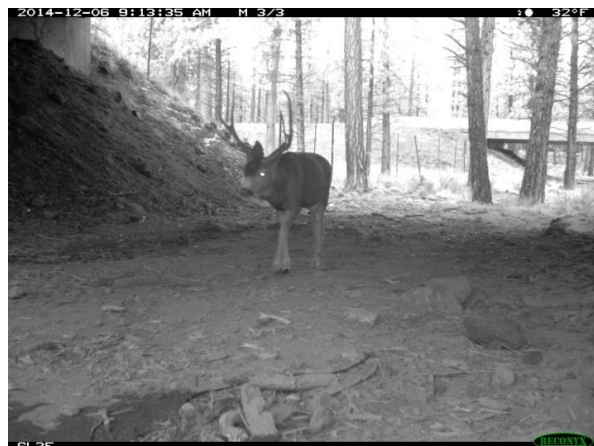
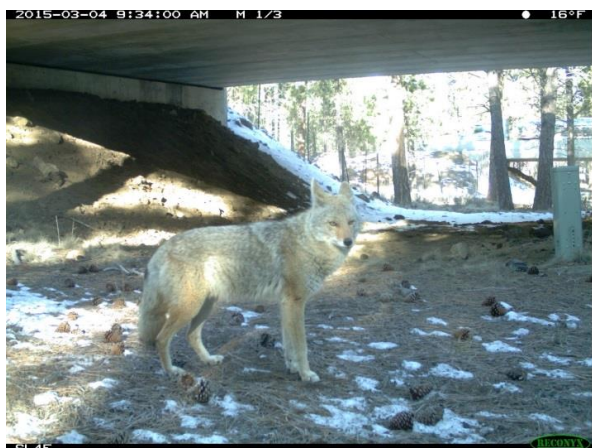
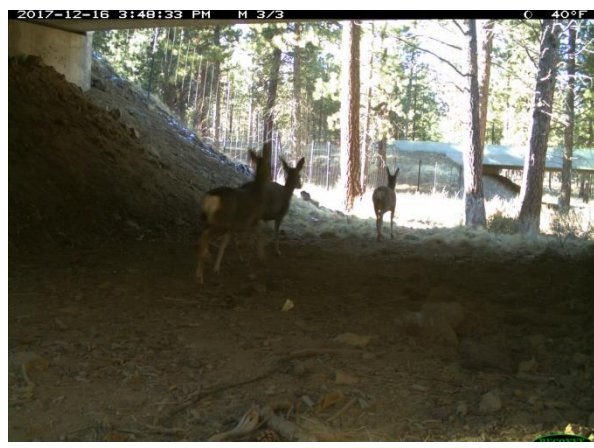
Appendix A2. Views from remote cameras at the South Lava Butte (SL) wildlife underpass on U.S. Route 97. Photos 2a-c and 2d-f represent views from cameras situated on the west side and east side of the underpass, respectively.

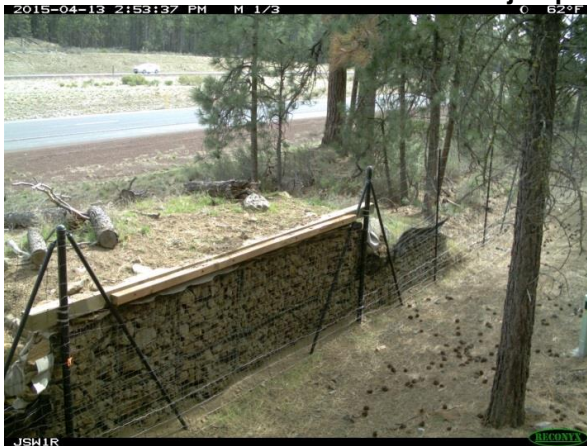
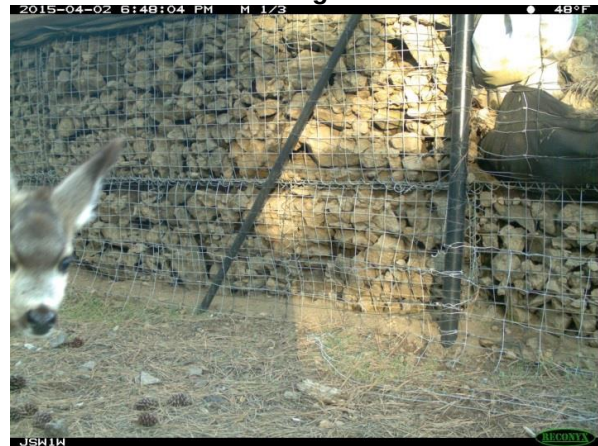
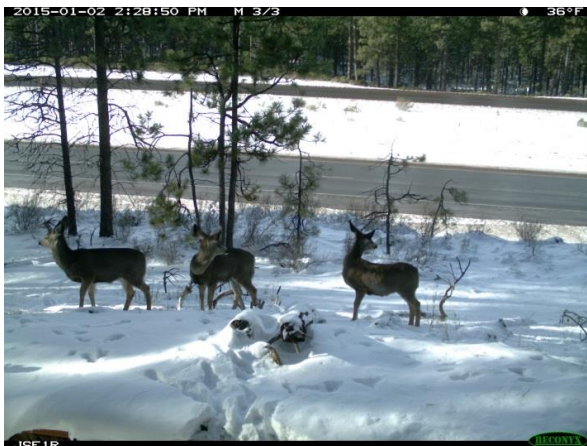
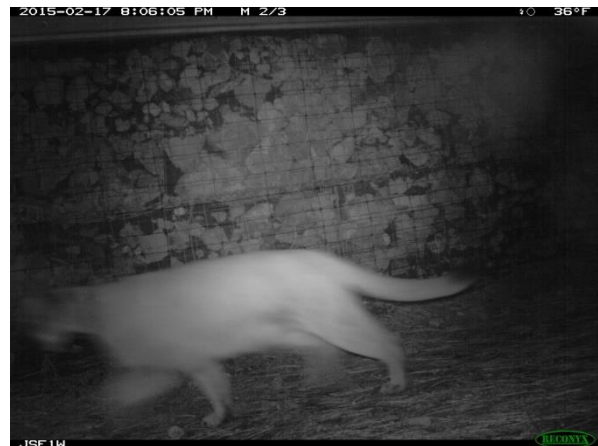
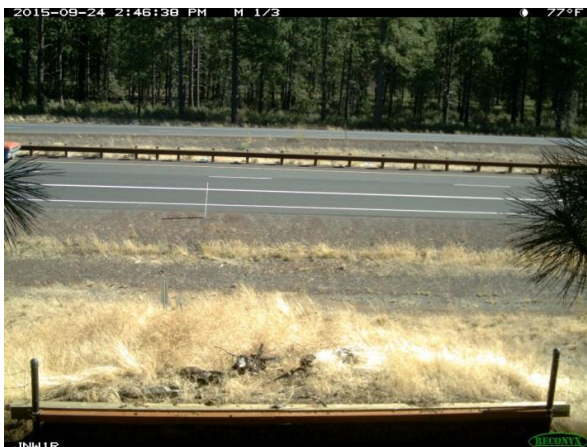
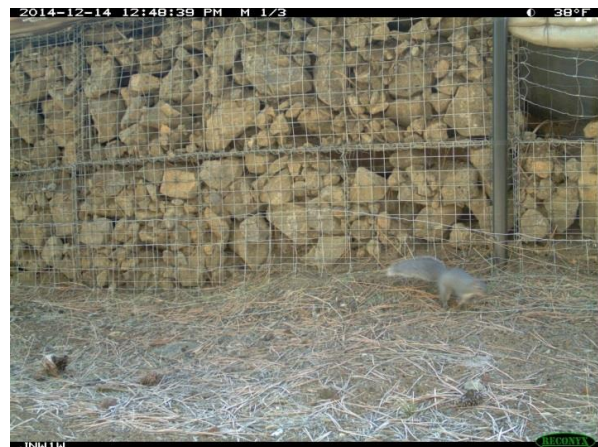
**Appendix A3. Views from remote cameras at the jump-outs in the exclusion fencing along U.S. 97.**  
**There are two cameras for each jump-out; one tree-based and one ground-based camera.**

majority of detections at Crawford Road, mule deer were consistently detected using the Crawford Road underpass, suggesting that the underpass is successfully being used by mule deer. Wildlife detections at South Lava Butte were dominated by mule deer, followed by coyotes (*Canis latrans*), indicating this structure is also functioning successfully for other large mammal species. Based on the data (304 detections at South Lava Butte compared to 34 at Crawford Road), it appears that coyotes may prefer to use the wildlife-specific crossing structure as opposed to one alongside a road (i.e., Crawford Road). Bobcats (*Lynx rufus*) were relatively common at Crawford Road ( $n = 26$ ), but rarely documented at other locations. The only large carnivore detected during this study was a cougar (*Puma concolor*) on the forest side of a jump-out (Table 4.2; Appendix A3).

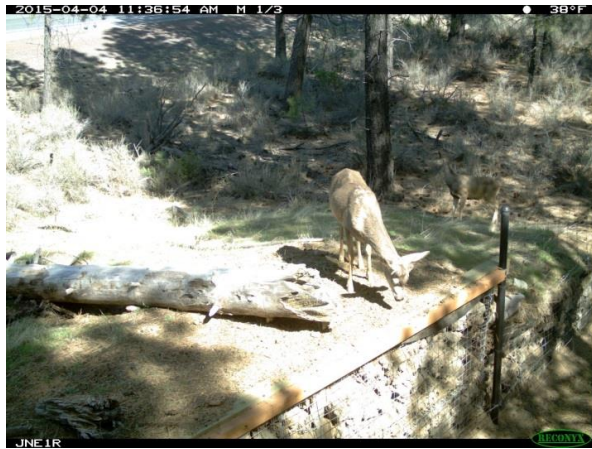
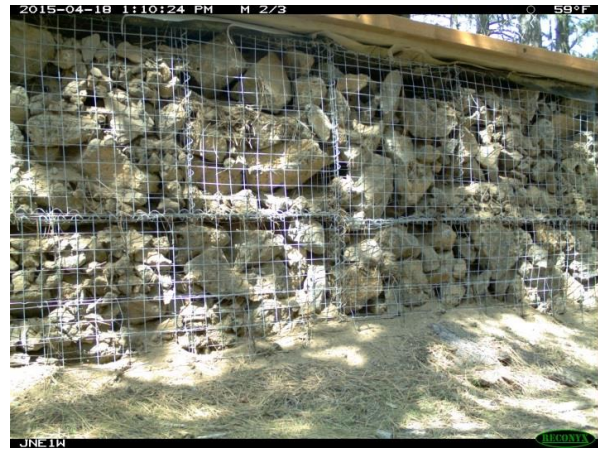
**Appendix A3. Views from remote cameras at the jump-outs in the exclusion fencing along U.S. 97.**  
There are two cameras for each jump-out; one tree-based and one ground-based camera.

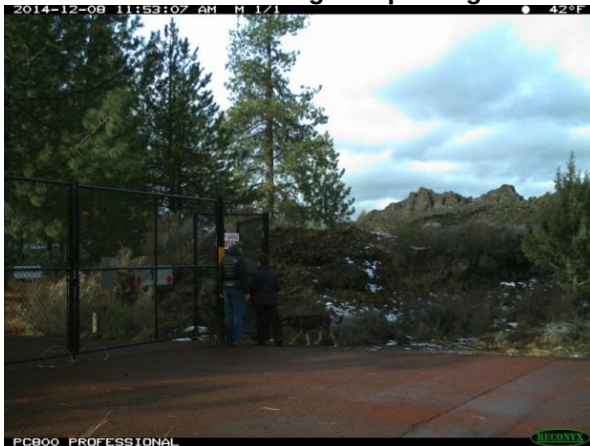
**1a. NWFE. Northwest fence-end that terminates at a lava mound.**

The north fence-end cameras were positioned at true fence-ends and could capture whether an individual crossed from one side of the fence to the other (see Appendix A4). The south fence-end cameras were not on true ends; instead the southwest fence-end camera (SWFE) was positioned near the farthest southwest corner within the median between the southbound off-ramp to South Century Drive and Route 97, and the southeast fence-end camera (SEFE) was positioned along the exclusion fencing just north of the southeast corner on the outside of the northbound onramp from South Century Drive onto Route 97 (Figure 2.1; Appendix A4). In fact, at the southern end of the project, there are in fact no true fence ends, as the fencing abuts and crosses the on/off ramps to South Century Drive via electric wildlife mats (ElectroMat™) and then wraps along the northern side of South Century Drive to the South Lava Butte underpass abutments (see Figure 4.1). This essentially leaves no way for deer (or other large mammals) to exit the southern end of the fenced treatment area, unless they successfully navigate over the ElectroMats™ to escape via the on/off ramps, use the Route 97 overpass over South Century Drive to exit to the south, or return to the jump-outs approximately half a mile back to the north or beyond to the northern fence ends.

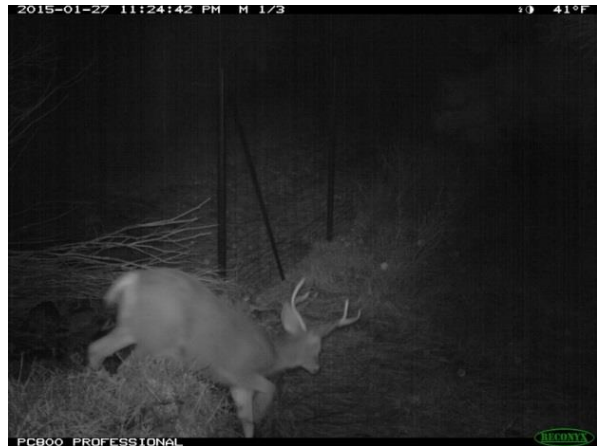
**1b. NEFE. Northeast fence-end that terminates at lava mound.**

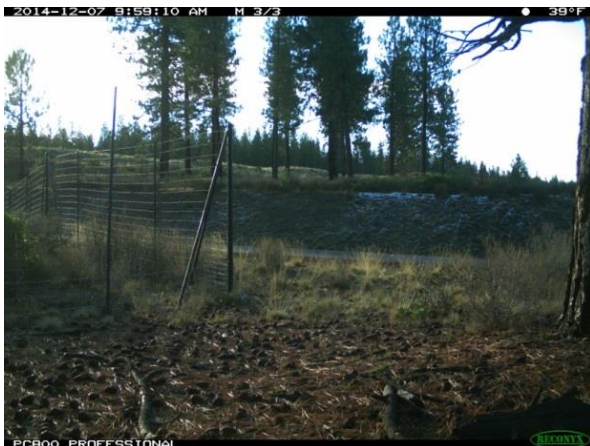
**1c. SWFE. Southwest fence corner near U.S. 97 south-bound off-ramp and Hwy 42.**

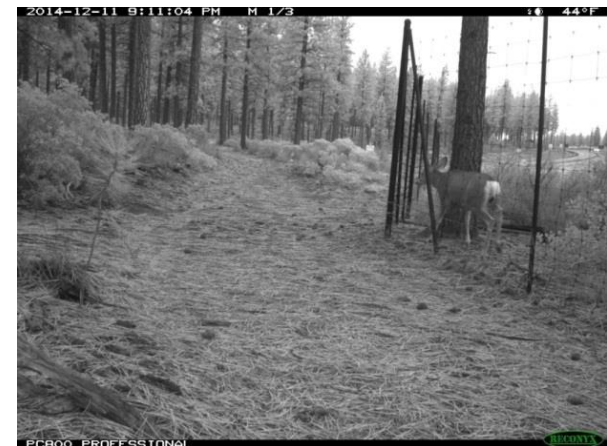
**1d. SEFE. Southeast fence line near U.S. 97 north-bound on-ramp along fence.**
