State of Oregon  
Department of  
Environmental  
Quality

# LANDFILL INSPECTION REPORT

| <b>FACILITY:</b> | Riverbend Landfill | | | | |
| <b>INSPECTOR(S):</b> | Bob Schwarz | | <b>INSPECTION DATE:</b> | Apr. 8, 2014 | |

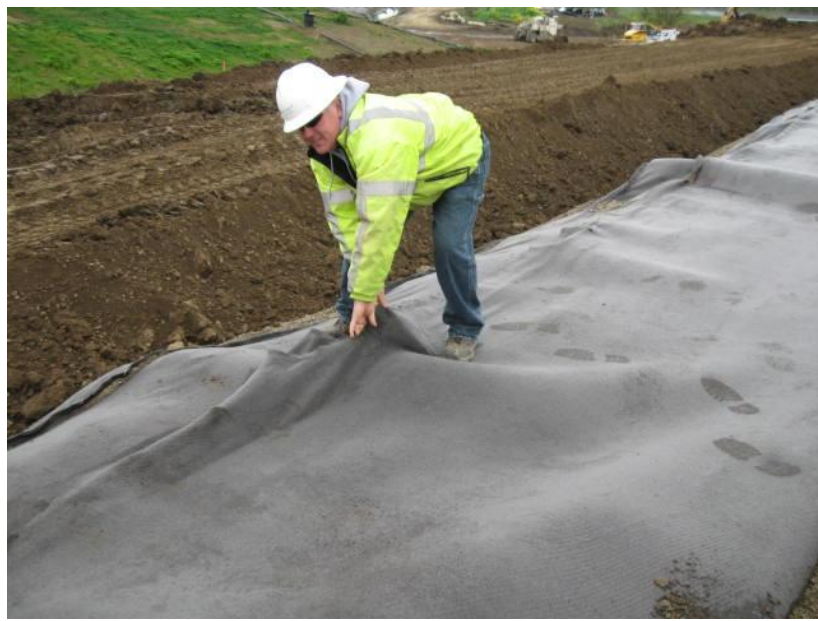
Photo shows the geosynthetic “chimney drain”. This is a geocomposite (drainage net sandwiched between two layers of geotextile) that runs vertically along the length of the berm, and separates the clay soil on the interior of the berm from the granular, reinforced soil on the exterior.

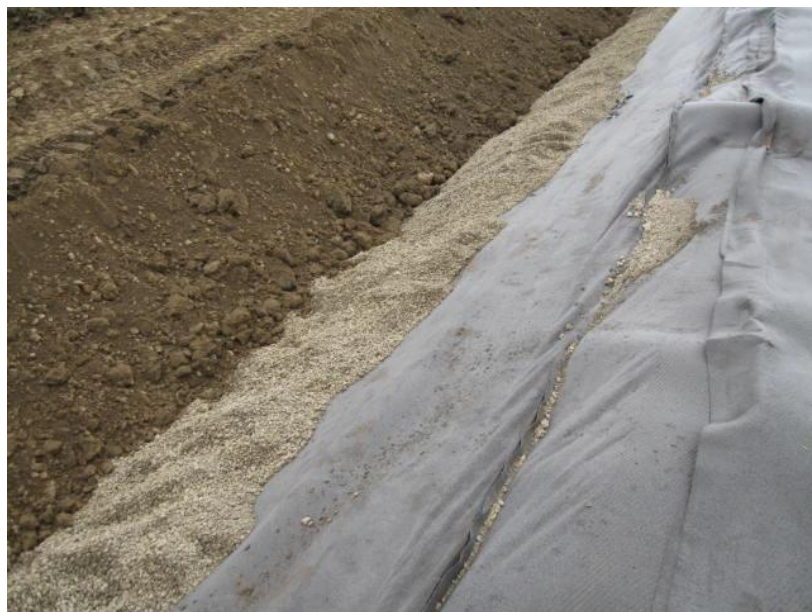
The contractor placed gravel along the outside of the chimney drain to protect it from damage during installation.

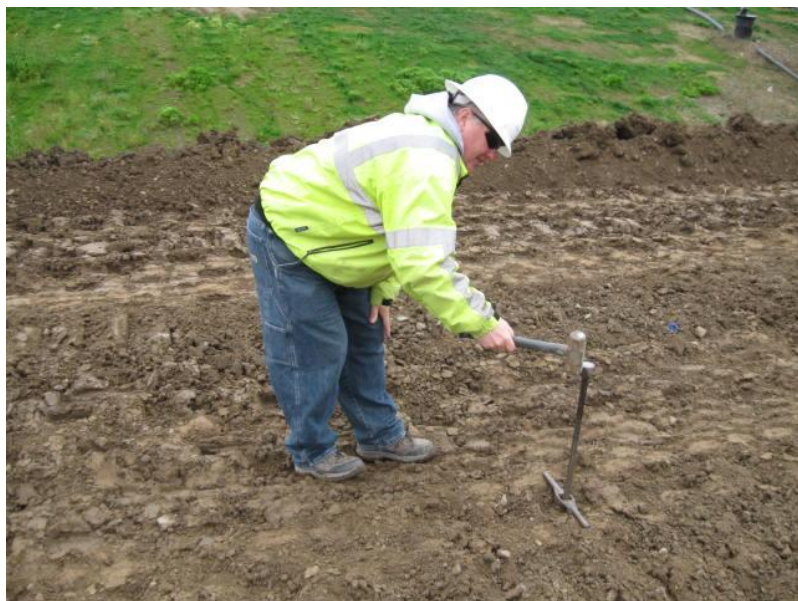
The clay for the berm interior is treated with cement to increase strength. Construction inspector hammers rod into treated clay as a qualitative test of the clay's strength.

| <p><b>MSE berm.</b> Work continues. Reinforced fill zone soil (granular soil) has not met specs recently regarding grain size distribution. This issue has temporary stopped import and placement of the fill zone on the outside of the berm. Clay soil on the inside of the berm is being spread today.</p> | | | | | |

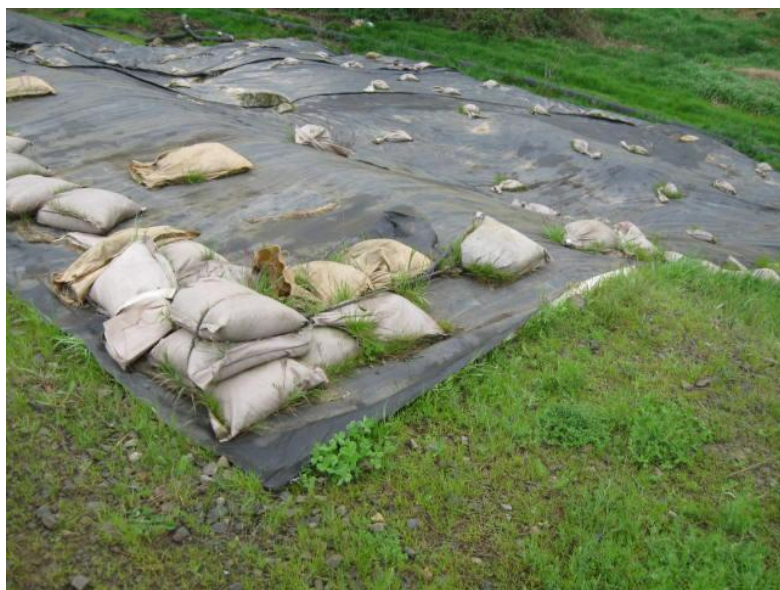
| <p><b>Soil sloughing on north side of landfill.</b> As noted in photos below, soil is sloughing on perimeter berm on landfill's north side. Geosyntec is working to address this problem.</p> | | | | | |

Topsoil has been observed sloughing off the perimeter berm on the north side of the landfill. A tarp was placed over a portion of this area to reduce the amount of rain getting into the soil. Waste Management's consultant, GeoSyntec, is evaluating how to correct this problem.

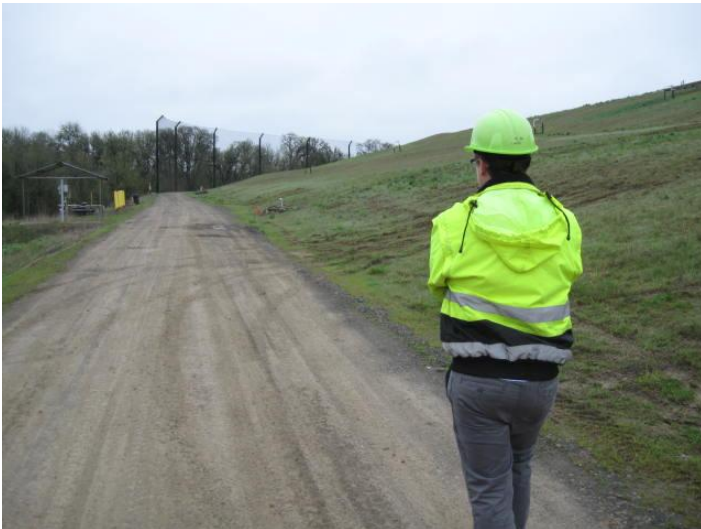
| <p><b>Litter. During March 19 inspection,</b> did observed plastic bags blowing off the landfill on the NE side. The litter fence on this side had large holes and bags were escaping from the landfill. As shown in photos below, the fence has been repaired. I did not see blowing litter during this inspection, though some plastic was captured by the litter fence.</p> | | | | | |

View of NE side of landfill. Blowing litter was observed during the previous inspection on March 19. Very little litter was observed today.

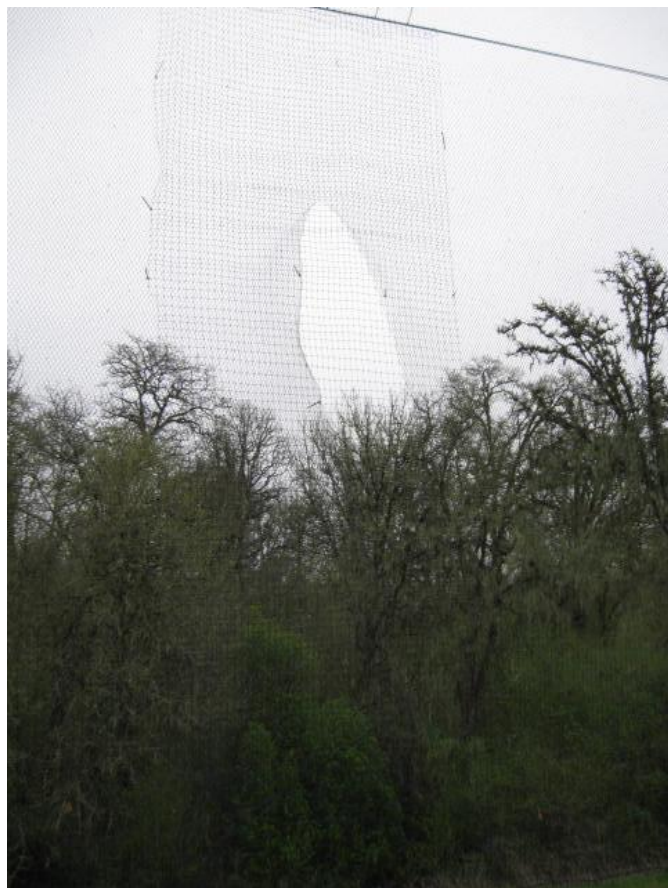
| I. | OPERATIONS | In Compliance | Not in Compliance | N/A for this Inspection | Follow-up required |
|---|---|---|---|---|---|
| | Notes: I observed approximately 50 to 100 bags on the north and east sides of the landfill, blowing to the northeast. The tall litter fence placed there had several very large holes, and some of the bags were getting through the holes and leaving the landfill. Tim Watson mentioned that these slopes were free of litter just a few hours before, and were the result of the wind gusts that had started in the afternoon. Tim also said he was working on getting bids for repair of the litter fence. Following my inspection, I contacted the landfill by email and requested details of schedule for repair of the fence and improved litter control efforts. | | | | |

The litter fence installed on the NE side of the landfill. During the March 19 inspection, large holes were found in the fence. These have been repaired. Some litter was observed at the bottom of the fence.

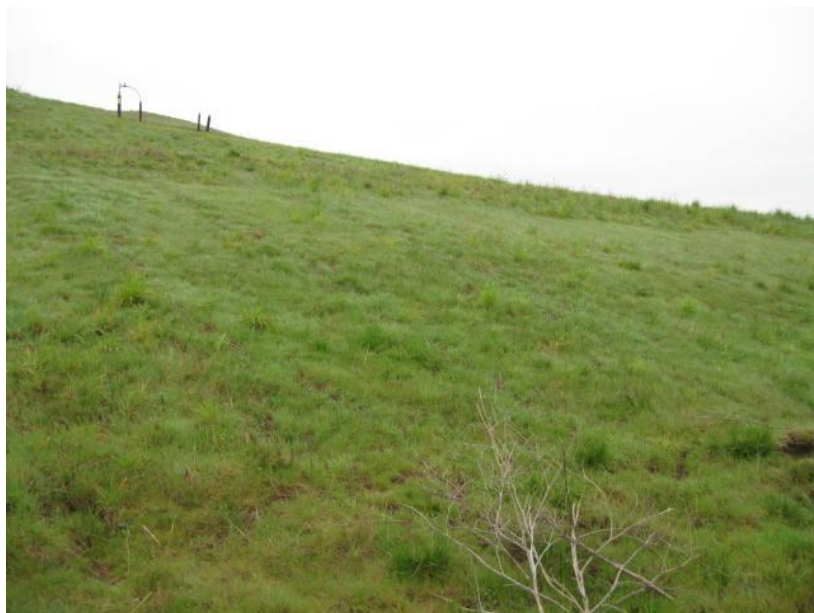
View of landfill's NE slope. As noted above, blowing litter was observed during the March 19 inspection. Much less blowing litter was seen today.
