**ASSESSMENT AND MITIGATION OF  
LIQUEFACTION HAZARDS TO  
BRIDGE APPROACH EMBANKMENTS  
IN OREGON**

**Final Report**

**SPR 361**

November 2002

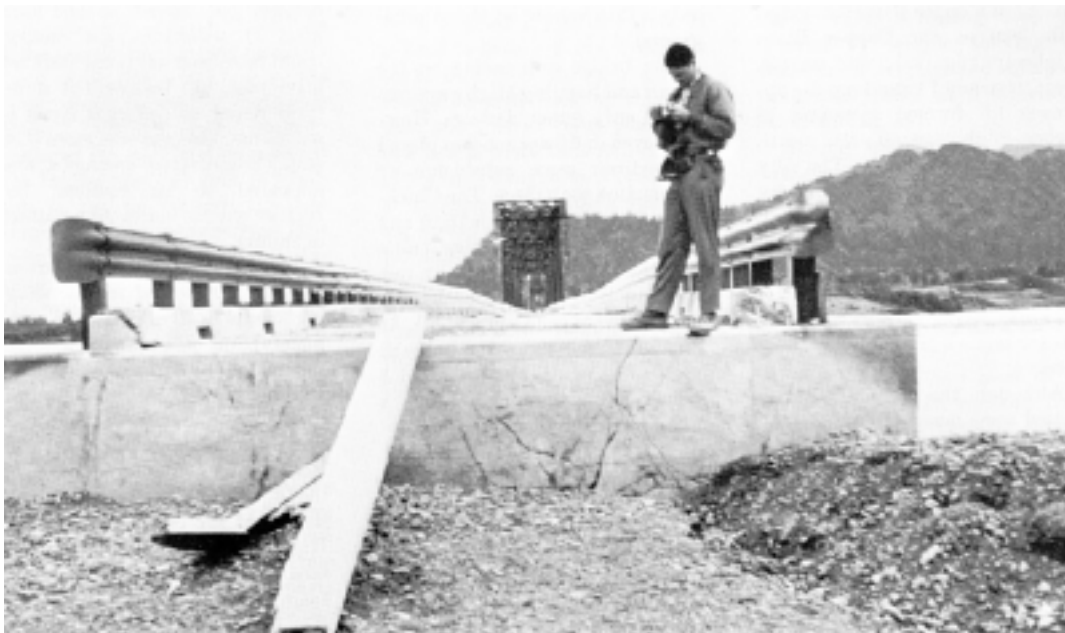
Figure 2.10(b): Post-earthquake Settlement at Copper River Bridge 334

Nineteen bridges were also damaged along a 35-km stretch of highway on the Copper River. Most of these bridges sustained moderate to severe deformations with spans collapsing in at least six crossings. Prevalent types of failure included severe abutment deformation and vertical displacement of foundations. At Bridge 334 shown in Figure 2.10(a), damage occurred as a result of differential pier settlement. Extensive deposits of sand and gravel dominate the Copper River region, where considerable evidence of liquefaction was present in the form of fissures and subsidence craters with adjacent ejected soil. Extensive post earthquake settlement of the approach fill was also evident at Bridge 334 as shown in Figure 2.10(b).

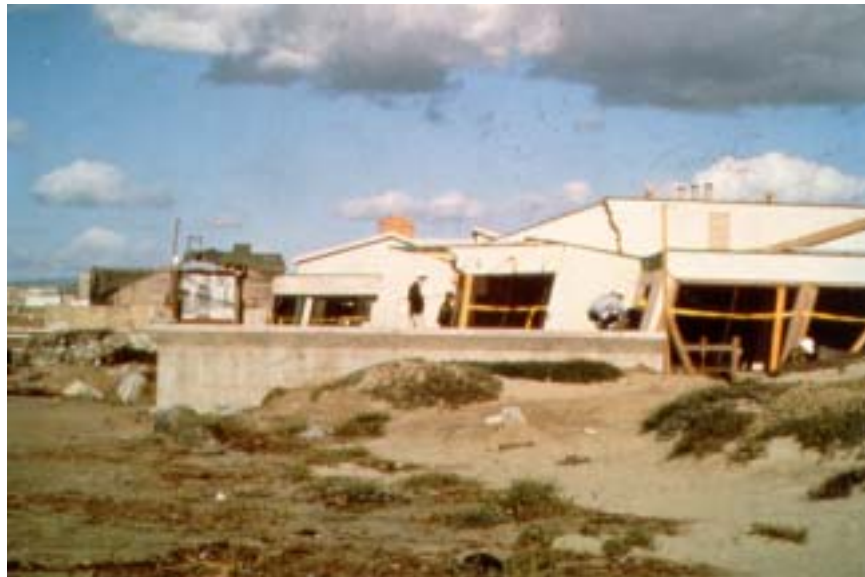
Figure 2.18: Damage to the Moss Landing Research Facility due to Settlement and Lateral Spreading

An interesting observation was that soil liquefaction in the Monterey and San Francisco Bay areas occurred at many of the same locations that exhibited ground failures during the 1906 earthquake. These ground failures were conspicuous in the Monterey Bay/Watsonsville region. Here, liquefaction was directly responsible for the destruction of a Marine Research Facility at Moss Landing as well as damage to other structures and facilities (*Seed et al. 1990; Boulanger et al. 1998a*). The Research Facility was located on a sandy peninsula between the Pacific Ocean and the old trace of the Salinas River. Fissures and sand boils were found in the immediate vicinity of the facility. As illustrated in Figure 2.18, the structure settled several meters, and lateral spread deformations of the foundation soils were roughly 2 m. Similar, yet more severe lateral spreading occurred in this area during the 1906 earthquake, as shown in Figure 2.19.

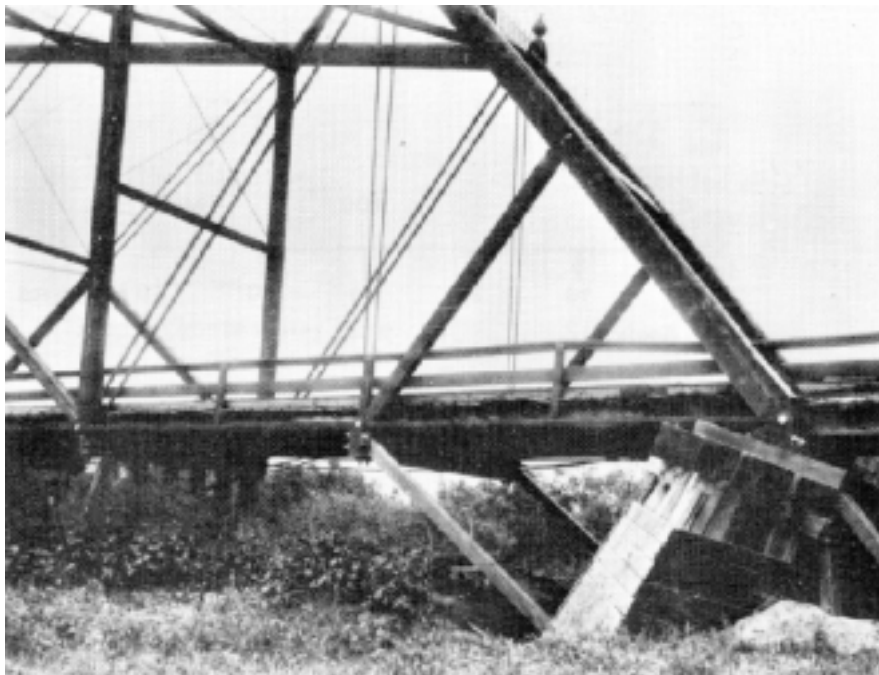
Figure 2.20: South Terminal Pier of Bridge over Salinas River 6.4 km South of Salinas

Several intriguing comparisons can be made regarding the seismic performance of highway and railroad bridges in the lower Salinas River region. The Salinas River Highway Bridge is located roughly 5 km from the Moss Landing site. Damage to a highway bridge at this site during the 1906 earthquake is illustrated in Figure 2.20. The ground displacement moved the base of the pier 2.8 m toward the river. The bridge deck and truss acted as strut, holding the tops of piers in place while their bases shifted inward.

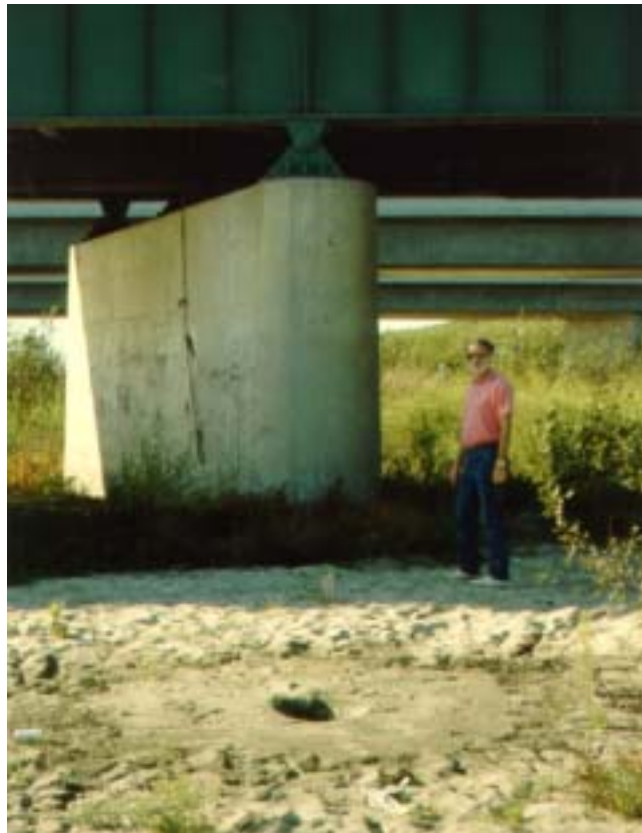
Figure 2.21: Liquefaction-induced Lateral Spreading beneath the Salinas River Highway Bridge

In this vicinity during the 1989 earthquake, liquefaction-induced lateral spreading was once again evident as shown in Figure 2.21. The U.S. Highway 1 and adjacent frontage road bridges were undamaged by the earthquake despite evidence of sand boils, ground oscillation, and lateral spreading of approximately 0.5 meter toward the river. At this same site, relatively large lateral and vertical ground deformations were observed next to a railroad bridge as shown in Figure 2.22. However, the bridge components were not damaged during this earthquake. It is of historic interest that the bridge pier shown in Figure 2.22 was substantially damaged during the 1906 earthquake. Finally, a one-lane bridge located at Moss Landing (in close proximity to the Research Facility) sustained minor damage due to lateral spreading of the approach fill as shown in Figure 2.23.

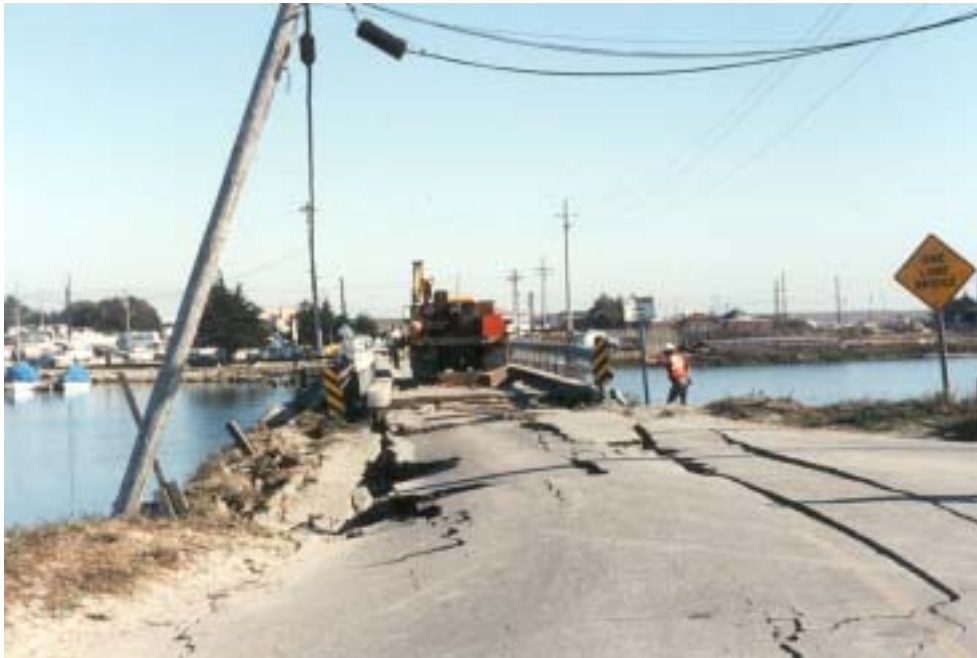
Figure 2.23: Excessive Settlement of Approach Fill

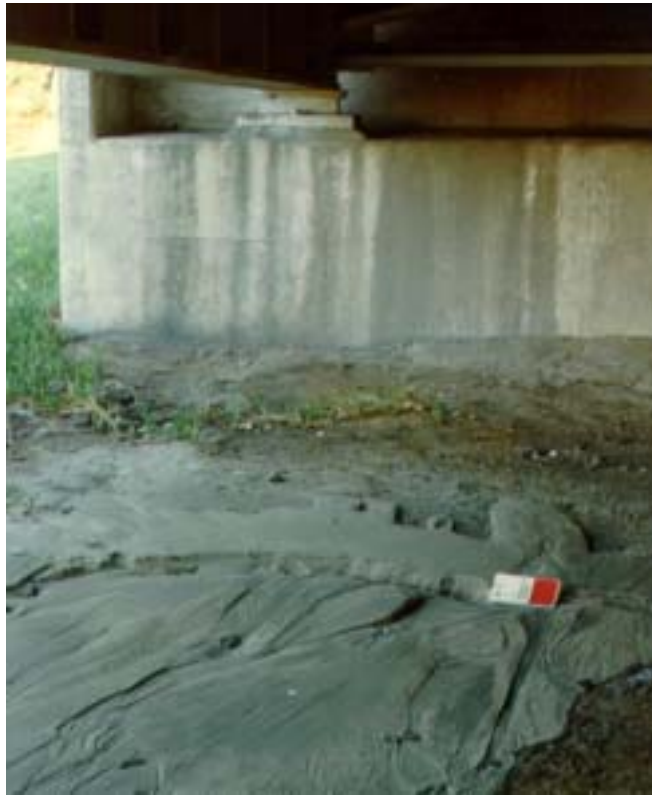
Figure 2.24: Sand Boils at the Oakland-San Francisco Bay Bridge Approach Fill

In the San Francisco Bay area, much farther from the rupture zone, minor liquefaction as evidenced by small sand boils also occurred beneath several elevated sections of the I-80/Grand Avenue Highway “distribution structure” immediately inland of the Oakland-San Francisco Bay Bridge approach fill. Figure 2.24 shows a linear zone of boils adjacent to a pile-supported abutment.

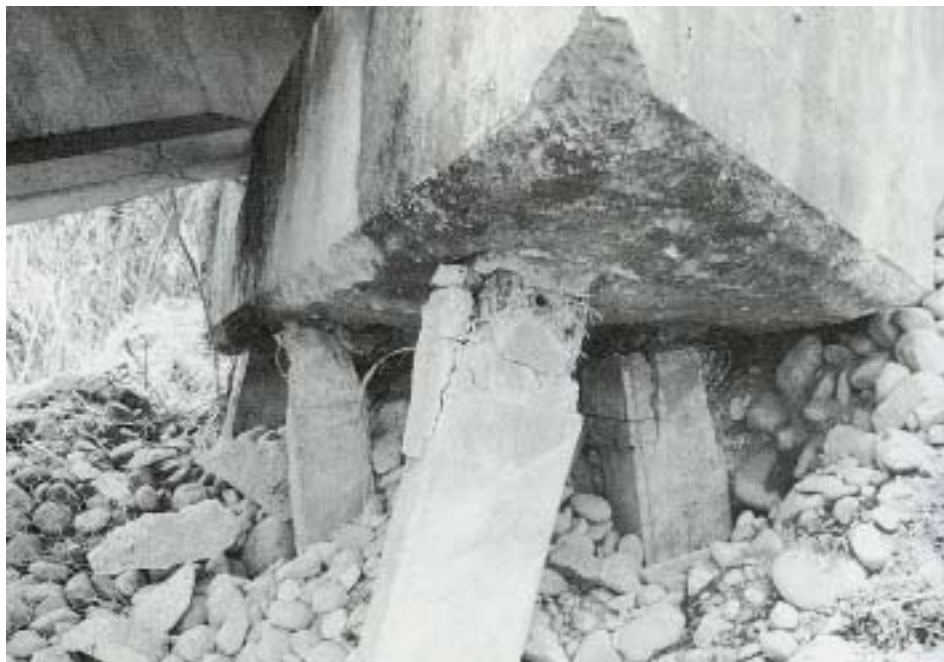
Figure 2.25: Rio Vizcaya Bridge, Pile Failures (North Abutment)

The Rio Viscaya Bridge, a three-span pre-stressed concrete bridge founded in loose sands, collapsed due to loss of soil support and ground deformations resulting from liquefaction. The bridge lost two spans due to severe abutment rotation, resulting in pile distress (Figure 2.25) and the collapse of one interior support. A second interior support settled vertically about 1 m. Geotechnical boring logs near the north abutment showed that the entire length of piles were supported in sands and silty sands. Liquefaction of soils in approach fills caused lateral spreading and bearing capacity failure. The north roadway approach fill settled approximately 1.2 m. Both north and south abutments rotated as a result of movement of liquefied soils.

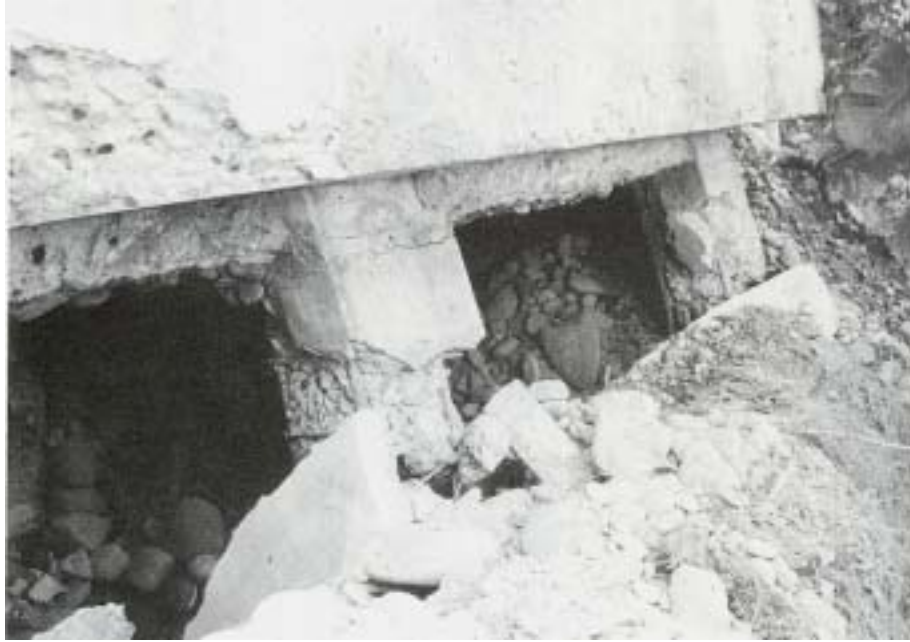
Figure 2.26: Damage due to Liquefaction at Rio Banano Bridge

The Rio Banano Bridge provides an additional example of severe damage due to liquefaction. It was a single lane bridge consisting of three 22 m spans of twin prestressed concrete I-beams, located at a river crossing. The soil movement caused about a  $9^\circ$  rotation of the south abutment resulting in a movement of the pile tops toward the river of roughly 0.7 m. All piles were 36 cm square precast concrete piles. The front piles, driven at a batter of 1H:5V, suffered flexural as well as shear failures (Figure 2.26). Vertical piles at the rear portion of abutment pile caps showed less damage. As observed at other bridges, the approach fills slumped substantially and restricted access until the grade could be restored.

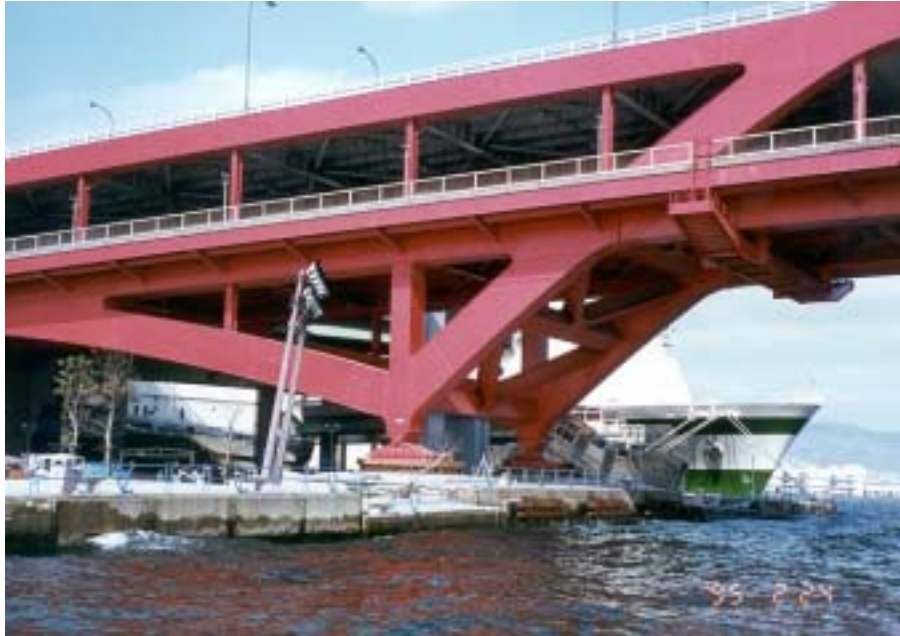
Figure 2.32: Kobe Ohashi Bridge Damage

The Kobe Ohashi Bridge also suffered damage due to the lateral displacement of the caisson foundations as shown on Figures 2.32 and 2.33. In this latter case, the effects of vertical and lateral foundation deformations were evident along the waterfront and at the sliding bearing at the north side of the bridge where roughly 0.6 m of offset was observed (Figure 2.33).

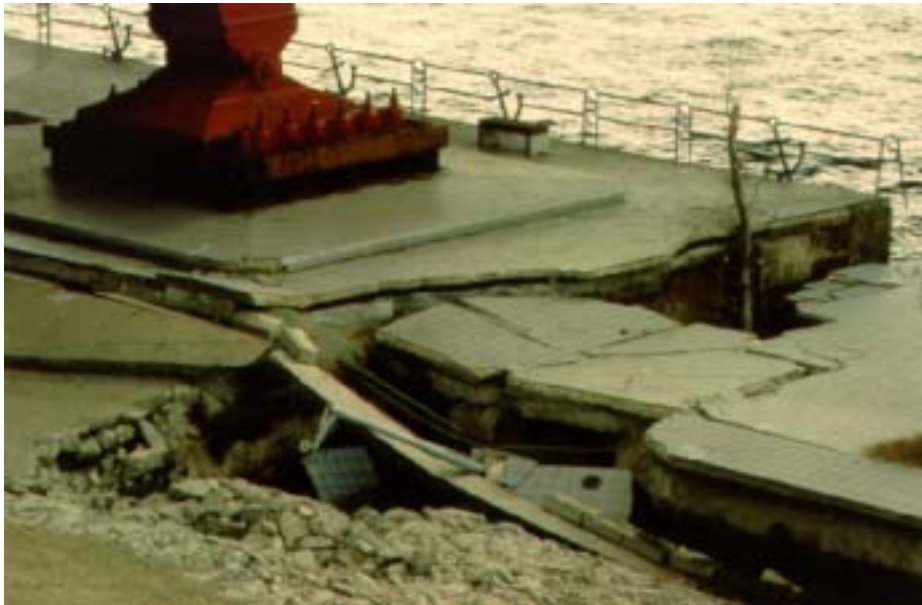
Figure 2.33: Foundation Damage at Kobe Ohashi Bridge

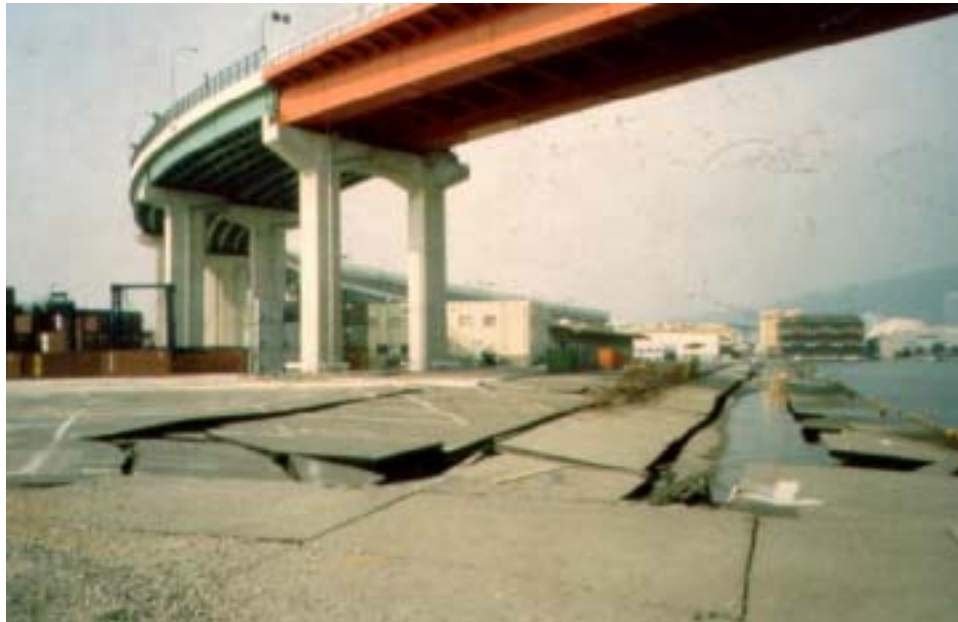
Figure 2.34: Nadahama Ohashi Bridge Lateral Spreading of 3 to 4 m

Examples of acceptable bridge foundation performance also were observed in areas conspicuous for liquefaction-induced ground failures. The foundations employed at several of these sites were large groups of steel pipe piles filled with concrete, thereby providing significant resistance to the lateral earth pressures and drag caused by liquefied soil. One such example is the Nadahama Ohashi Bridge where lateral spreading of about 0.5 m was found, as shown in Figure 2.34, yet the bridge did not experience any loss of service (*Hamada et al. 1995*). Soil liquefaction and ground surface settlement was evident at the pile cap adjacent to the waterfront (Figure 2.35).

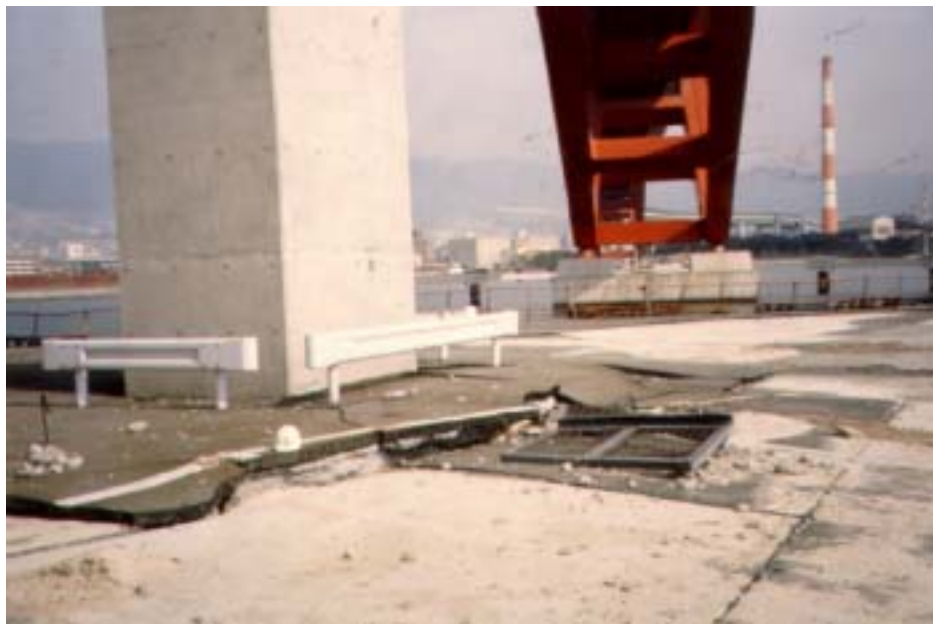
Figure 2.35: Liquefaction Damage Adjacent to the Nadahama Ohashi Bridge

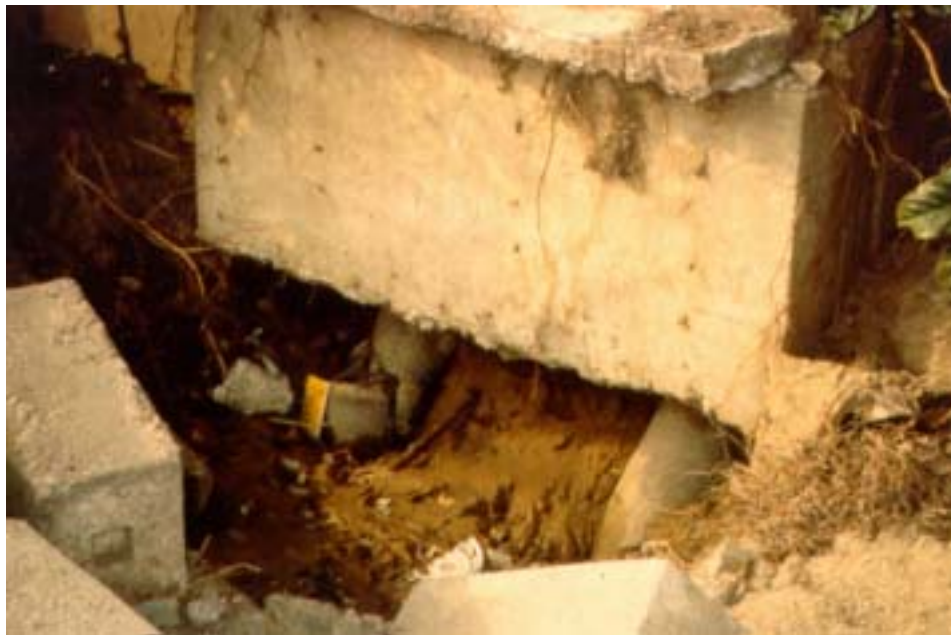
Figure 2.37: Damage to Pile Foundations near the Nadahama Ohashi Bridge
